Appendix J : “As-Found” Conditions Photographs

J.1 Past/Present Conditions Photographs

J.2 “As-Found” Exterior Photographs

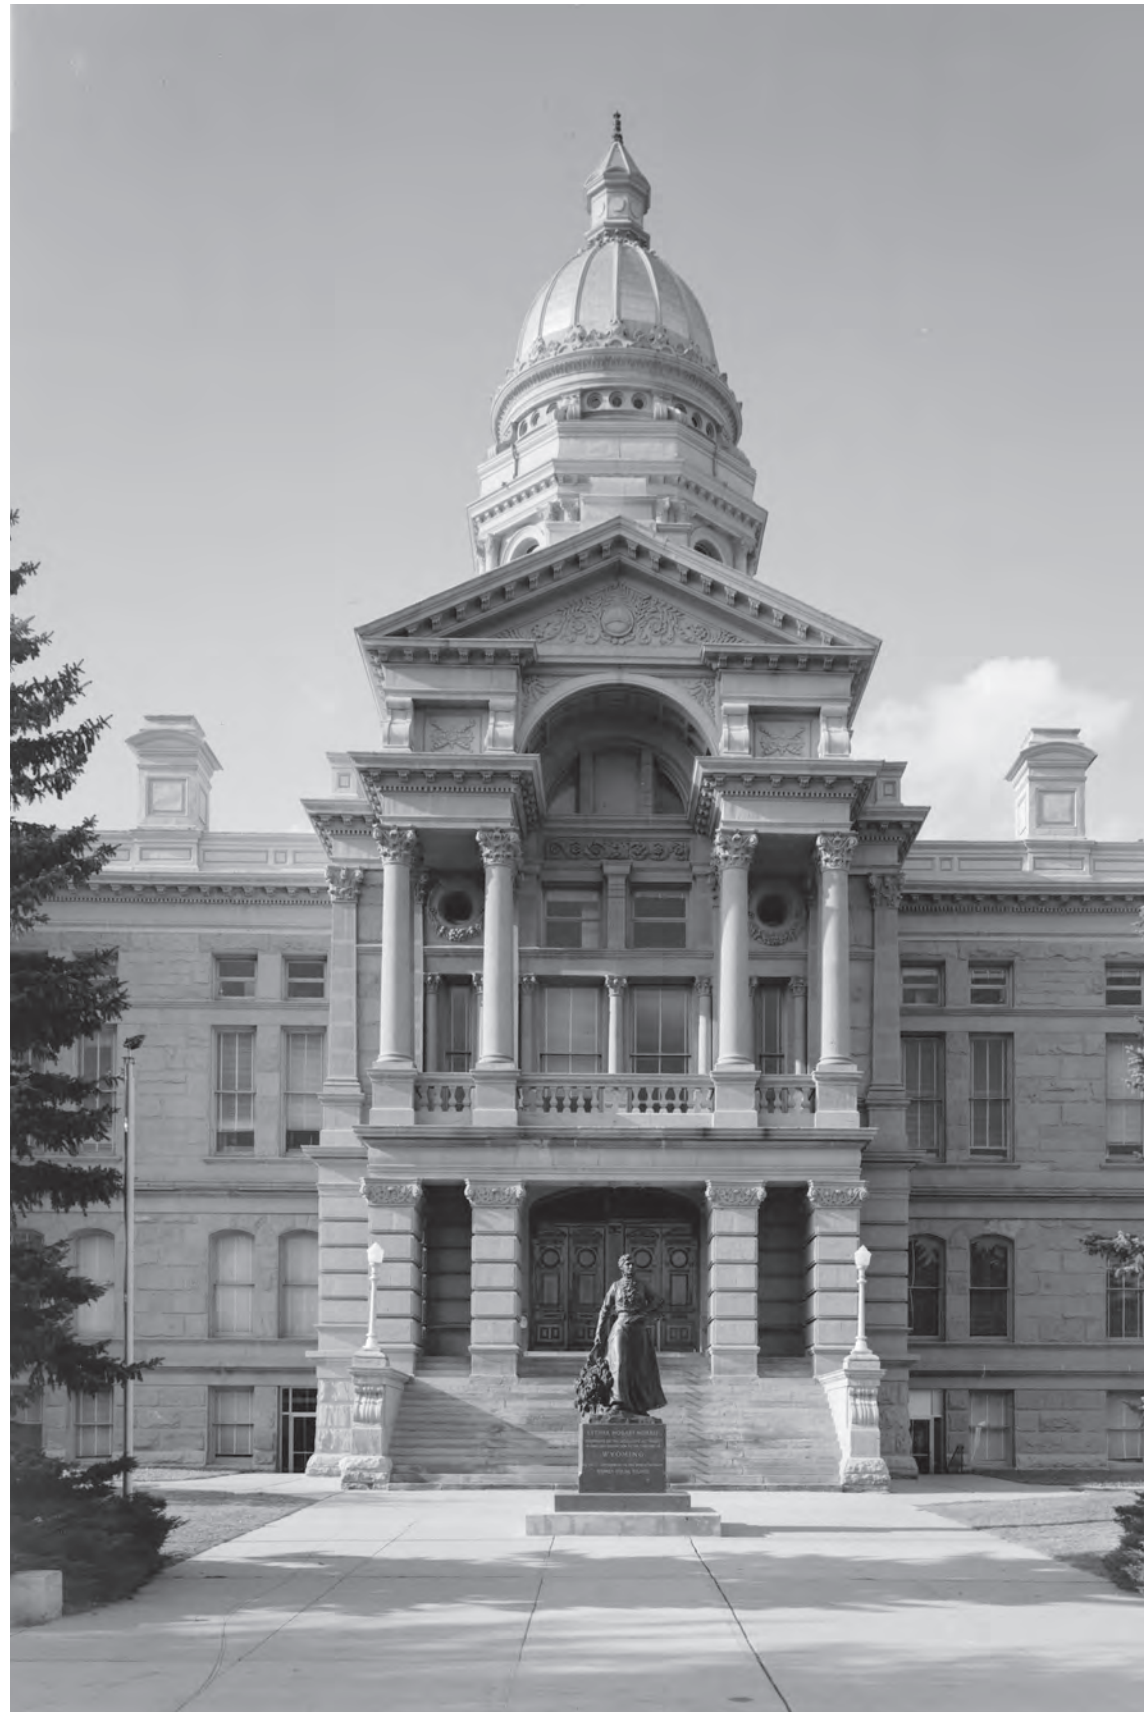
Figure J.1.7: HABS Photograph, ca. 1979 of the South Portico, Looking North. Note the South Plaza is Flanked by Two [2] Blue Spruce Trees and the Statue of Esther Hobart Morris is Located in the Center.

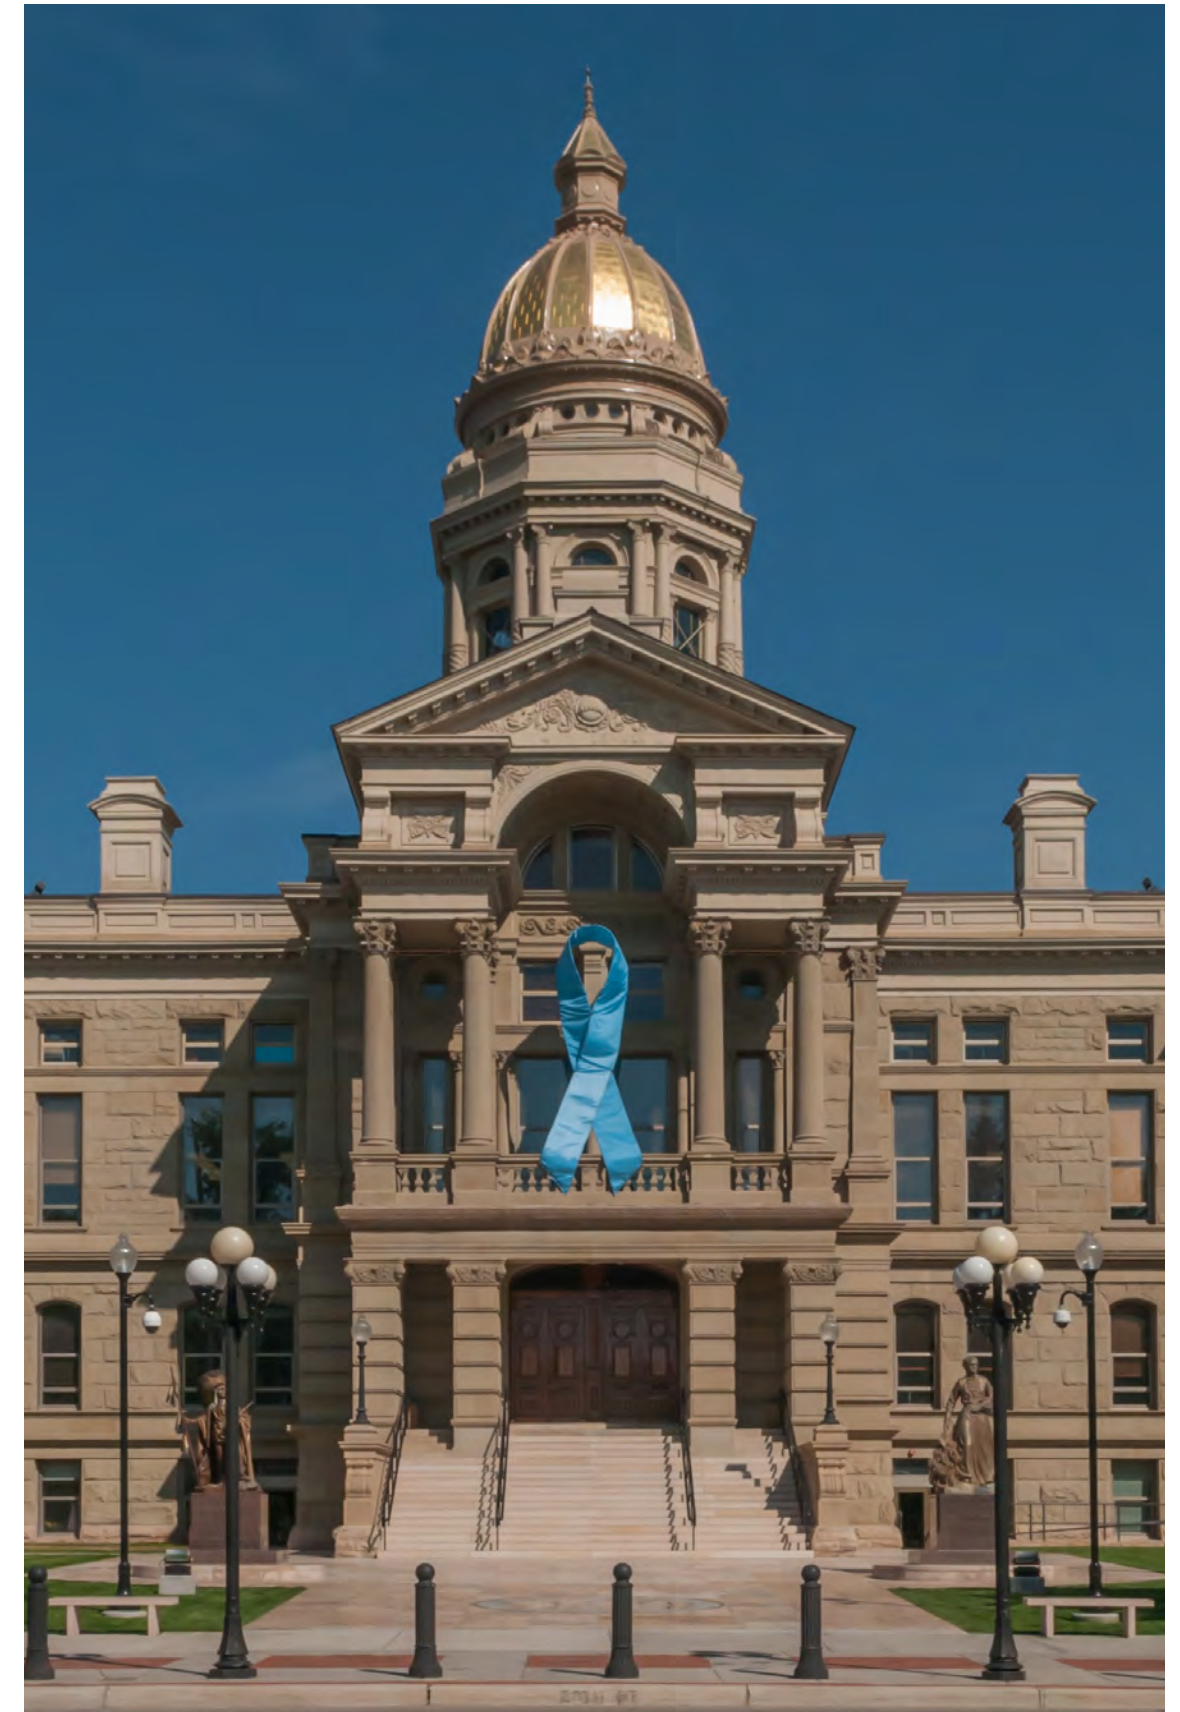
Figure J.1.8: South Portico, Looking North. Note the Spruce Trees Are No Longer Extant and the Statues of Esther Hobart Morris and Chief Washakie Are Situated on the East and West Sides of the South Plaza.

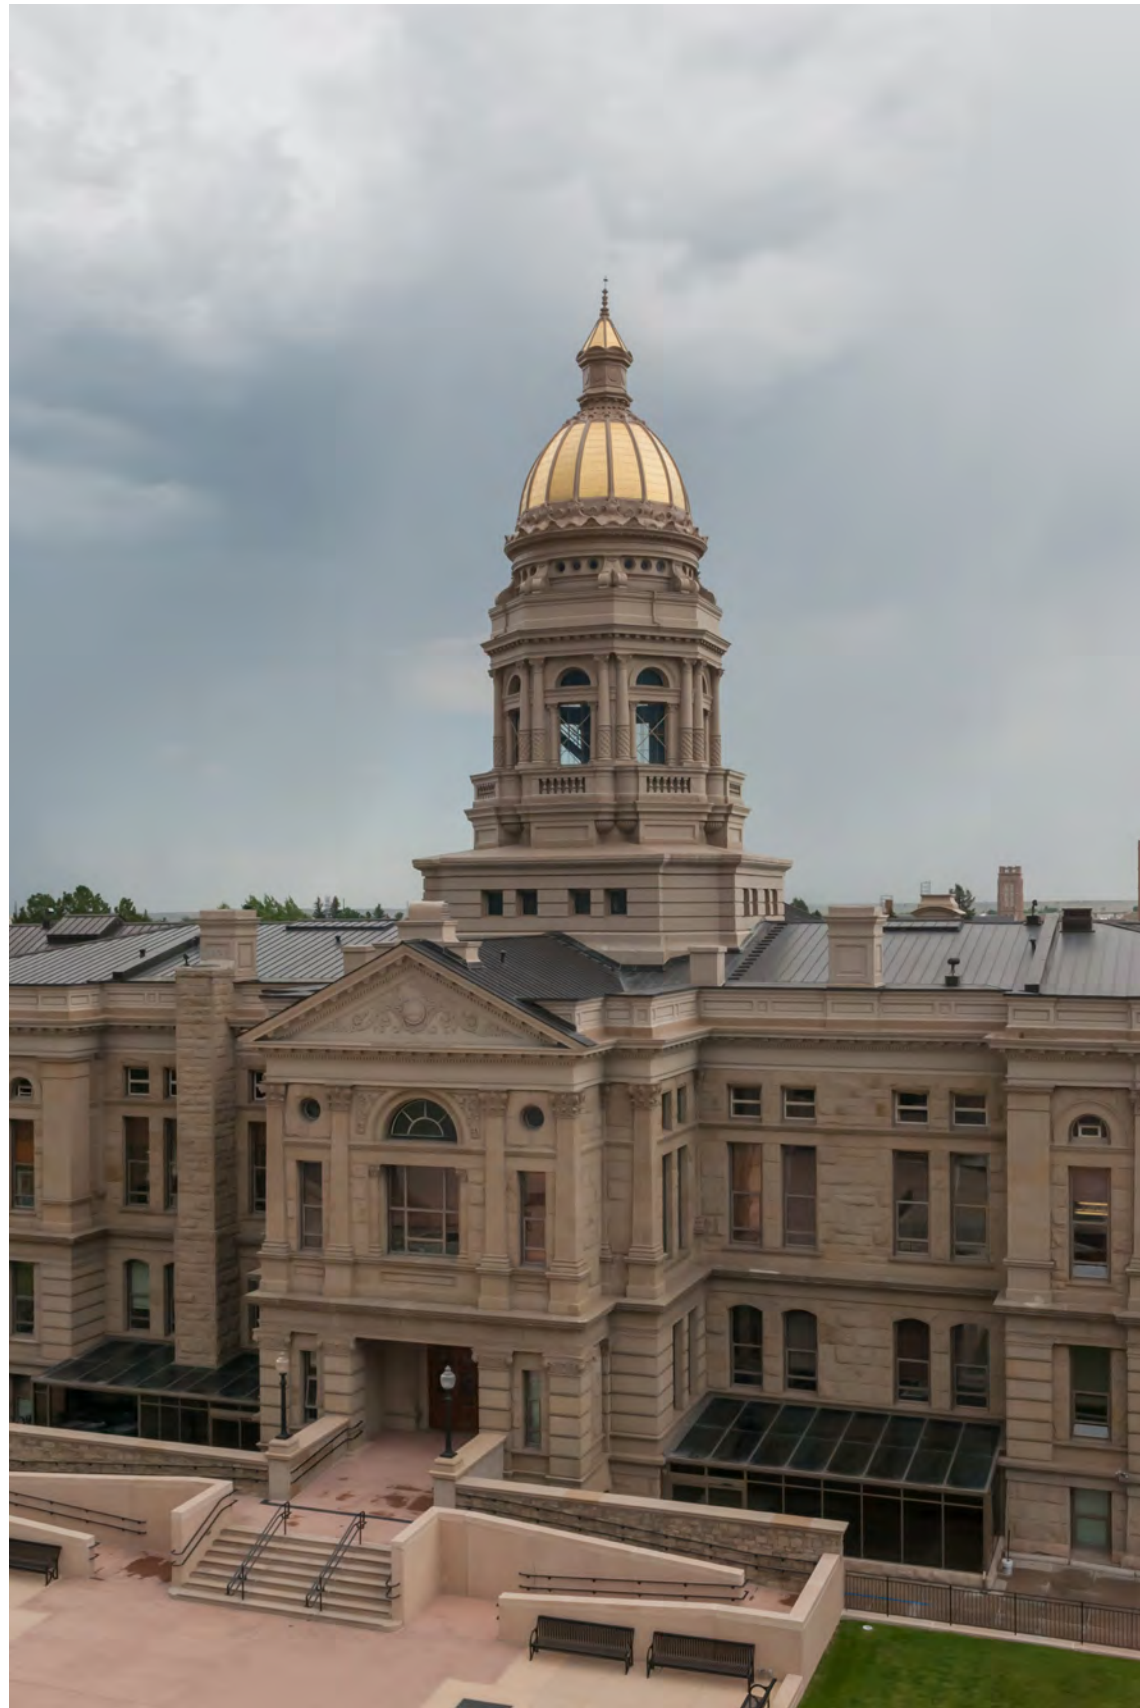
Figure J.2.26: North Elevation and Herschler Plaza Looking Southeast From the Roof of the Herschler Building. Note the Stair and Flanking ADA Ramps Leading From Herschler Plaza to the Capitol North Entry Door.

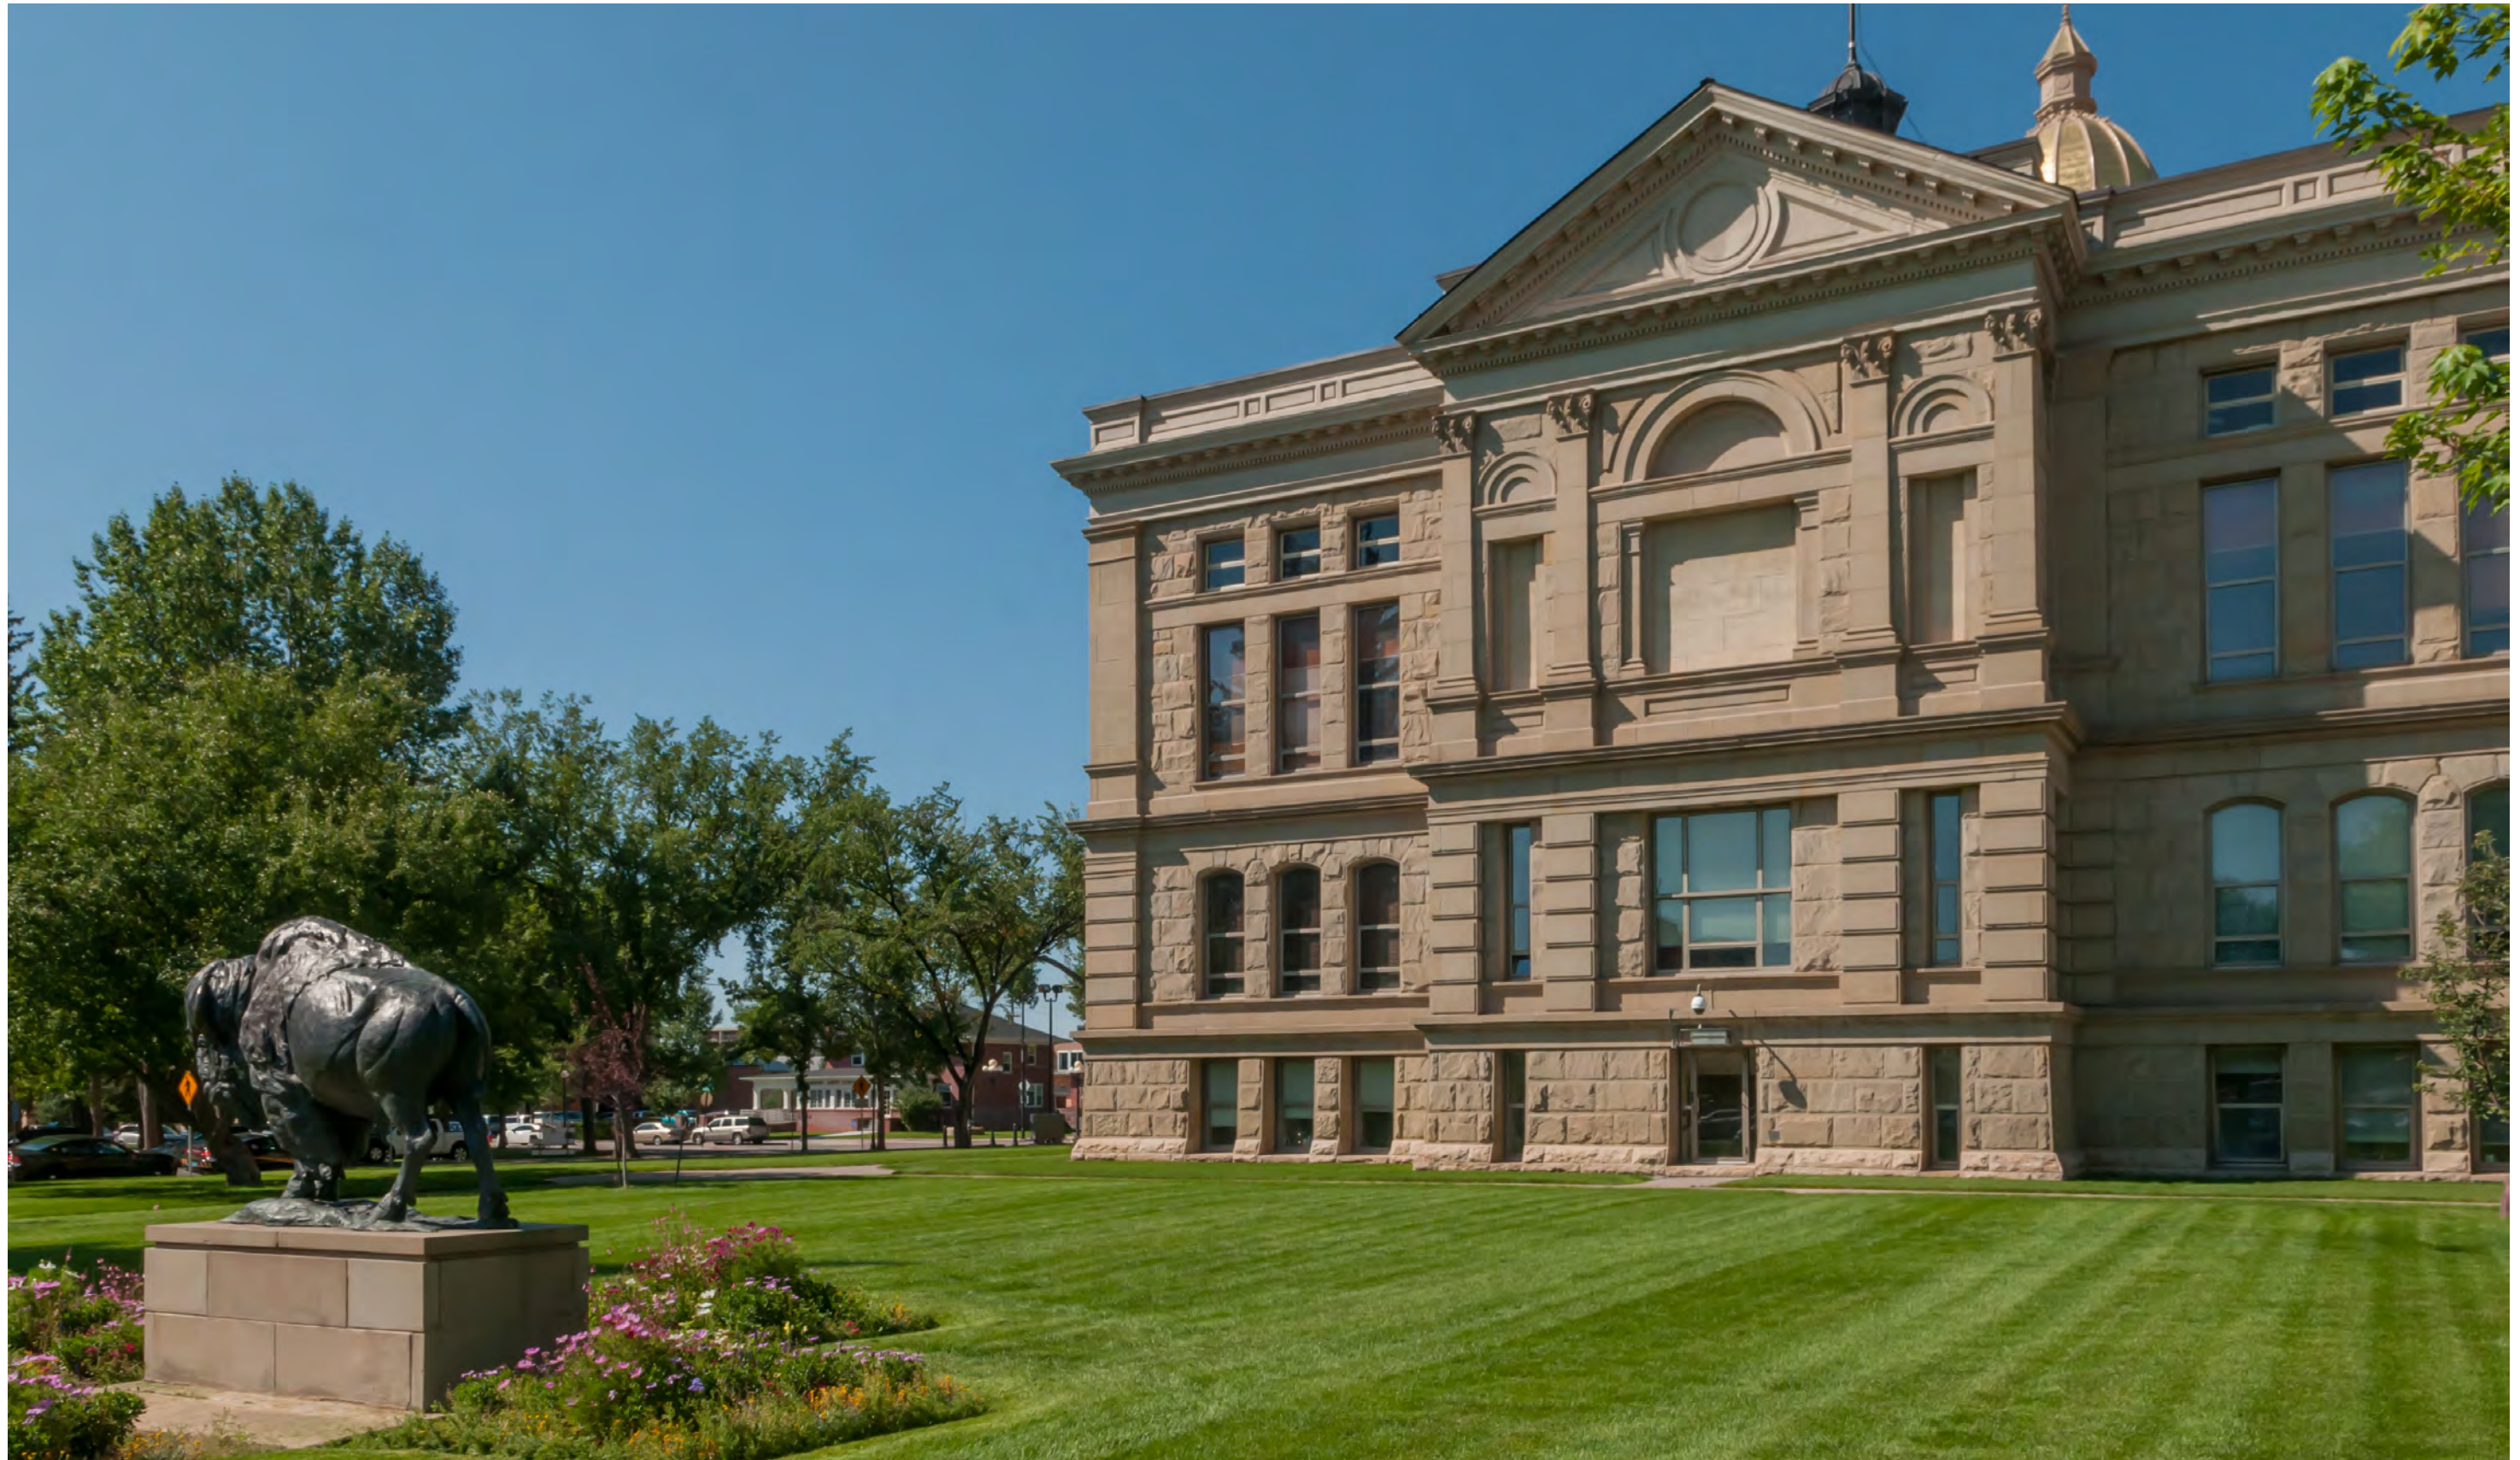
Figure J.2.38: East Elevation Looking Southwest. Note the Bronze Bison Statue and Radiating Flower Beds in Center of East Lawn.
