WYOMING STATE CAPITOL REHABILITATION & RESTORATION

LEVEL I RECONNAISSANCE / LEVEL II FEASIBILITY STUDY

Appendix K : Capitol Dome Conditions Survey Report

LEVEL I /LEVEL II CAPITOL DOME CONDITIONS SURVEY REPORT

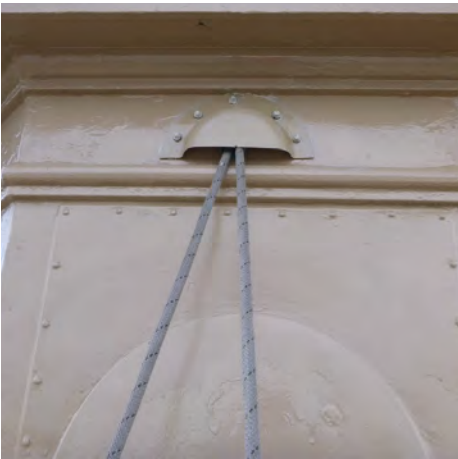
Figure 2. The painted copper cowl was screwed and caulked in place from the exterior.

At project completion, VA removed all rigging equipment from the building and installed a cowl over the rigging hole to prevent water infiltration. The copper cowl was painted to match the lantern exterior (with paint supplied by Suzanne Norton) then was screwed and caulked in place over the rigging hole (see Figure 2). The cowl permits future use of the rigging hole without requiring removal. From the interior, VA installed an expandable rubber plug to prevent bats, debris and other material from going through the rigging hole (see Figure 3).

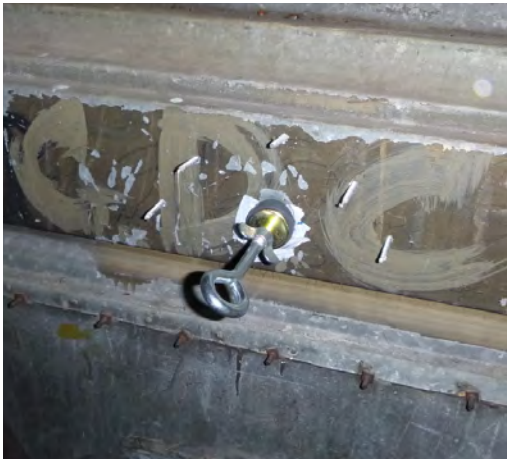
Figure 3. An expandable rubber plug was installed from the interior of the rigging hole
