Appendix M : Life Safety and Fire Protection Assessment

WYOMING STATE CAPITOL REHABILITATION & RESTORATION

LEVEL I /LEVEL II LIFE SAFETY AND FIRE PROTECTION ASSESSMENT

24 FEBRUARY 2014

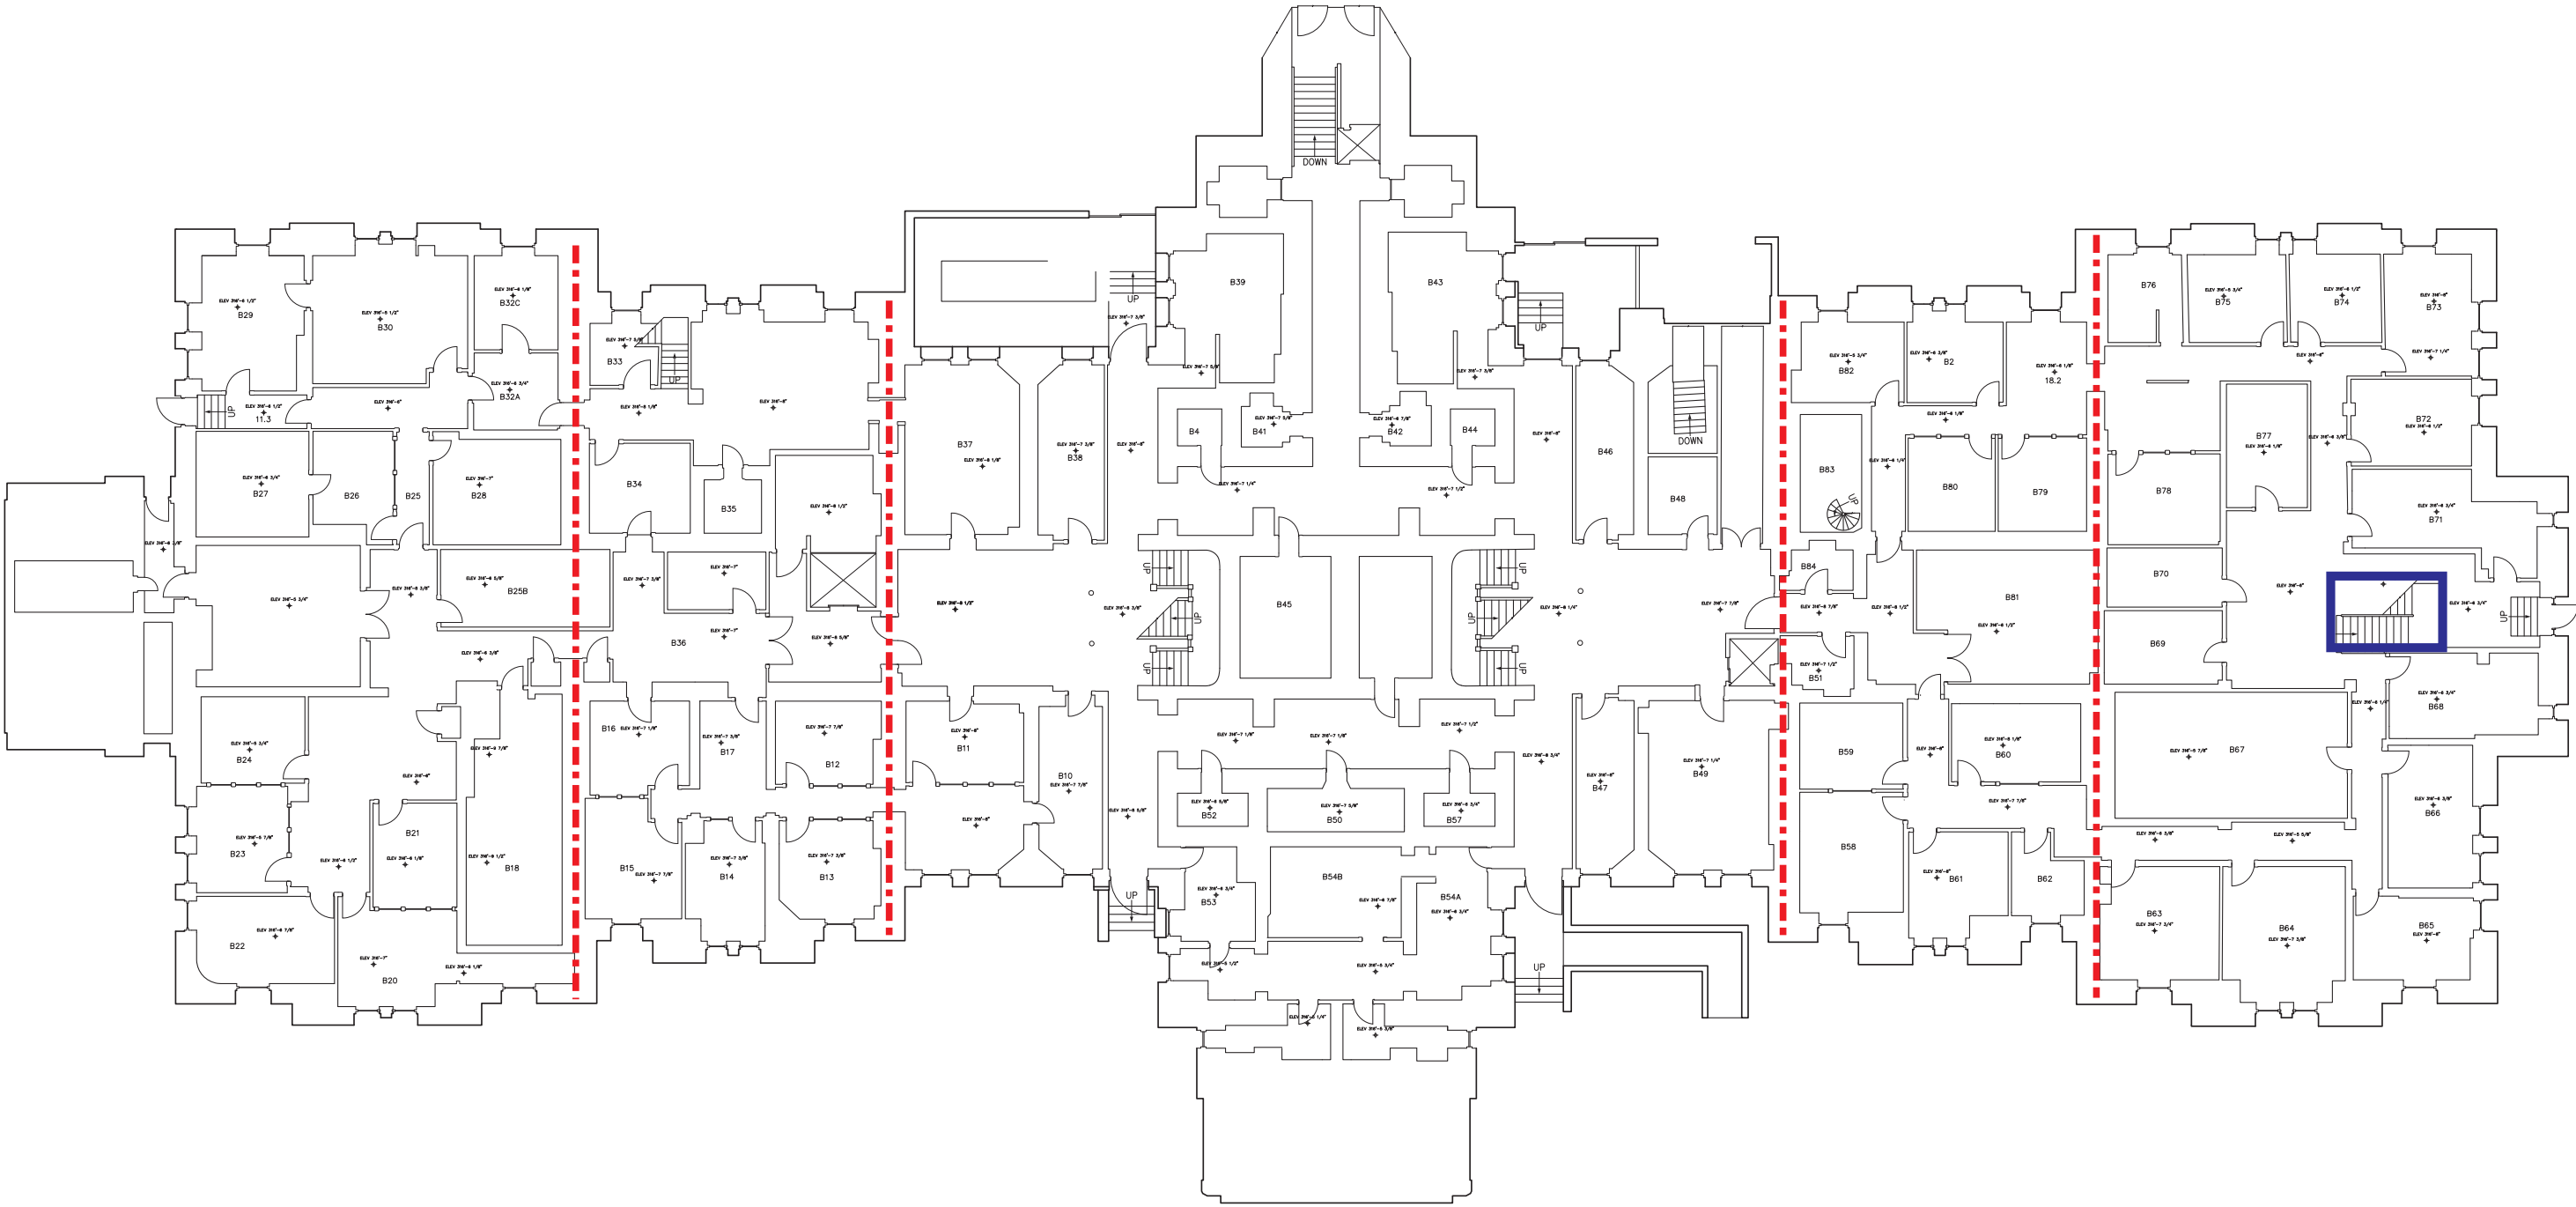
Figure 2-3. Basement Level Existing Horizontal Fire Barriers and Vertical Openings.

A preliminary review of the floor/ceiling assemblies separating the Basement, First Floor, Second Floor, and Third Floors indicates the assemblies provide a minimum 1-hour fire-resistance rating/separation. Vertical openings [stairs] between the Basement and First Floor are protected with 1-hour fire-resistance-rated door assemblies, thus creating two separate vertical fire compartments as shown in [Figure 2-3](#).

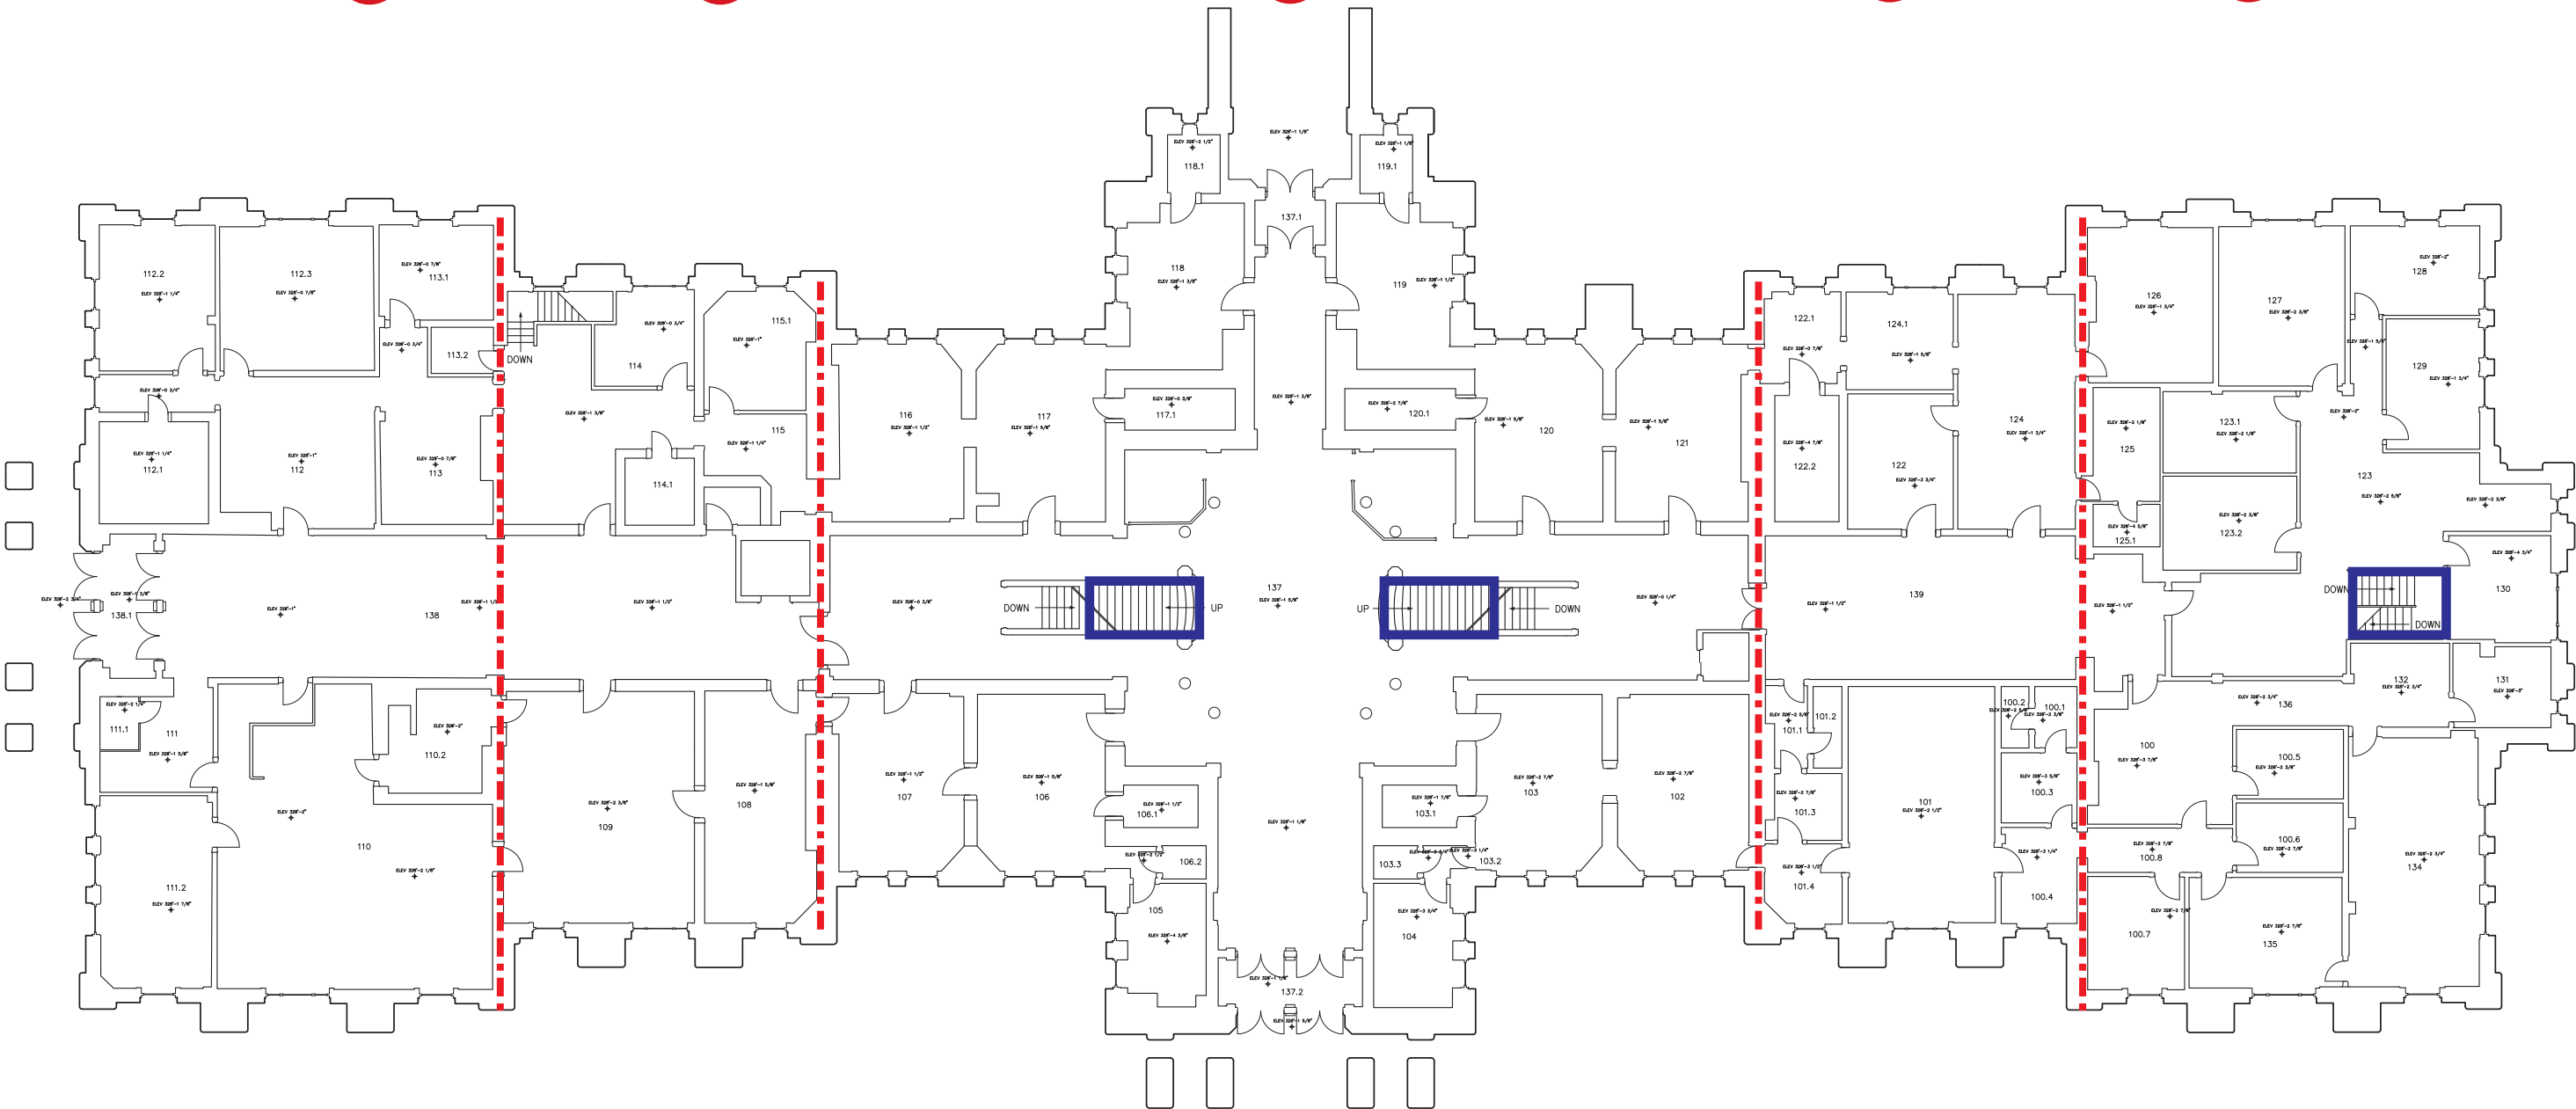
Figure 2-4. First Floor Level Existing Horizontal Fire Barriers and Vertical Openings.

The First through Third Floors are open to each other via the Rotunda and two stairs, thus creating a single fire area. The floor/ceiling assembly separating the Third Floor from Attic appears to be of steel and wood frame construction that, thus, does not provide a fire-rated separation. Therefore, the building center extending from the First Floor to Third Floor and the entire Third Floor and Attic are considered to be a single fire area.

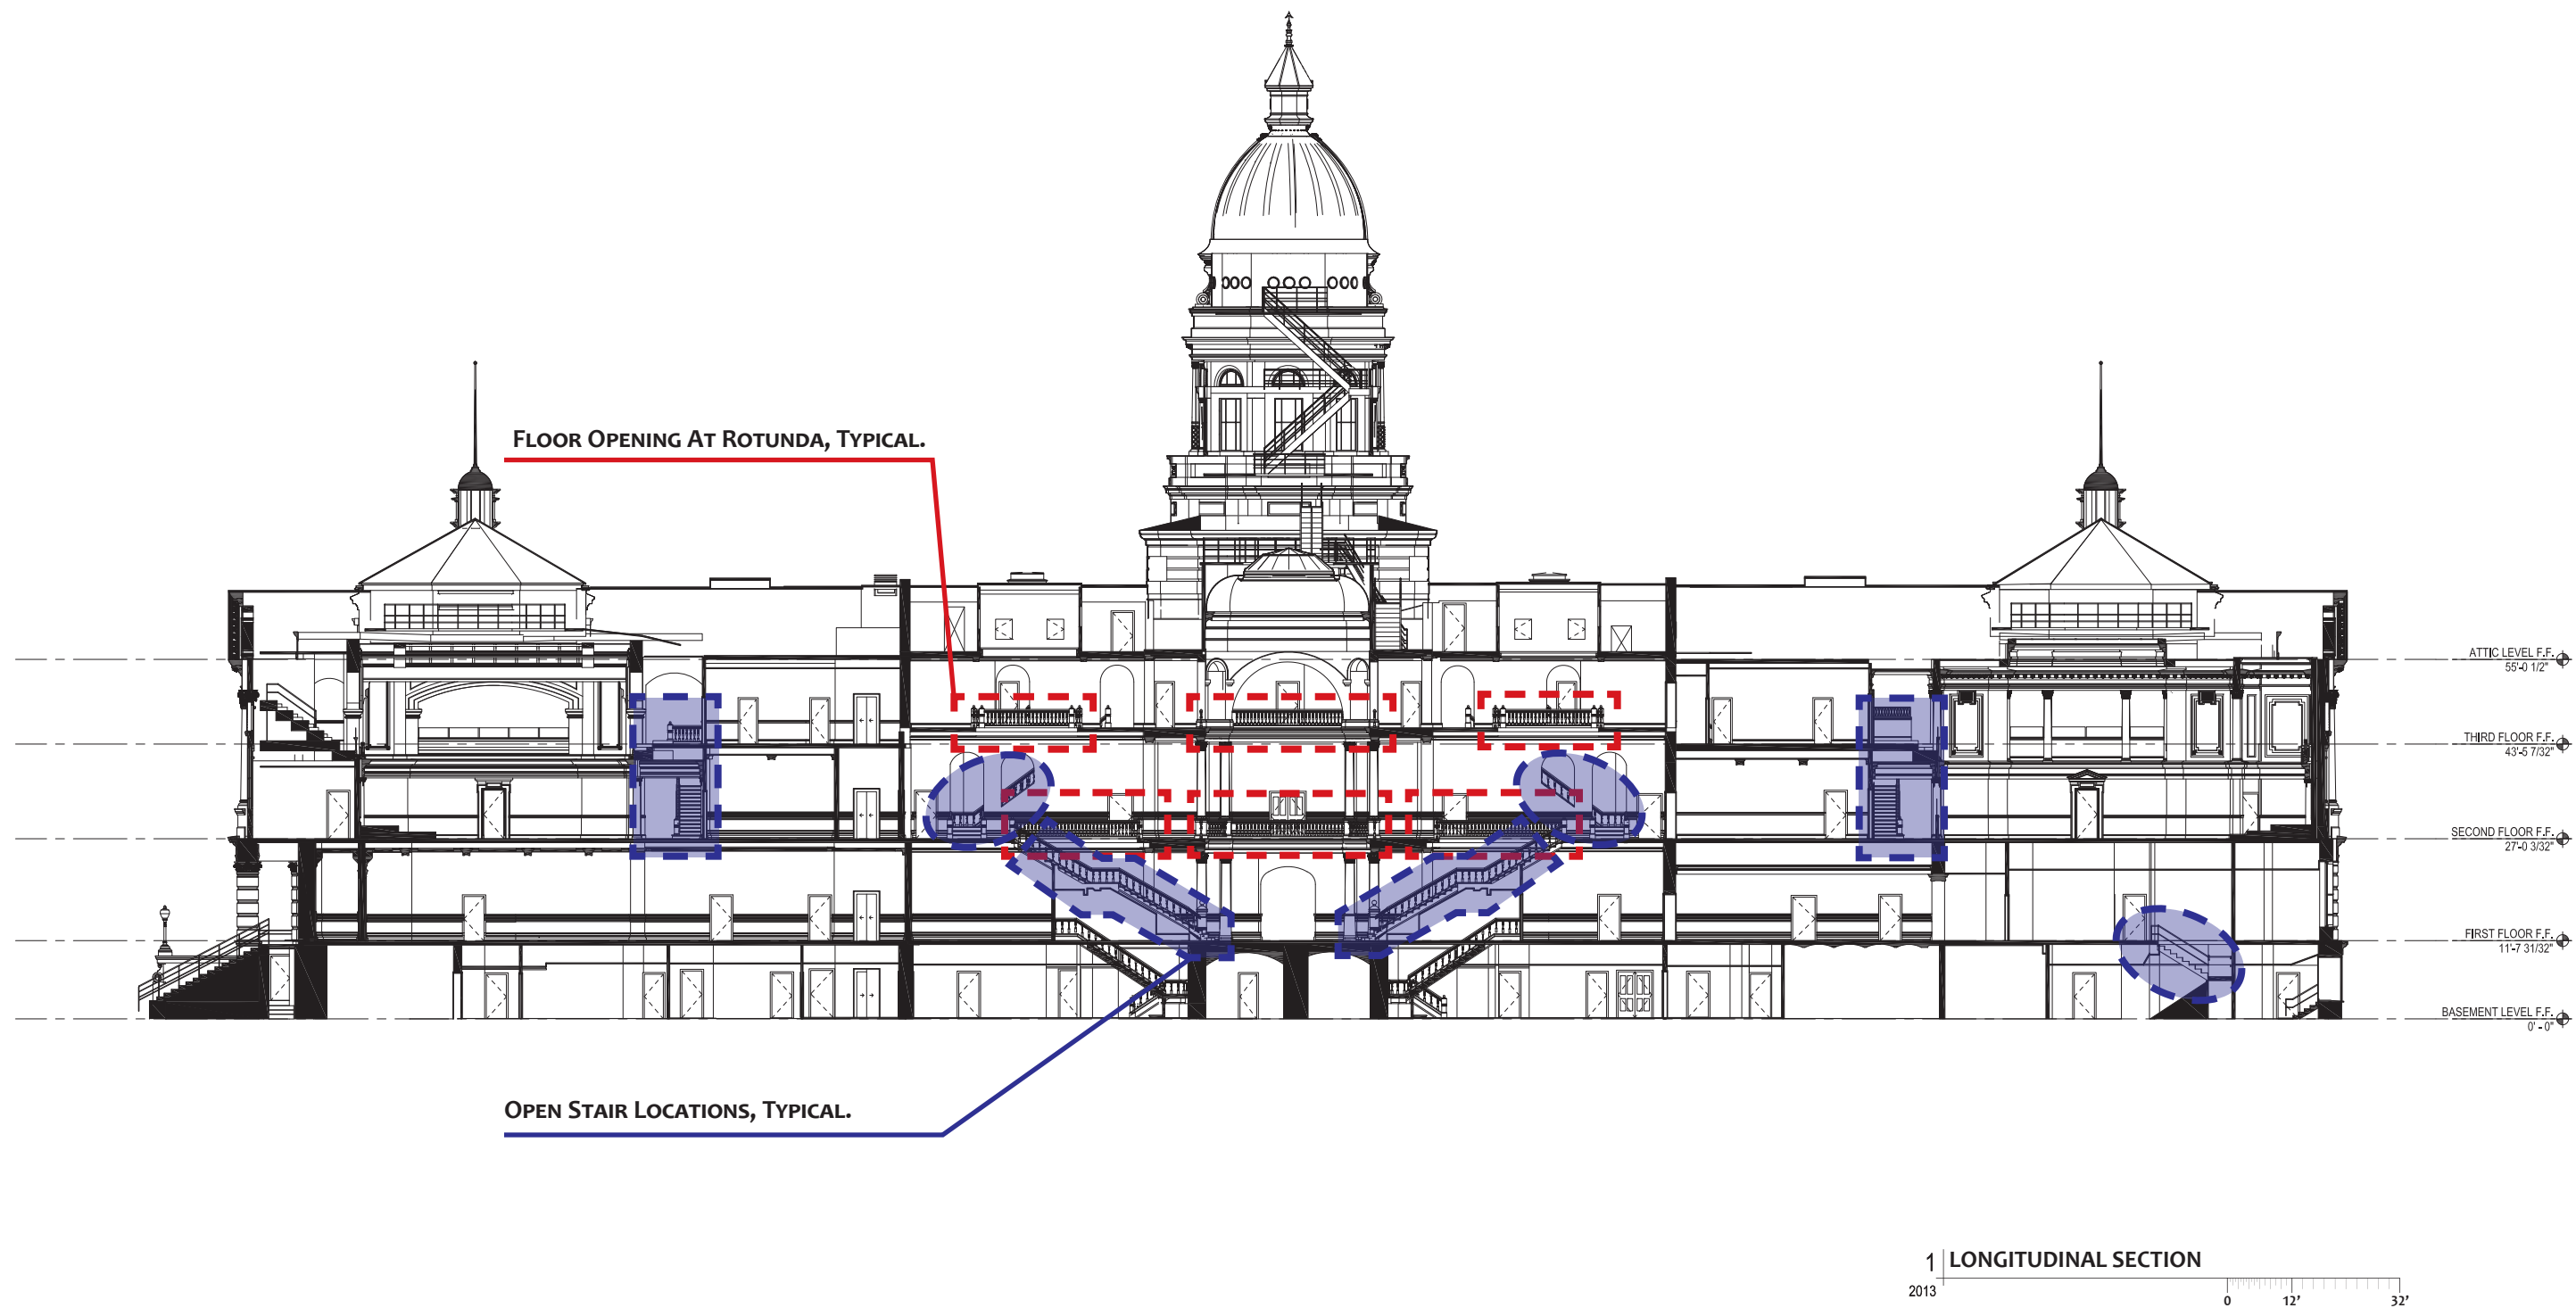
Figure 2-7. Longitudinal Building Section Indicating the Existing Floor/Ceiling Assembly Openings and Fire Barrier Continuity.

Because of the lack of separation - vertically and horizontally - on all floors and attic, the Capitol Building is considered to be a single space and single fire area.
