## **Appendix D : Parking Structure Report**

Re: *Herschler Building Parking Structure*  
*Letter Report*  
*Project No. 23-7441.00*  
*Cheyenne, Wyoming*

## HERSCHLER BUILDING PARKING STRUCTURE - CONDITION ASSESSMENT

CHEYENNE, WYOMING

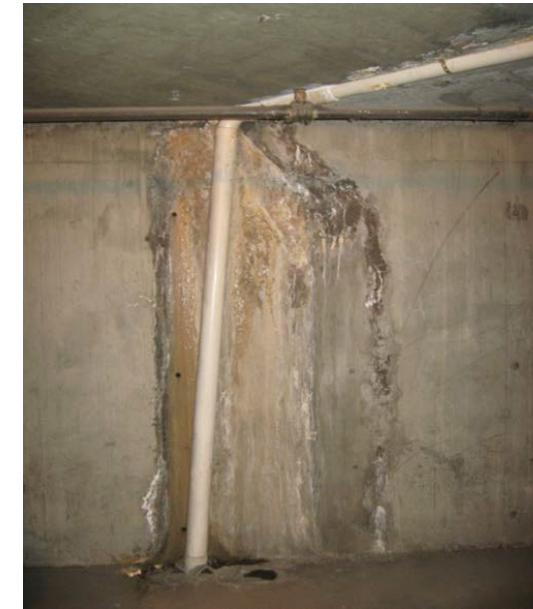
Spalling/Deterioration of the concrete foundation walls was observed in select locations of the structure. Concrete repair of the spalled walls is required. The spalled concrete areas should be squared up, chipped out, prepared and repaired with a polymer modified repair concrete.

- Delaminated concrete walls were observed in select locations. Photo 1.

Photo 1 – Deteriorated foundation wall.

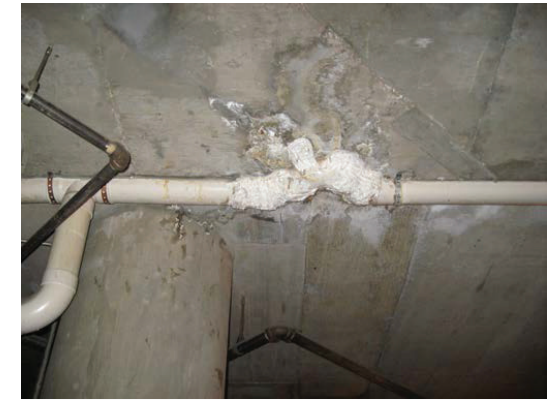
PVC pipe was attached to the ceiling below the plaza expansion joints and is actively leaking. This PVC pipe was installed presumably as a gutter system to remediate active leaking of the plaza above. This gutter runs the length of the building and then discharges through downspouts directly on the slab on grade floor with the intent of traveling across the slab on grade to the floor drains.

- PVC pipe was attached to the ceiling between the double column rows presumably under the plaza expansion joint. This PVC drain pipe was then connected to a downspout which discharged on the slab on grade slab. Photos 1, 2, 3.
- Trench drains at the bottom of the entrance/exit ramps had debris and leaves in the bottom of the basin.
- Fire sprinkler system appears to be in good condition.

Photo 2 – Leak under plaza expansion joint.

These gutters should be removed during the replacement of the expansion joint in the plaza repair work.

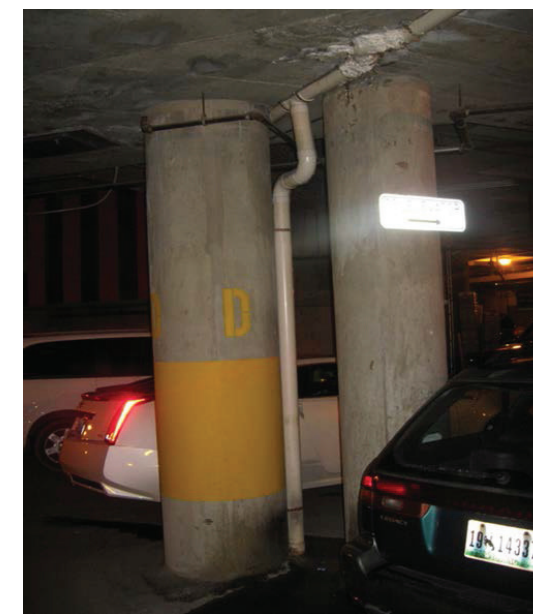
This supplemental gutter system is causing deterioration to the north foundation wall in two locations and is depositing excess water on the slab on grade adjacent to columns. There is no cove sealant around the columns and the water is traveling through the slab on grade concrete and possibly causing erosion of the sub grade base.

Photo 3 – Downspout discharging on floor surface.

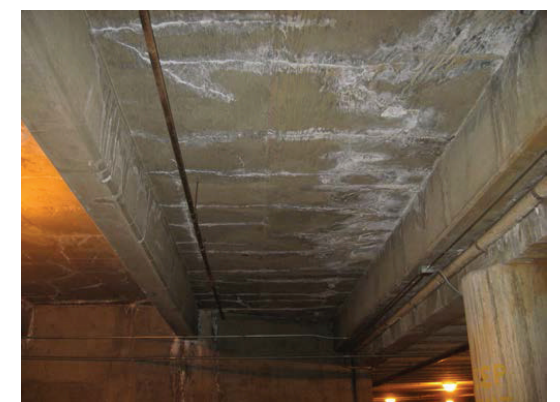
The concrete ceiling slab and beams of the west entrance tunnel appear to be cracked and efflorescence was observed at the cracks. This indicates that there is moisture coming through the slab and carrying leachates through the concrete. Moisture infiltration of the concrete slab can accelerate the corrosion of the structural reinforcement in the concrete. Waterproofing of the elevated slab is required from above.

Select locations of the structure exhibit deterioration primarily due to moisture infiltration of the concrete ceiling slab. The deterioration is located primarily on the concrete slab over the west entrance /exit. Cracks in the slab allow moisture infiltration from the plaza above and heavy signs of efflorescence are present. Cracks in a beam on the west entrance are also exhibiting cracking and effervesce staining.

Photo 4 – Cracked and leaking cast-in-place slab at west entrance /exit.

Cracking and deterioration of the supported slabs allow water infiltration of the structural components of the garage. Water and moisture infiltration of the concrete can lead to corrosion of the embedded reinforcement which can impact the load capacity of the structural members of the parking structure. Repairs to the beam and cracked slab by epoxy injection are required to repair the cracked concrete.

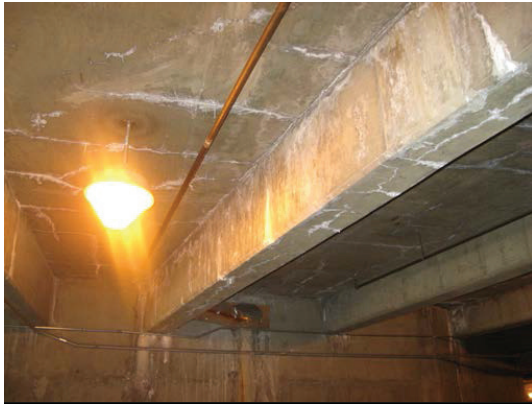
Photo 5 – Cracked and deteriorating beam at west entrance.

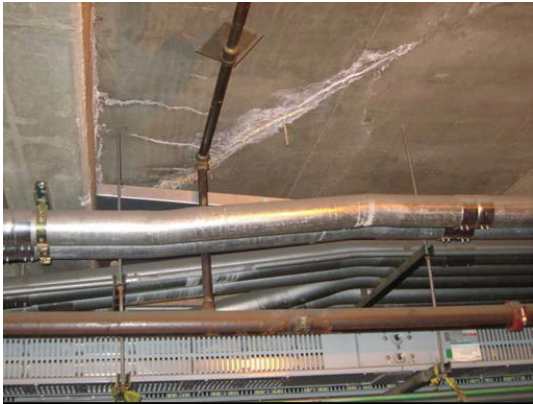
- Metal catch pans were installed in the past under problematic leaks of the plaza above in select locations of the structure.
- There is a metal catch pan located on the east exit ramp ceiling over a bank of electrical conduit. Photo 6.

Photo 6 – Cracked & leaking cast-in-place slab over electrical conduit at east entrance/exit.

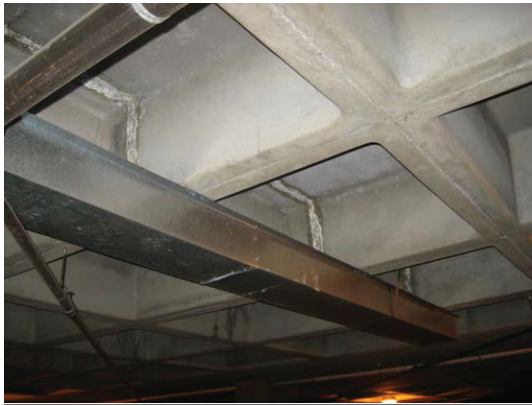
Photo 7 – Metal pan fabricated to collect leaking water from plaza above.

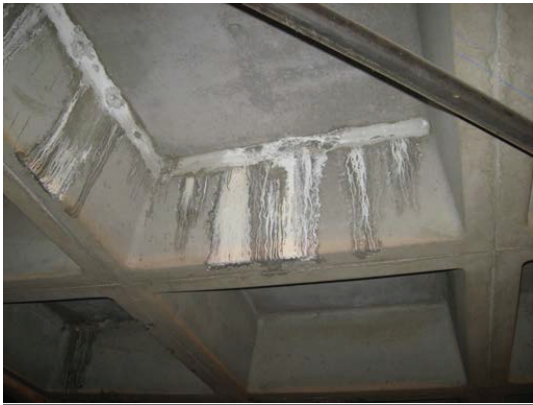
The plaza area to the north foot print of the building is the roof of the underground parking structure. This area is approximately 30,000 sf in its present configuration. There are areas of the plaza where we observed evidence of leaking through the concrete slab/roof into the parking level below. This appears to be an ongoing occurrence as collection devices have been installed in an attempt to collect the active moisture leaks and discharge it to the slab on grade concrete and ultimately into the slab on grade floor drains in the parking structure. We assume the waterproofing membrane and expansion joints in the plaza area are from the original construction. These waterproofing systems are breached in a number of locations and we recommend they be replaced as they are beyond their expectant service life.

Photo 8 – Evidence of leaking from plaza area above (typical).

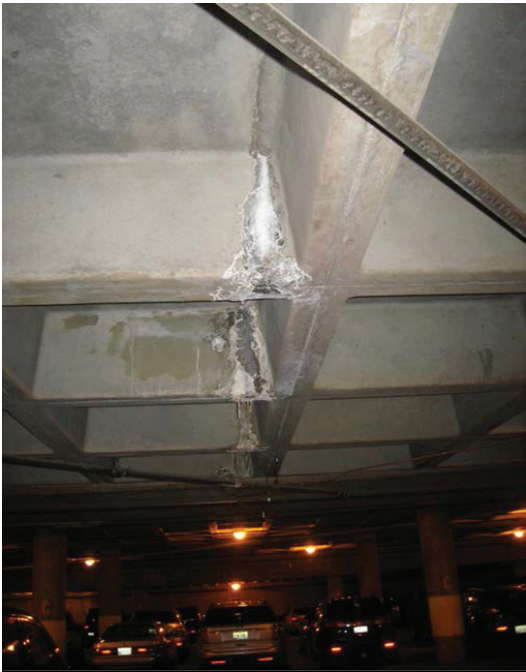
Photo 9 – Evidence of leaking from plaza above.

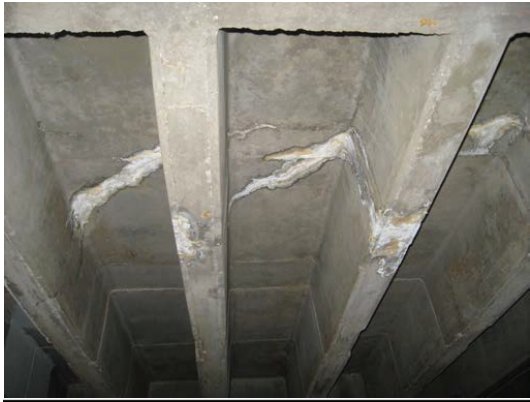
Cracks and active leaks through the planters on the perimeter of the building wings were evident in the parking structure below. Waterproofing of the planters is recommended as part of the plaza waterproofing replacement.

Photo 10 – Evidence of leaking below plaza planter.

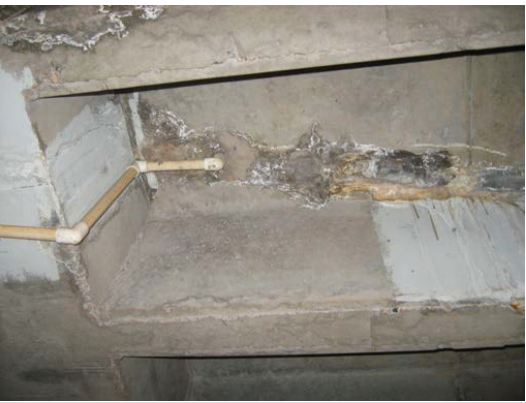
Photo 11 – Evidence of leaking at drain penetration in plaza planter.

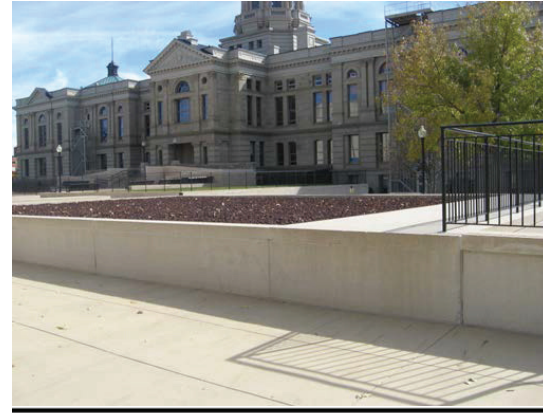
Photo 14 – Plaza planter over west entrance.

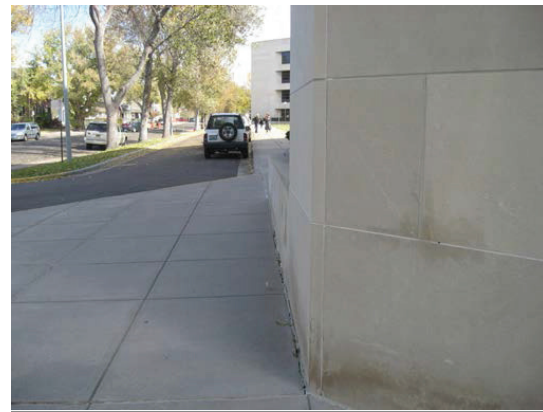
Photo 15 – Failed core sealant plaza level over north foundation wall of parking.

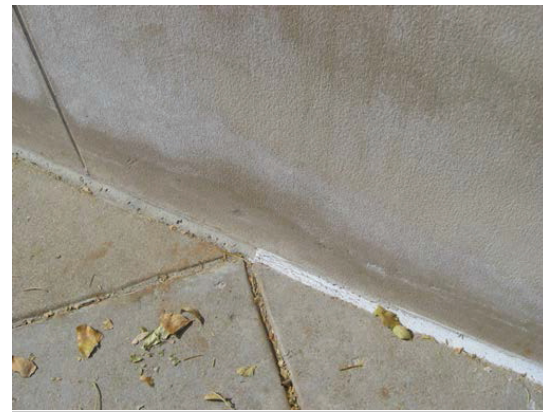
Photo 16 – Failed cove sealant at planter plaza level.

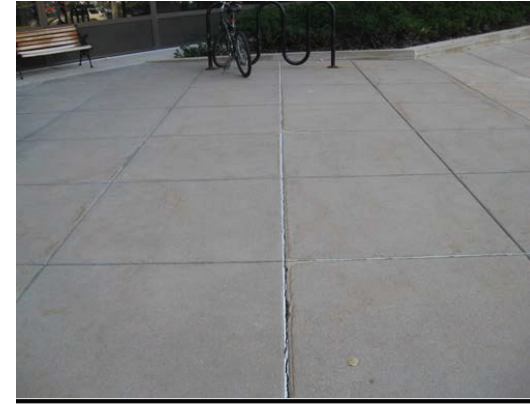
Photo 17 – Failed sealants plaza level.

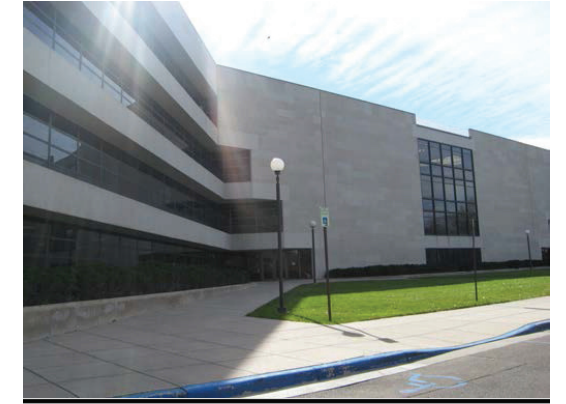
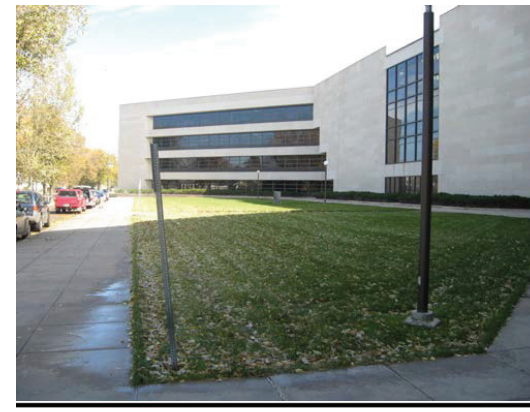
Since the structure is 30 years old, we suspect the waterproofing membrane and expansion joints in the plaza area (roof of parking structure) are from the original construction. These waterproofing systems are at the end of their respective service life and we recommend they be replaced.

Photo 18 – North plaza area over parking garage below.

Photo 19 – North plaza area over parking garage below.

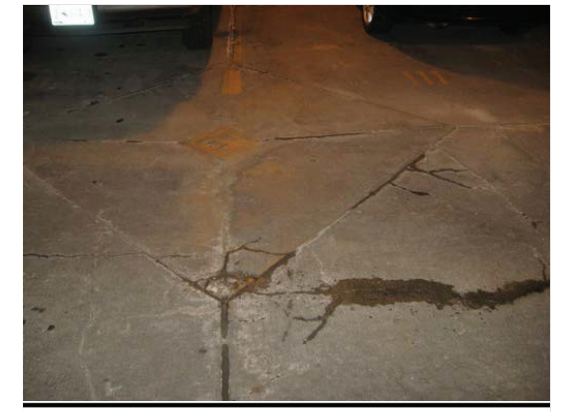
Photo 20 – Cracked slab on grade concrete in parking garage.

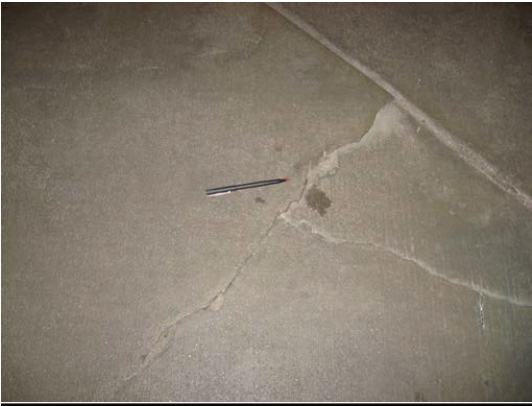
Photo 21 – Cracked slab on grade floor.
