Section 5: Site & Building Assessment

As part of the **Level I / Level II Study** for the Wyoming State Capitol, members of the **HDR/PDP/Plan1 Design Team** performed a comprehensive visual assessment of the exterior and interior of the Capitol Building and Site. Multiple site visits were made by the Design Team from March, 2013 through October, 2013 to conduct an intensive assessment of the building interior and exterior, including the existing building systems. With the assistance of members of the **State of Wyoming Department of Administration and Information Division of Construction Management [AICM]** and the Capitol facilities team, up-close visual access to the building was conducted using 125’ and 80’ high portable lifts and ladders. In addition, visual assessment of the Dome exterior and interior was performed using industrial rope access techniques. Interior assessments and building surveys were also conducted during this period.

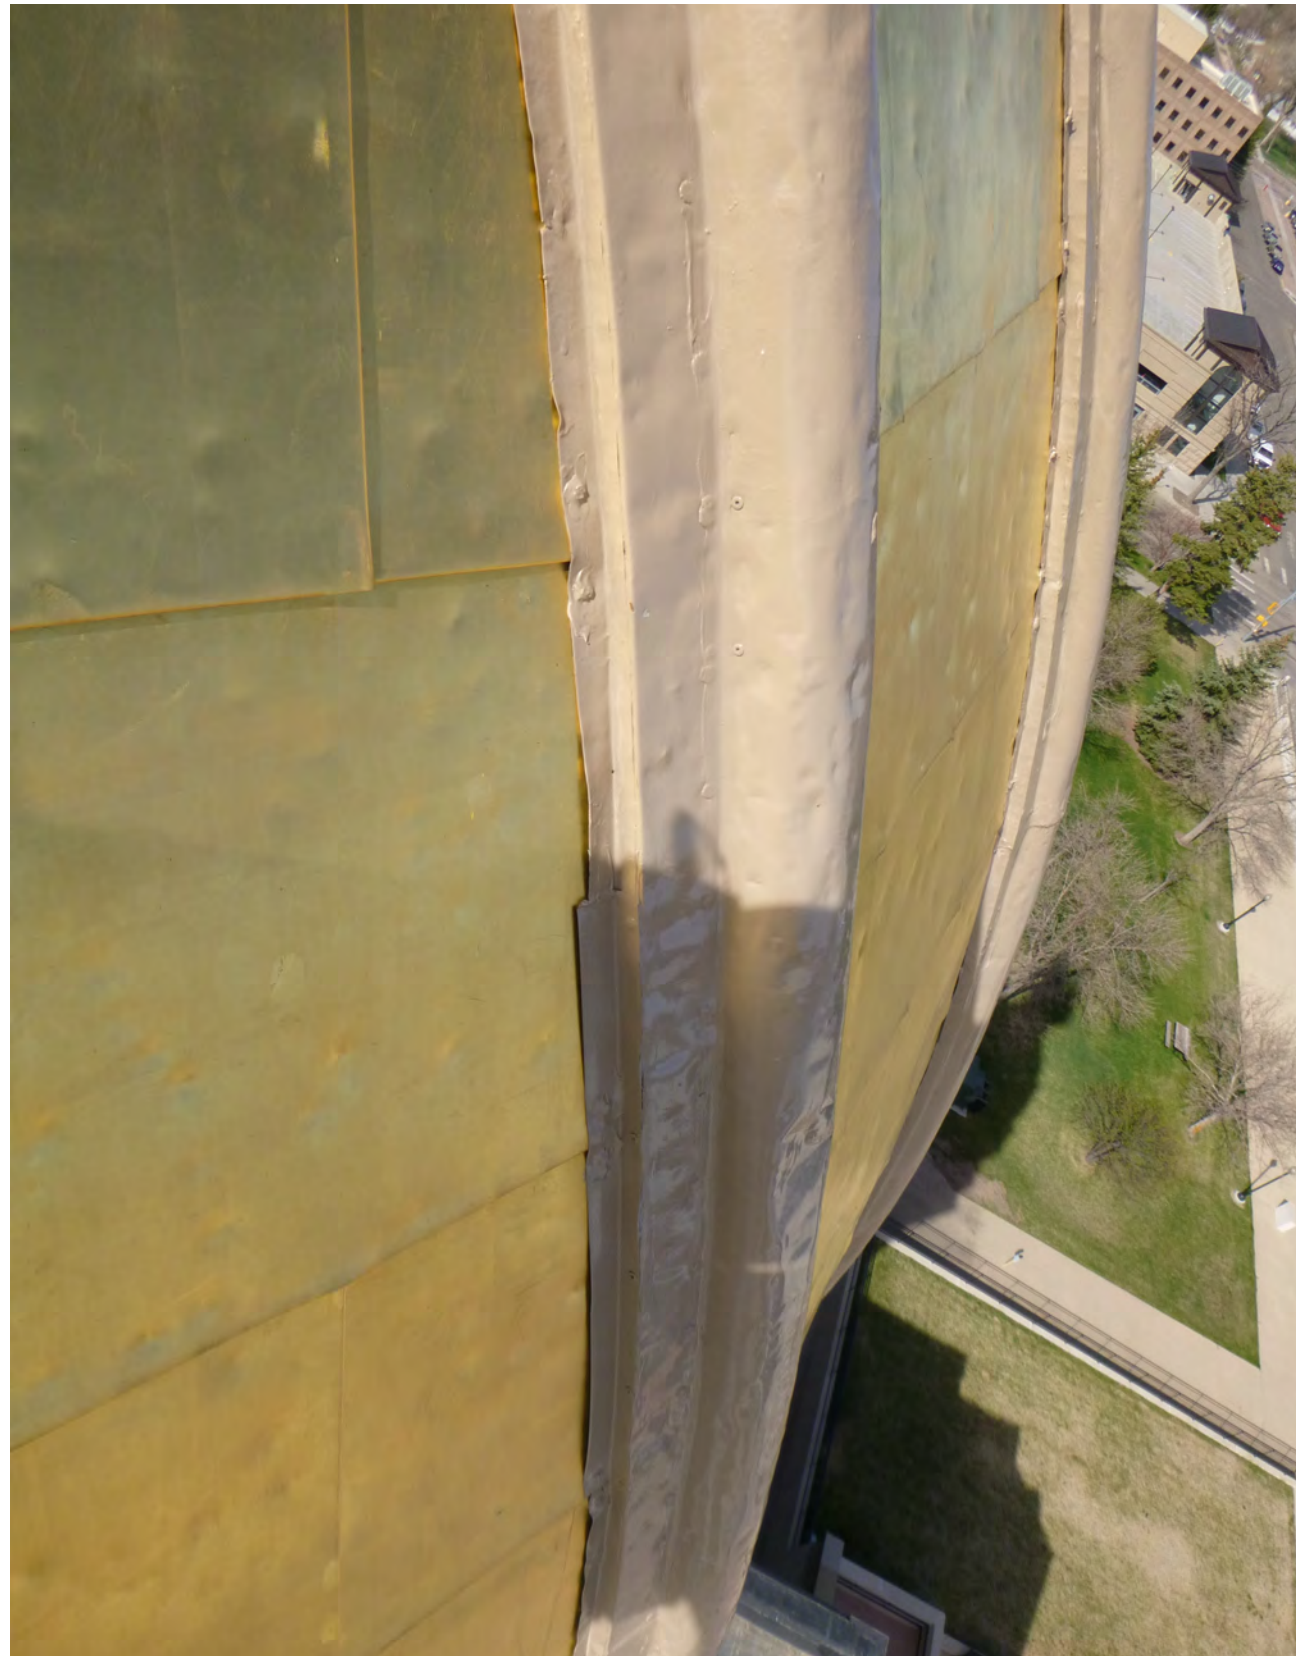
Figure 5.2.5: Failed Seams at the Dome Ribs.

- The rib covers between the gilded facets of the Dome are galvanized sheet metal. The sheet metal is in good condition, with some denting and open seams noted. [Figures 5.2.5 and 5.2.7] Some sections of the rib covers appear to be replacement pieces, and likely date to the 2009 Dome Restoration project performed by Sheet Metal Products, Inc. [SMP] and Glenn Otto & Son Painting. The previous paint coatings at the ribs appear to have been completely removed prior to the last painting campaign.

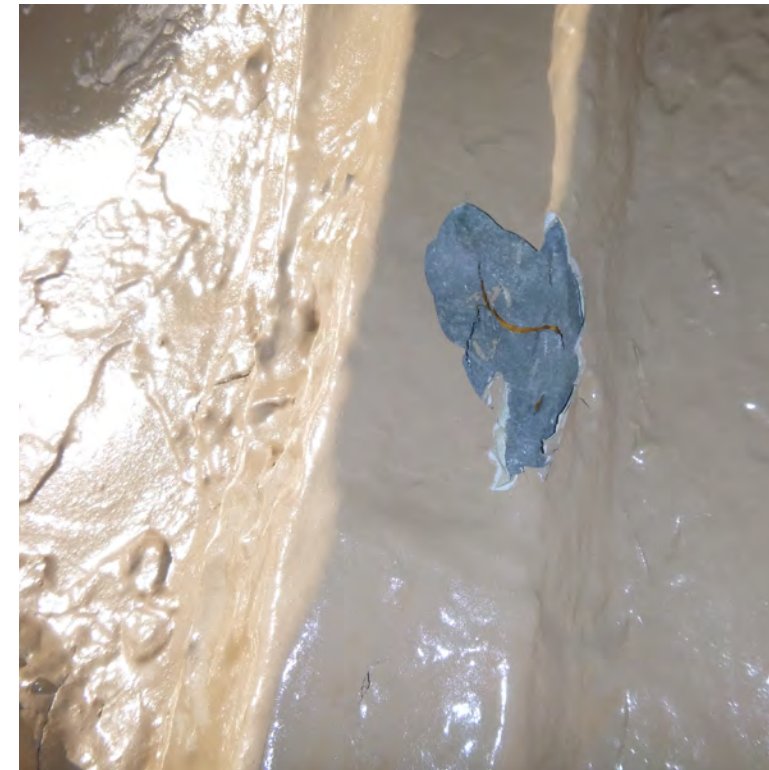
Figure 5.2.6: Coating Failure and Spot Corrosion at the Lantern.

- The lantern at the top of the Dome is in fair condition. Similar to the drum and Dome, the galvanized sheet metal of the lantern exhibits paint failure. [Figure 5.2.6] The gilded copper panels of the lantern roof installed in 2009 are in good condition, with dents from hail damage, but no apparent tears or punctures. [Figure 5.2.5]
- The galvanized sheet metal finial at the top of the lantern is in good condition. The paint coatings at the finial exhibit discrete areas of loss. Where the paint coatings are missing, traces of gilding as the earliest coatings on the sheet metal are visible.

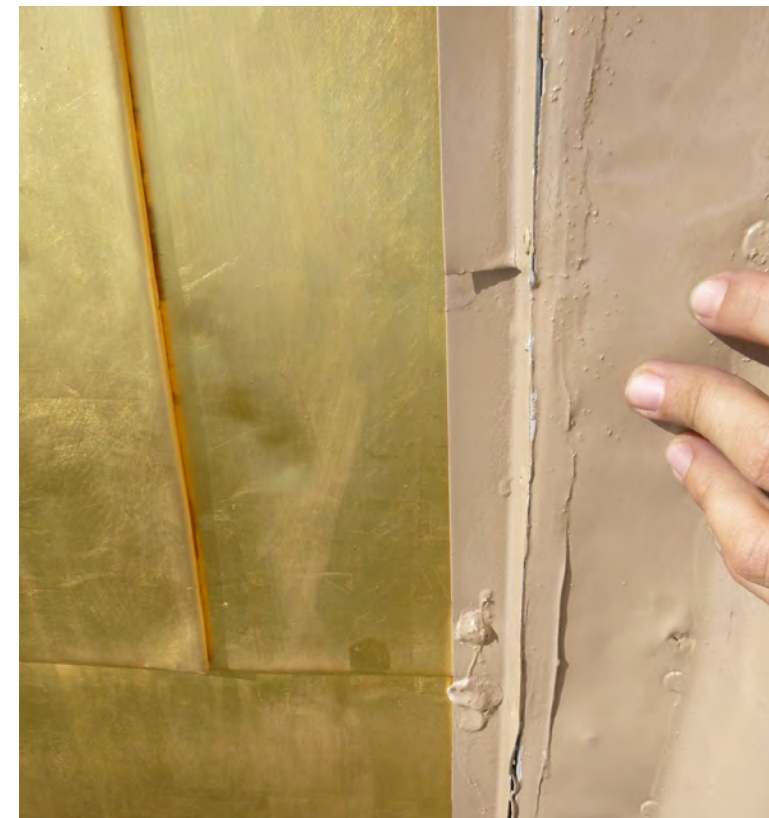
Figure 5.2.7: Failed Seams at the Dome Ribs.

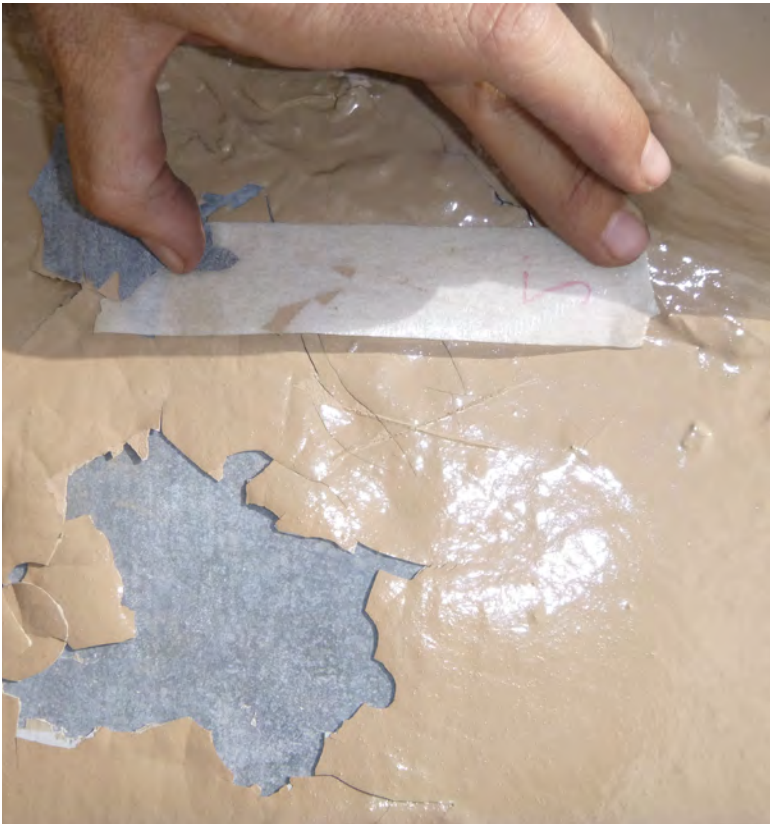
- The paint coatings at the galvanized sheet metal cladding of the drum are in poor condition, with widespread paint loss and peeling. [Figure 5.2.8] In some locations, especially at the cornice elements of the drum, the more recent paint coatings are separating from underlying coatings, increasing the probability of exposure of the underlying galvanized sheet metal. In other areas, the paint loss is so severe that the galvanized sheet metal substrate below is exposed to the elements. In addition to being visually detracting, prolonged exposure of the galvanized sheet metal could lead to deterioration and corrosion of the base metal. The paintings and coatings at the Dome not only complete the visual aesthetic of the Capitol, but they form a protective layer over the various metal surfaces of the Dome’s exterior envelope.

Figure 5.2.8: Adhesion Test Indicating in Coating Failure. The existing coating is not currently properly adhering to the metal substrate.

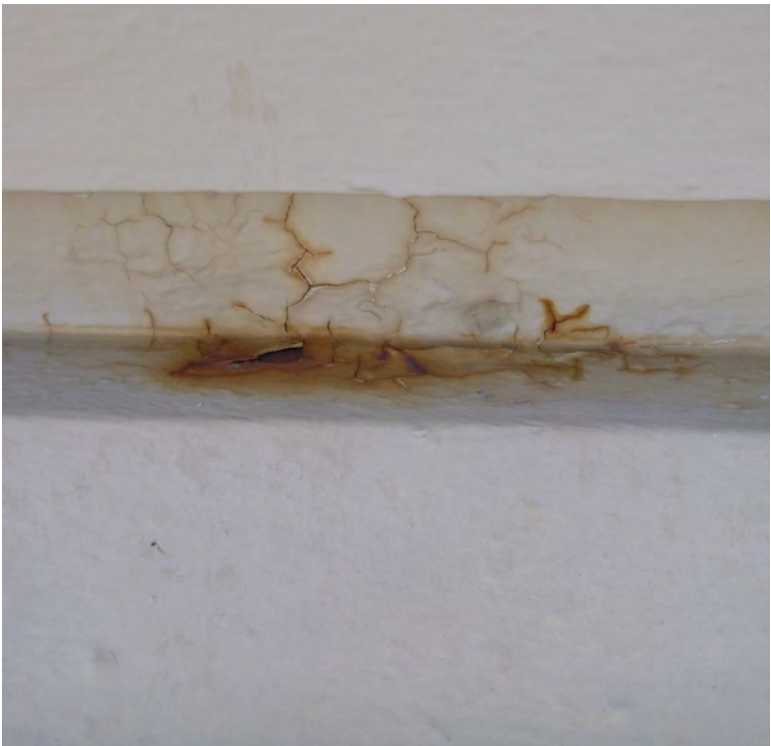
- At some locations where paint loss was observed, minor surface corrosion of the galvanized sheet metal was also noted. [Figure 5.2.10] Surface corrosion was noted at the console scrolls of the consoles at the drum attic. [Figure 5.2.9]

Figure 5.2.10: Spot Corrosion at the Drum.

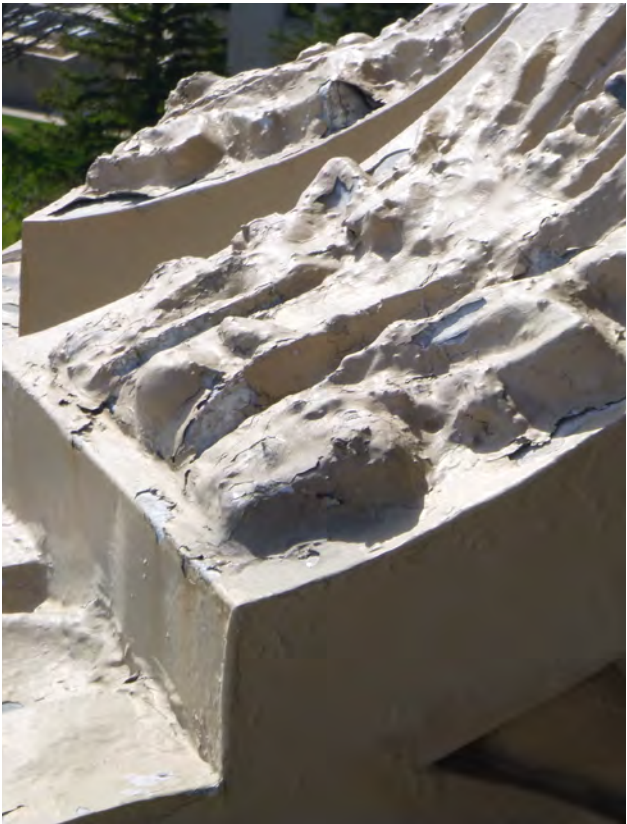
Figure 5.2.9: Coating Failure at the Console.

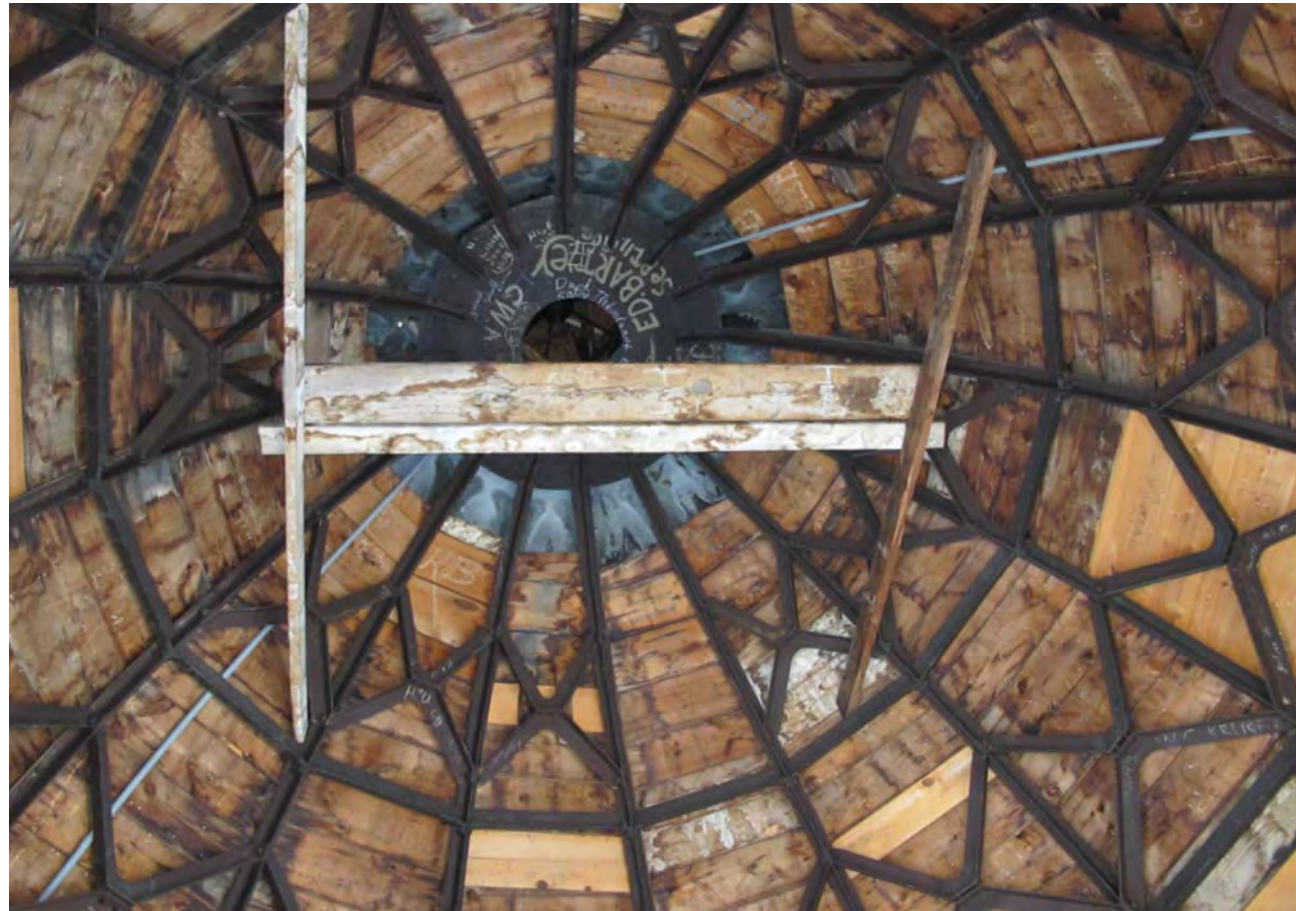
Figure 5.2.15: Widespread Moisture Damage at the Inner Face of the Dome Wood Decking.

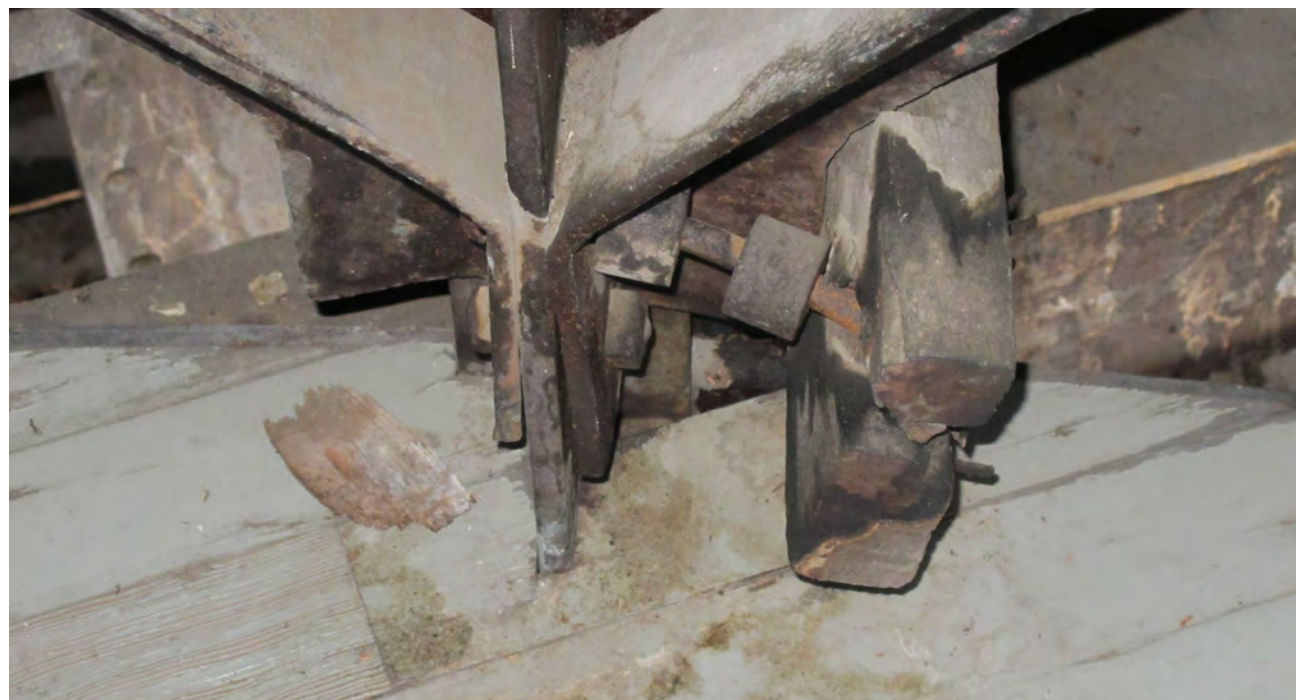
Figure 5.2.16: Moisture Damage at a Failed Connection Between the Metal Dome Structure and a Wood Outrigger.

In addition, deterioration and/or damage was observed at multiple wood outriggers. While the deterioration of the outriggers can be attributed to the previously described moisture issues at the interior, the damage is likely a structural issue that may be related to the tension and shear load paths of the Dome structure. [Figure 5.2.16]

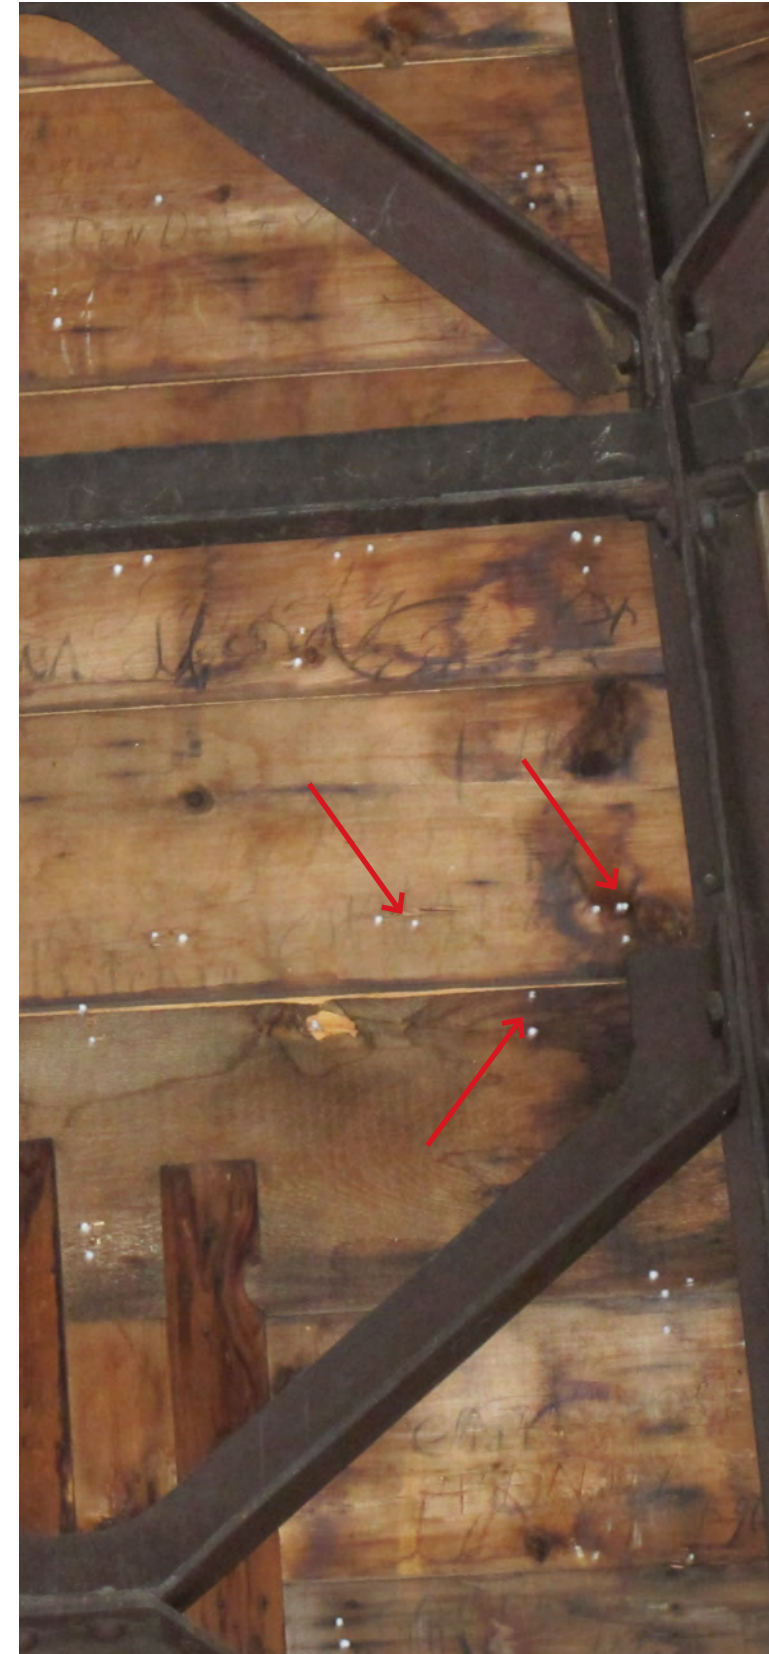
Figure 5.2.17: Visible Frost on Nail Heads and Adjacent Moisture Damage at the Wood Decking Along the Dome Interior.

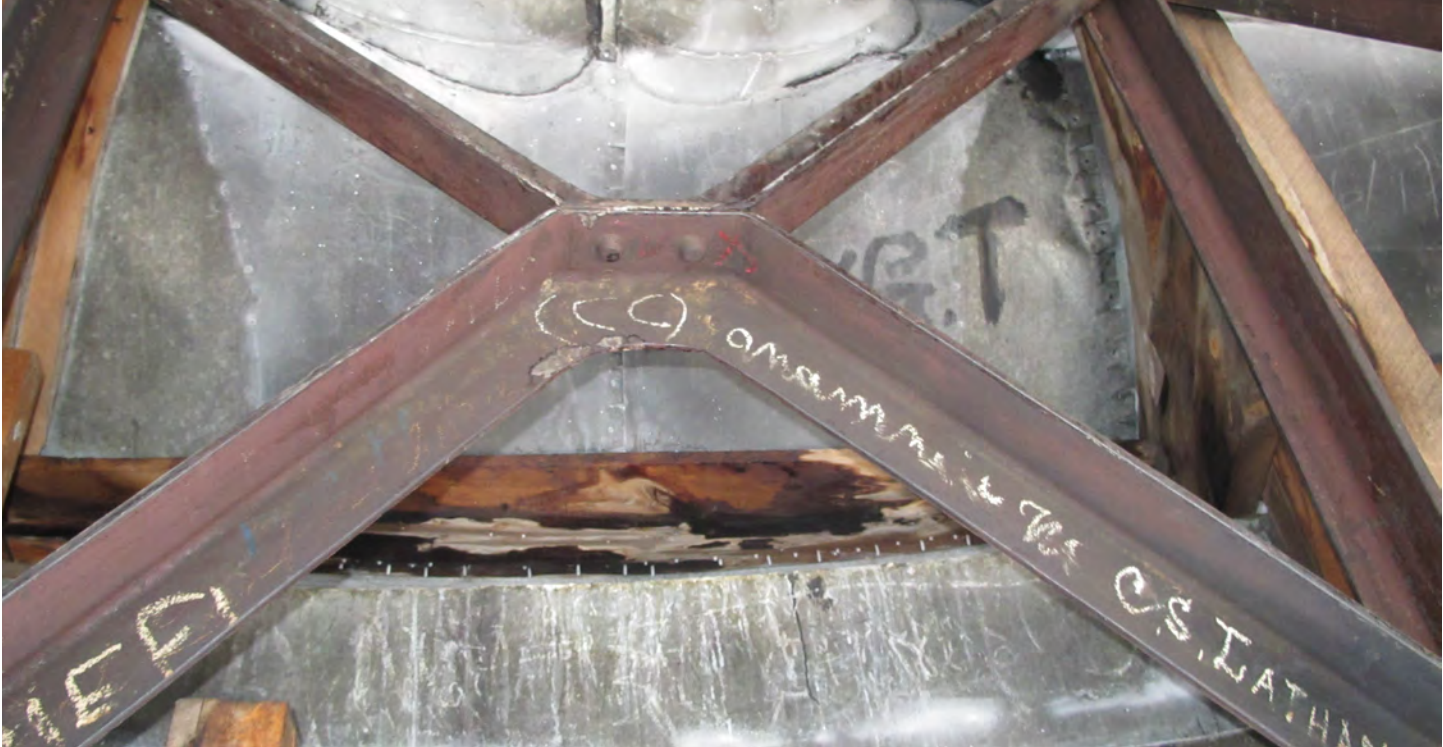
Figure 5.2.19: Visible Frost on the Inward Face of the Metal Drum and Moisture Damage at the Adjacent Wood Framing.

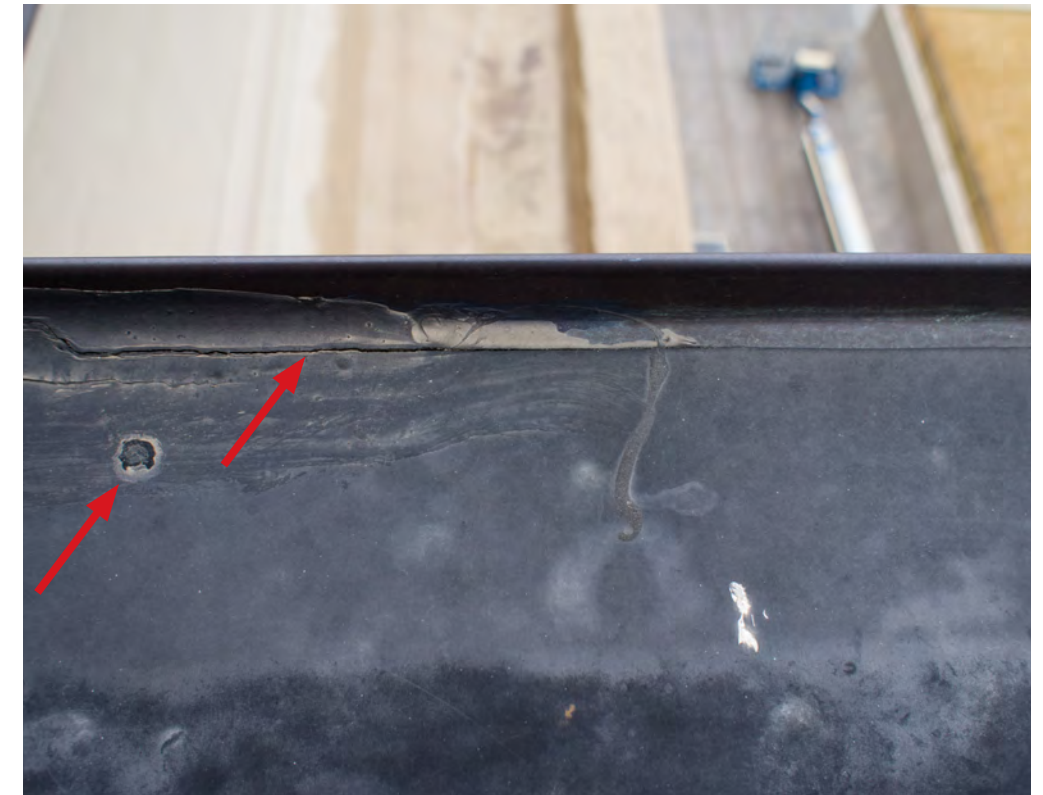
Figure 5.3.2: Detail View of EPDM Roofing. There are holes and cracking, which can allow water to infiltrate the roofing assembly.

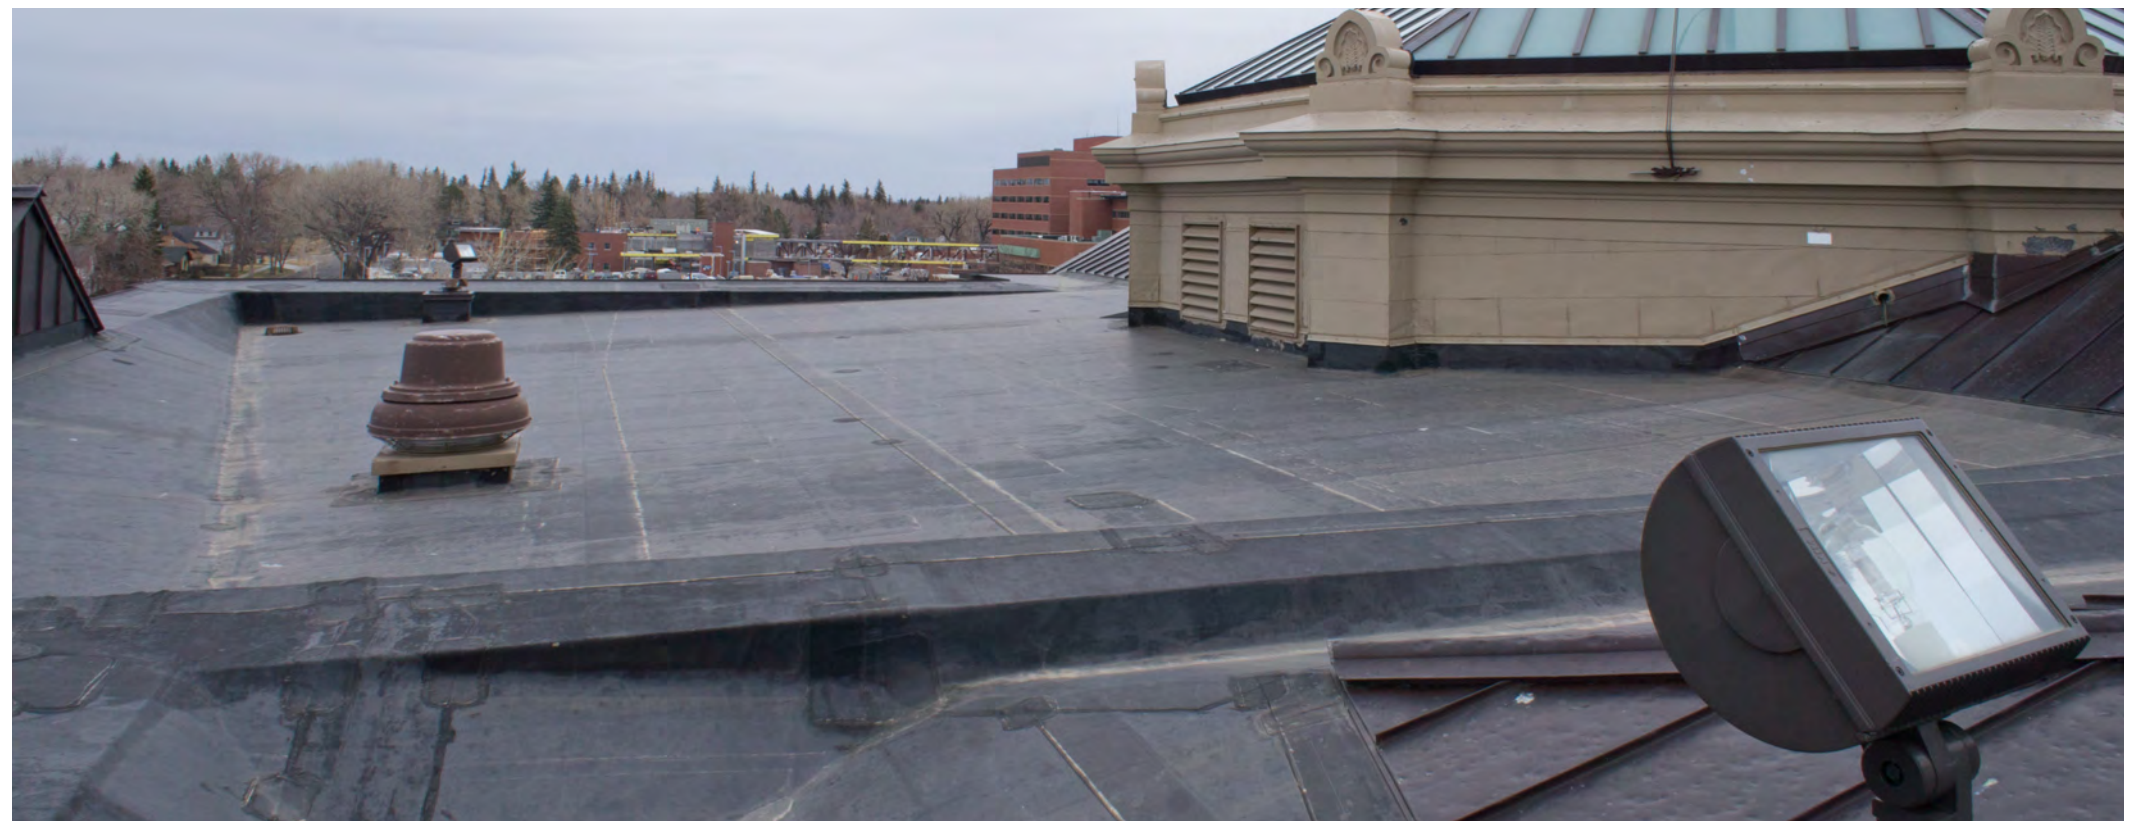
Figure 5.3.3: View of EPDM Roofing. Note the Numerous Patches. The maintenance staff states that they patch the roof on an annual basis. The flashing at the base of the skylight is sealed with sealant, a short-term solution.

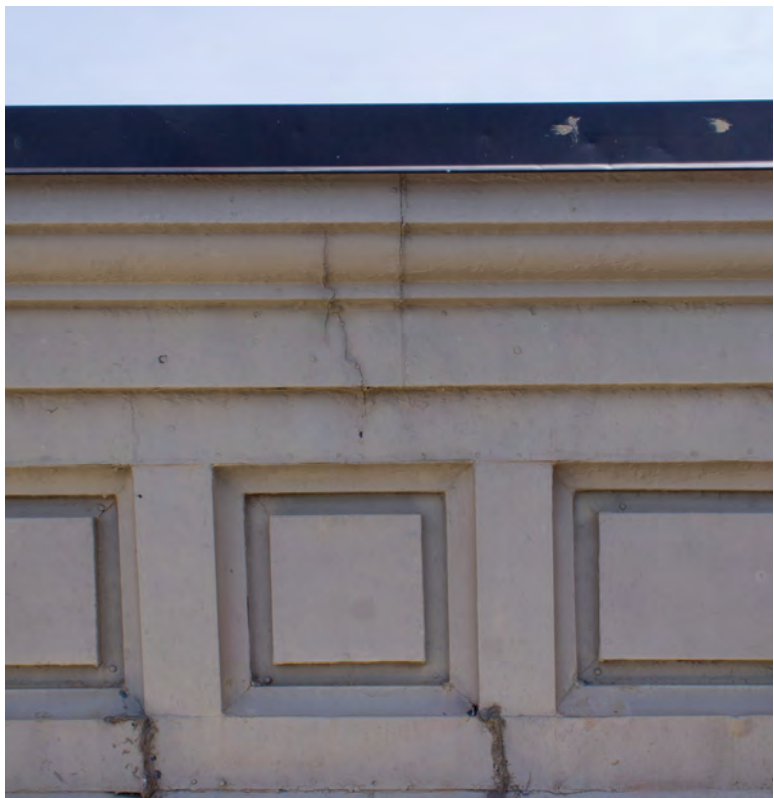
Figure 5.4.5: Many of the Joints Have Been Sealed with Sealant, which Is Visually Obtrusive and Only Functions as a Short-Term Repair.

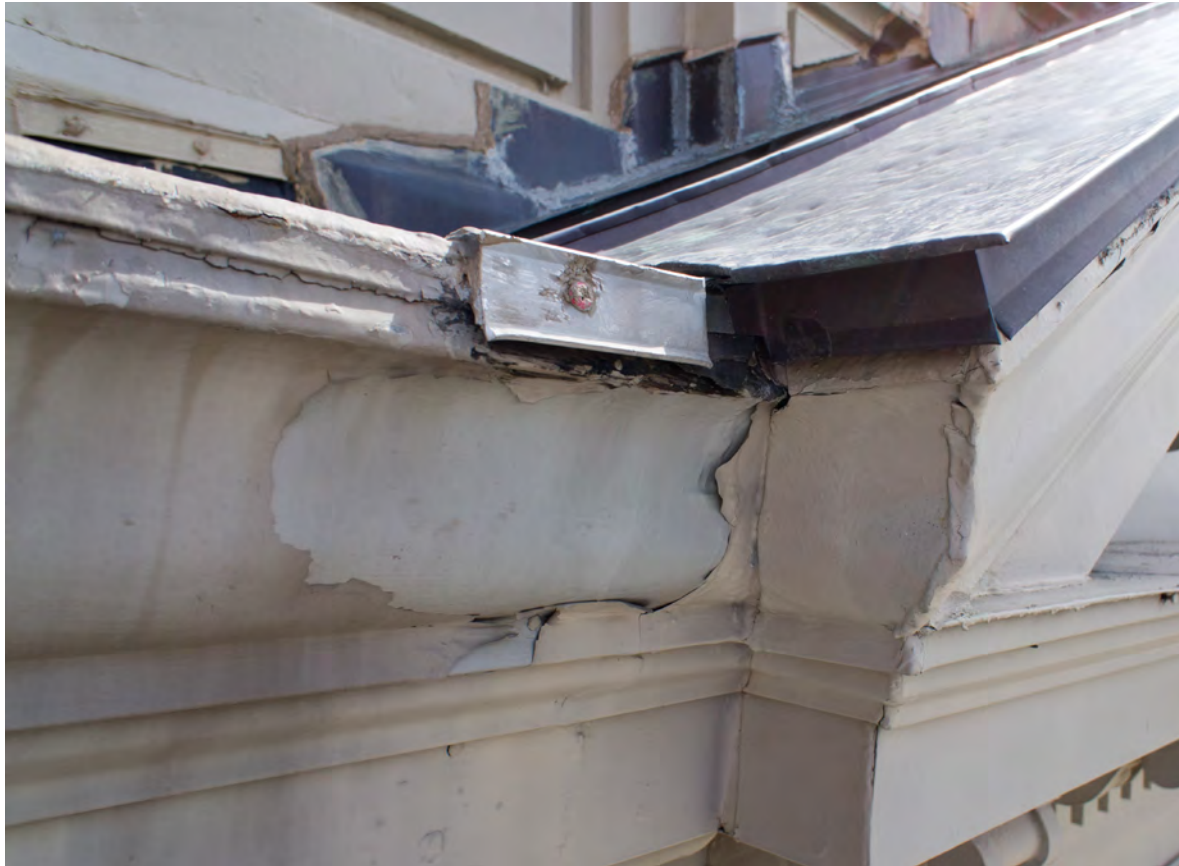
Figure 5.4.6: Typical Peeling Paint at the Galvanized Metal.

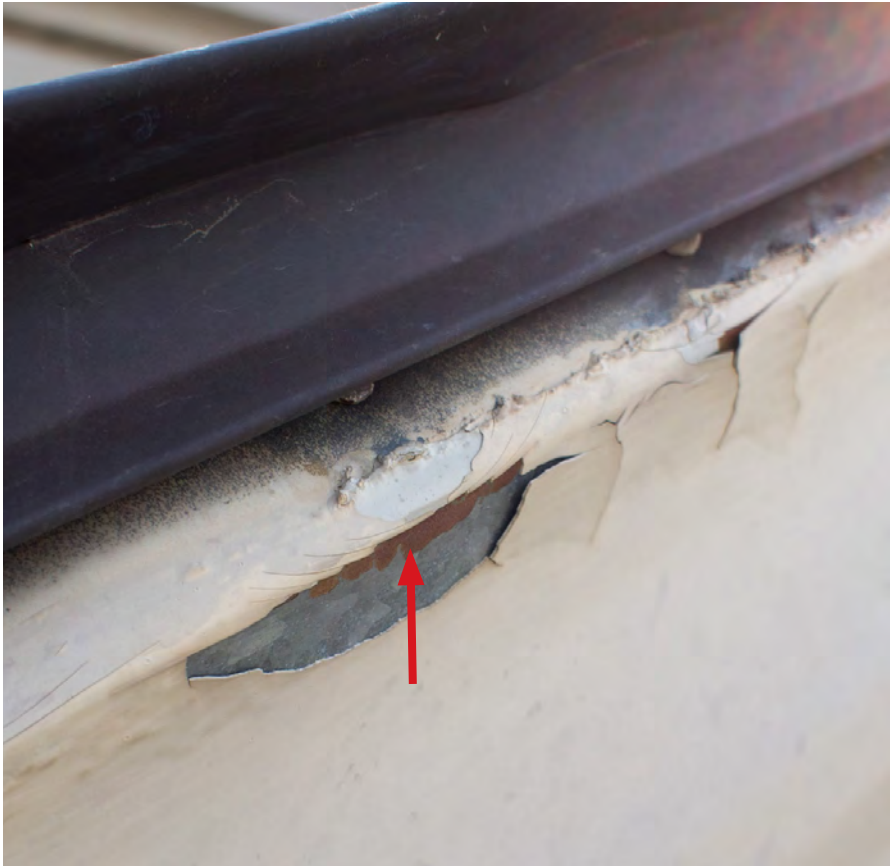
Figure 5.4.7: At Some Locations Corrosion Was Visible at Areas Where Paint Has Peeled.

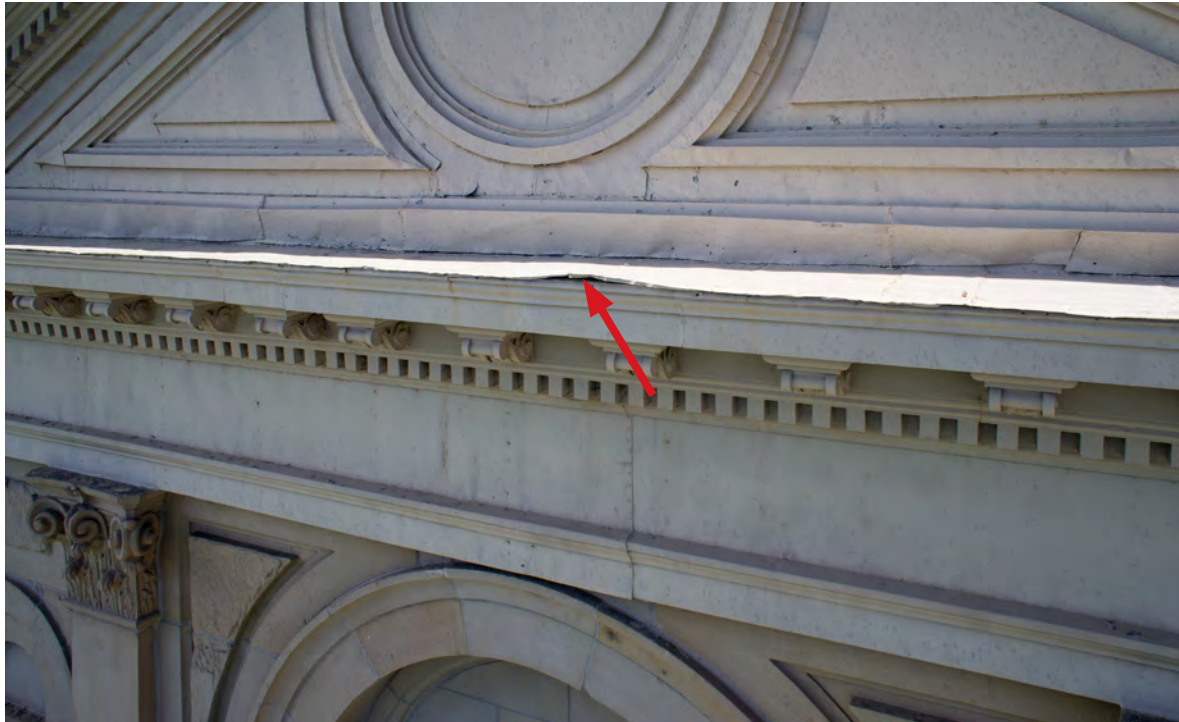
It appears that a cold-fluid applied membrane has been applied to the cornice. At some locations the membrane does not appear to be fully adhered to the cornice, particularly at the edges. Standing water was also noted at the cornice following rain events. [Figures 5.4.8, 5.4.9, and 5.4.14].

Figure 5.4.8: Delamination of the Cold-Fluid Applied Material at the Cornice at Pediment at East Elevation.

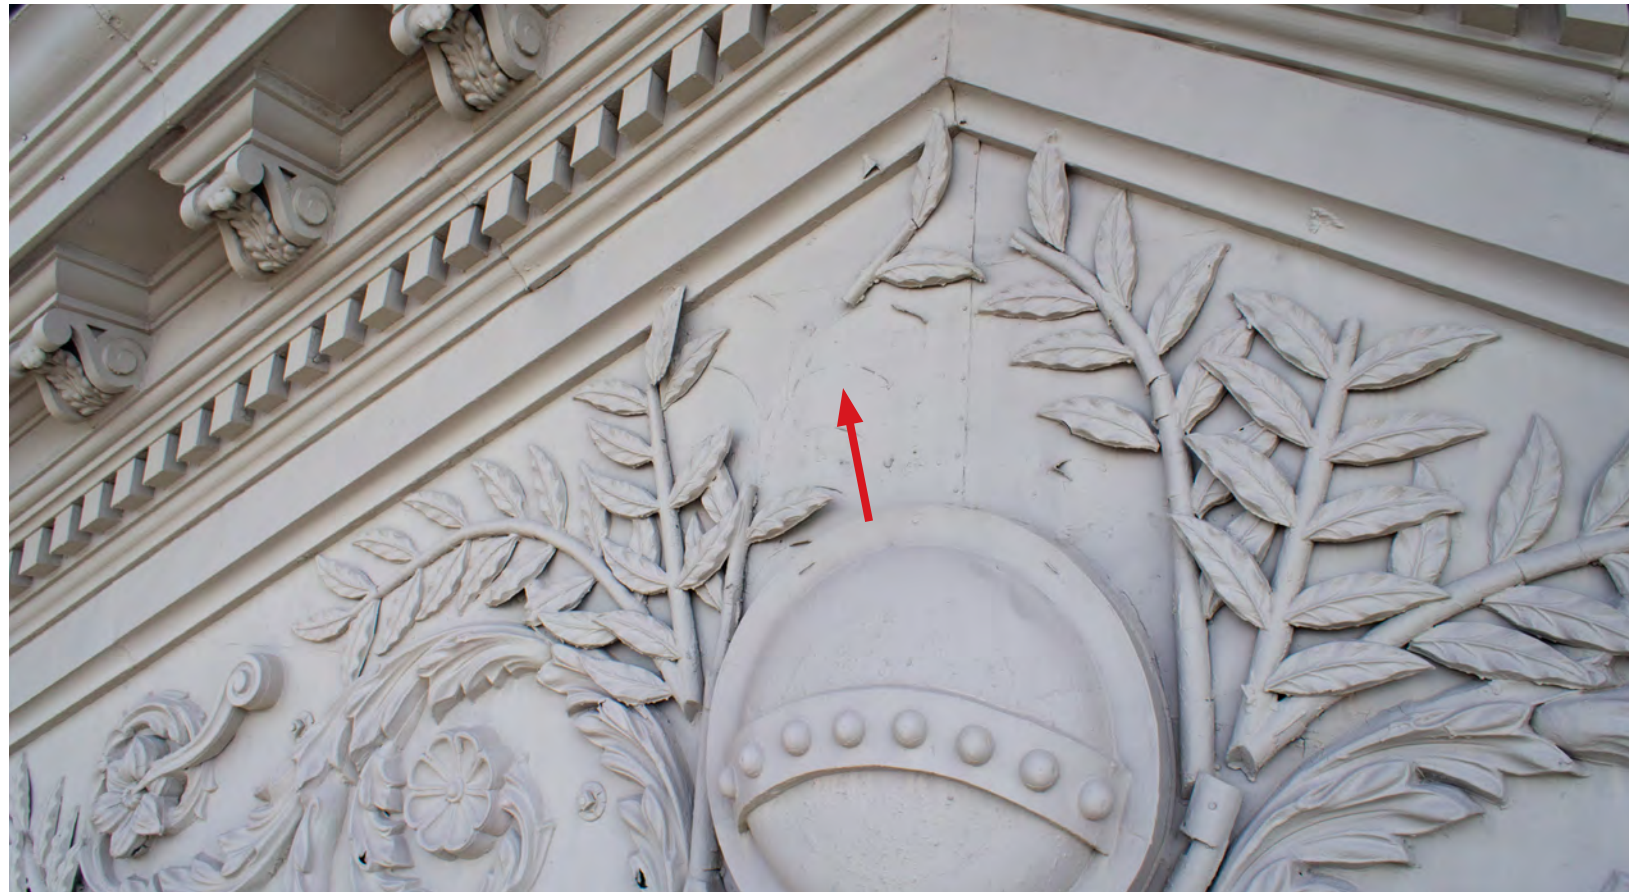
Figure 5.4.10: Typical Ornament at the Pediments. At some locations the ornament has broken or is missing.

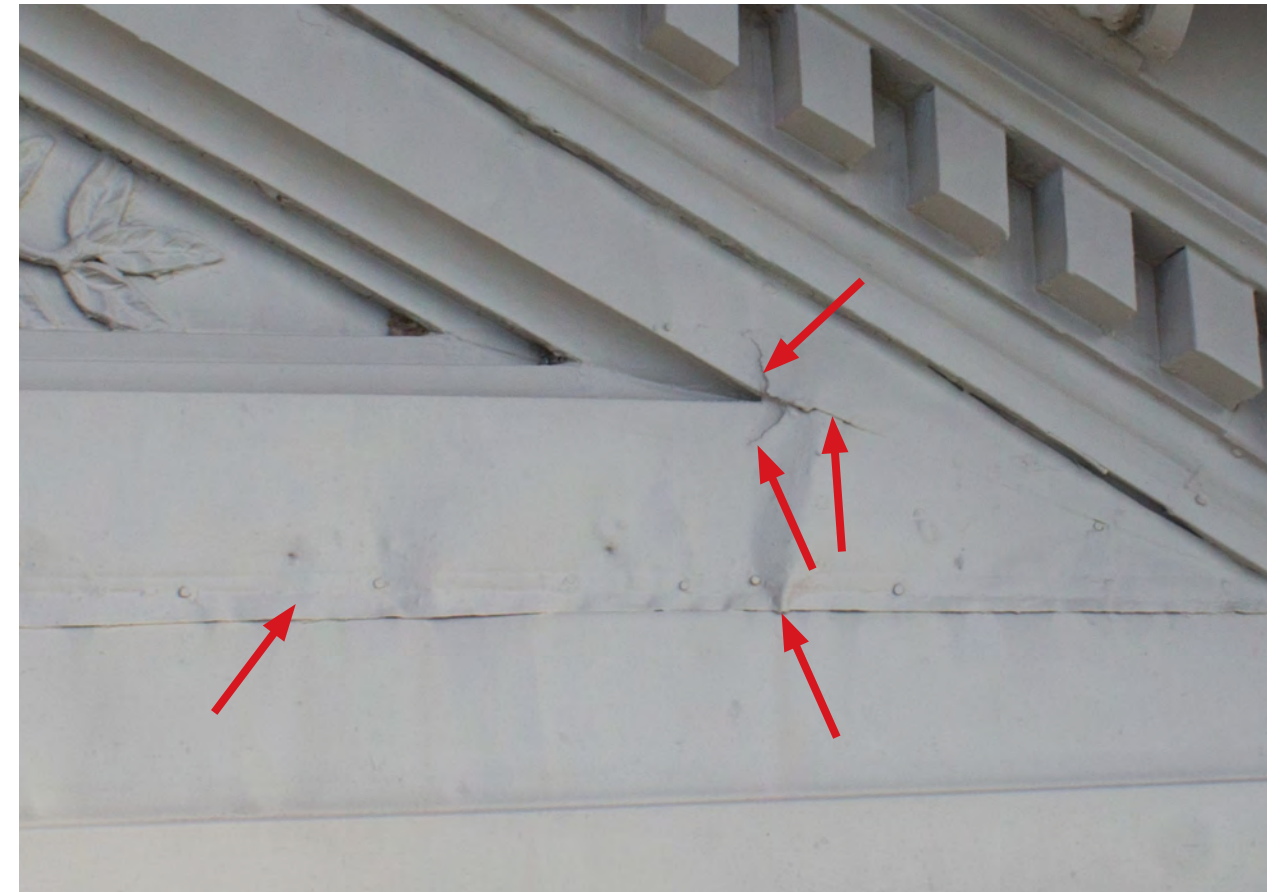
Figure 5.4.11: Detail at North Elevation Corner of Pediment Showing Cracks and Poorly Implemented Repairs Where the Metal Bulges.

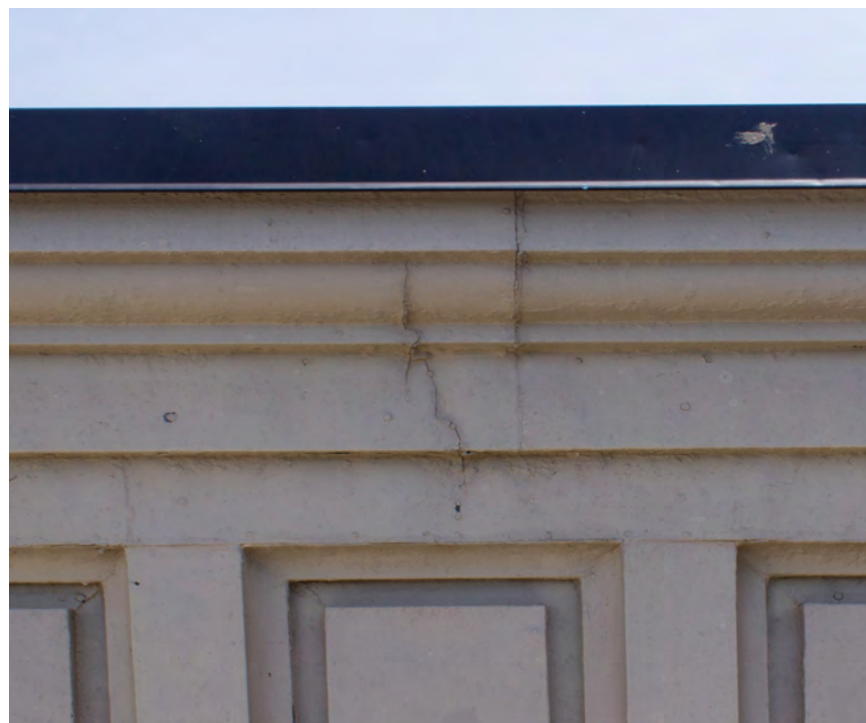
Figure 5.4.12: Open Cracks in the Metal, Typical at Some Locations, Allowing Water to Infiltrate the Assembly.

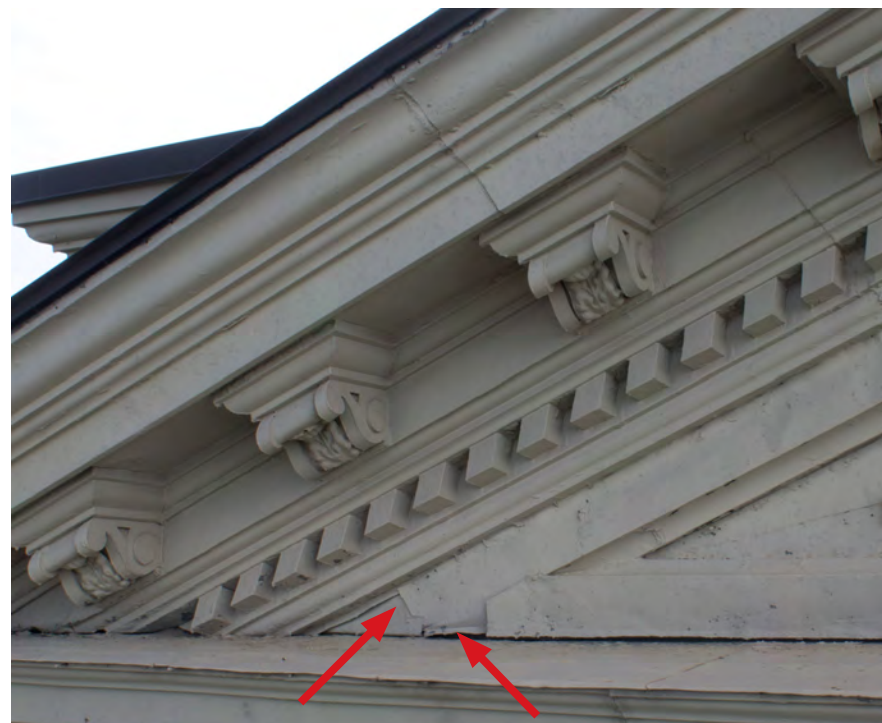
Figure 5.4.13: Detail at Corner of Pediment Showing Poorly Implemented Repairs.

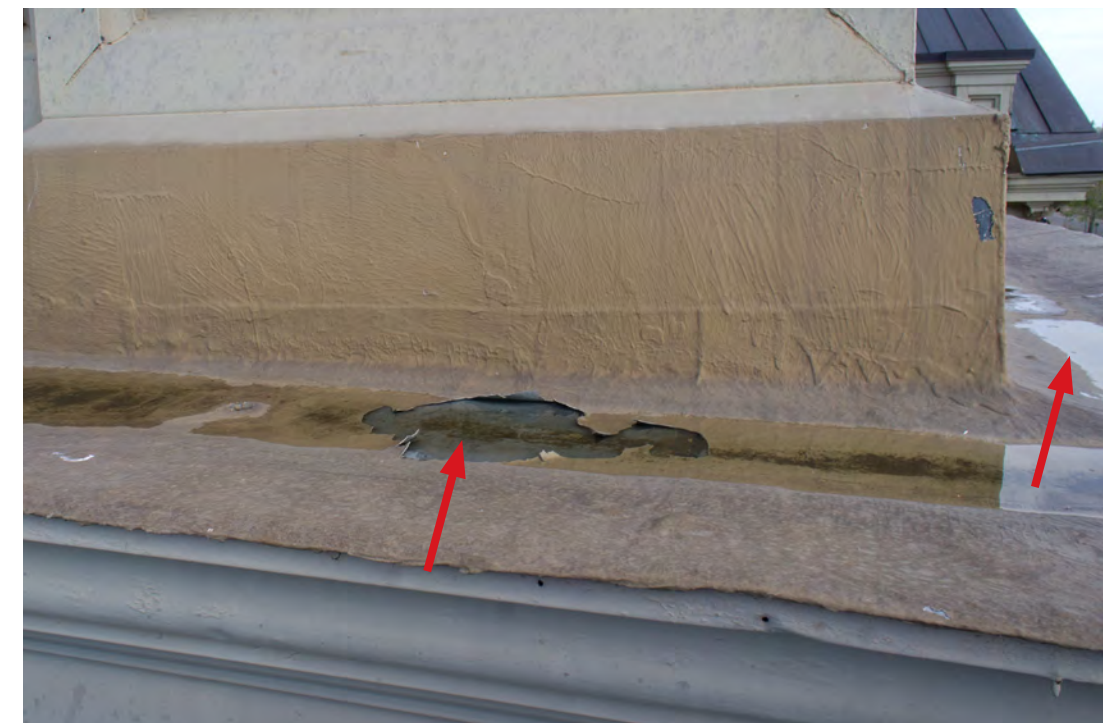
Figure 5.4.14: Detail Showing Loss of the Weatherproofing Membrane at the Cornice. Note the standing water at the cornice.

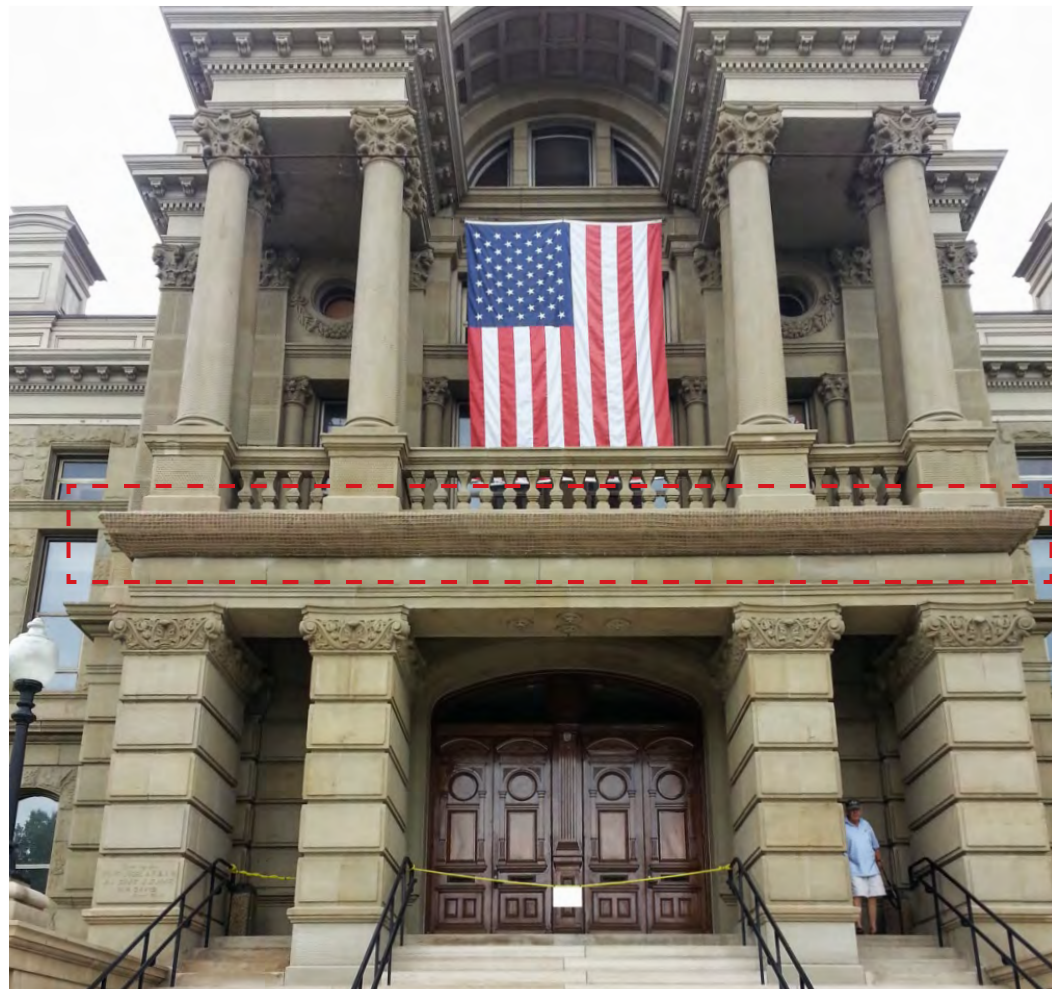
Figure 5.5.1: South Elevation, View Looking North. The red rectangle identifies the area of masonry distress and deterioration at the cornice above the south entrance and the protective netting installed as a result.
