Section 5: Site & Building Assessment

As part of the **Level I / Level II Study** for the Wyoming State Capitol, members of the **HDR/PDP/Plan1 Design Team** performed a comprehensive visual assessment of the exterior and interior of the Capitol Building and Site. Multiple site visits were made by the Design Team from March, 2013 through October, 2013 to conduct an intensive assessment of the building interior and exterior, including the existing building systems. With the assistance of members of the **State of Wyoming Department of Administration and Information Division of Construction Management [AICM]** and the Capitol facilities team, up-close visual access to the building was conducted using 125’ and 80’ high portable lifts and ladders. In addition, visual assessment of the Dome exterior and interior was performed using industrial rope access techniques. Interior assessments and building surveys were also conducted during this period.

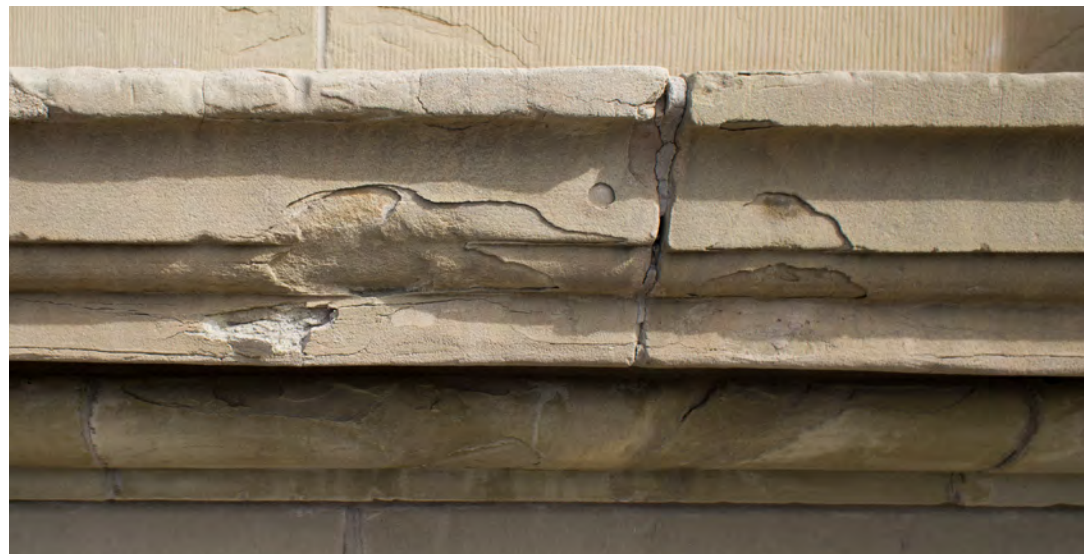
Figure 5.5.3: Severely Delaminated Eroded Stone Adjacent to Open Joints at the Cornice Stones Above the South Entrance.

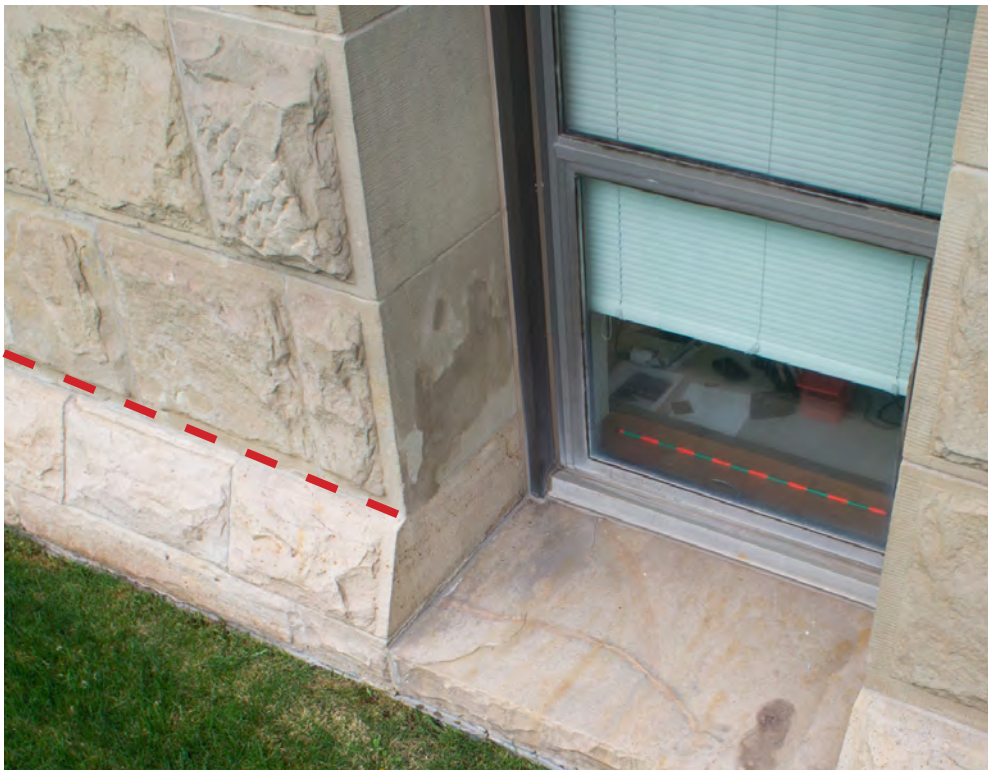
Figure 5.5.4: The First Two Courses of Sandstone, Below the Dashed Line are Buff/Pink Sandstone from Fort Collins, Colorado. The remaining sandstone is quarried from Rawlins, Wyoming. Note the efflorescence at the jamb caused by the upward migration of groundwater through the stone.

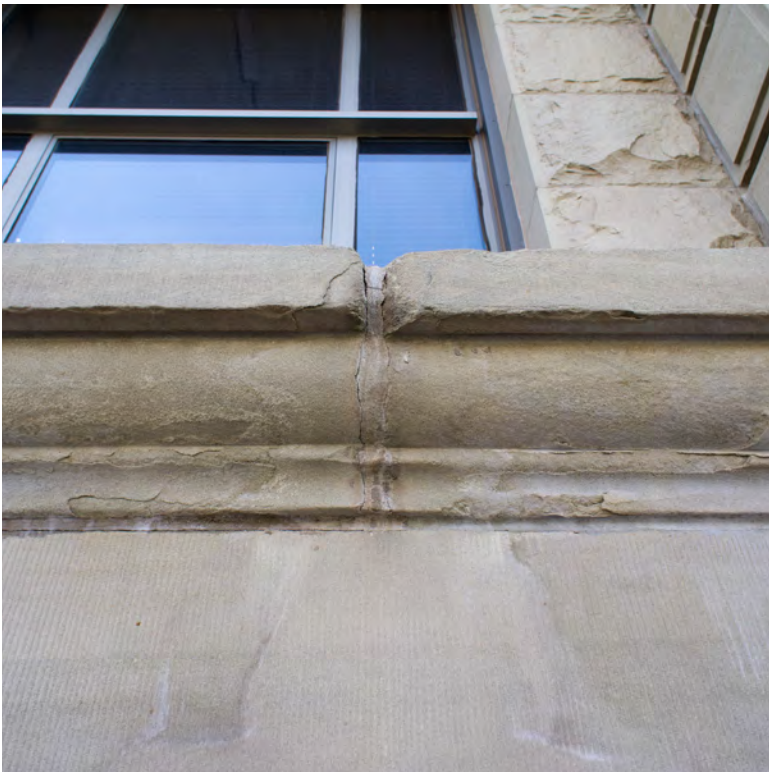
Figure 5.5.5: Eroded and Spalled Stone Conditions Adjacent to Open and Deteriorated Joints.

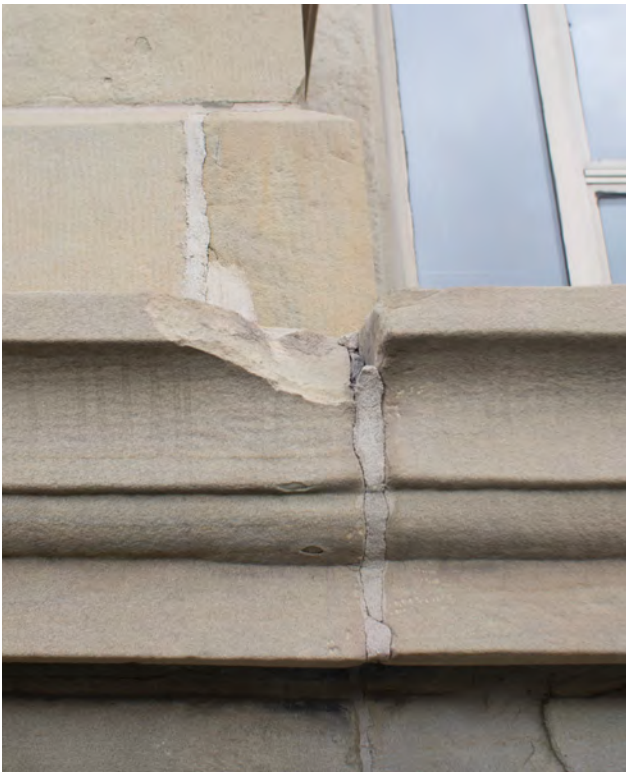
Figure 5.5.6: Large Spall Adjacent to a Deteriorated Joint at the Projecting Cornices.

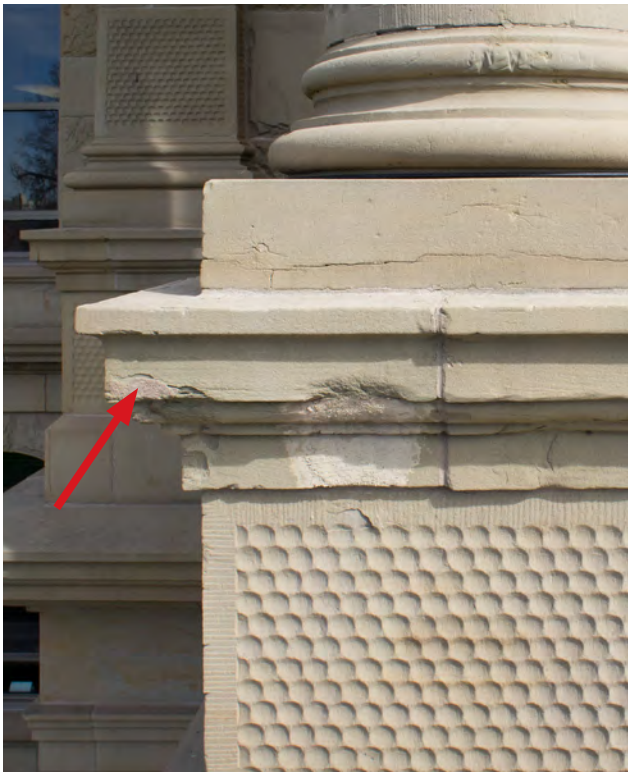
Figure 5.5.7: Deterioration and Failed Patch Repairs at the Column Bases.

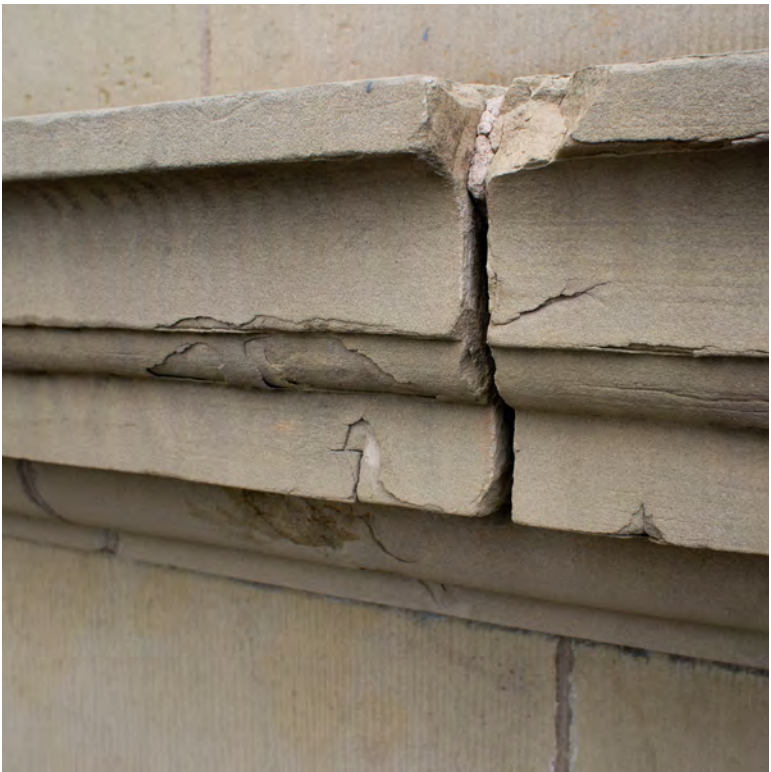
Figure 5.5.8: Delaminated, Eroded, Cracked and Spalled Stone Adjacent to Open Joint above South Entrance.

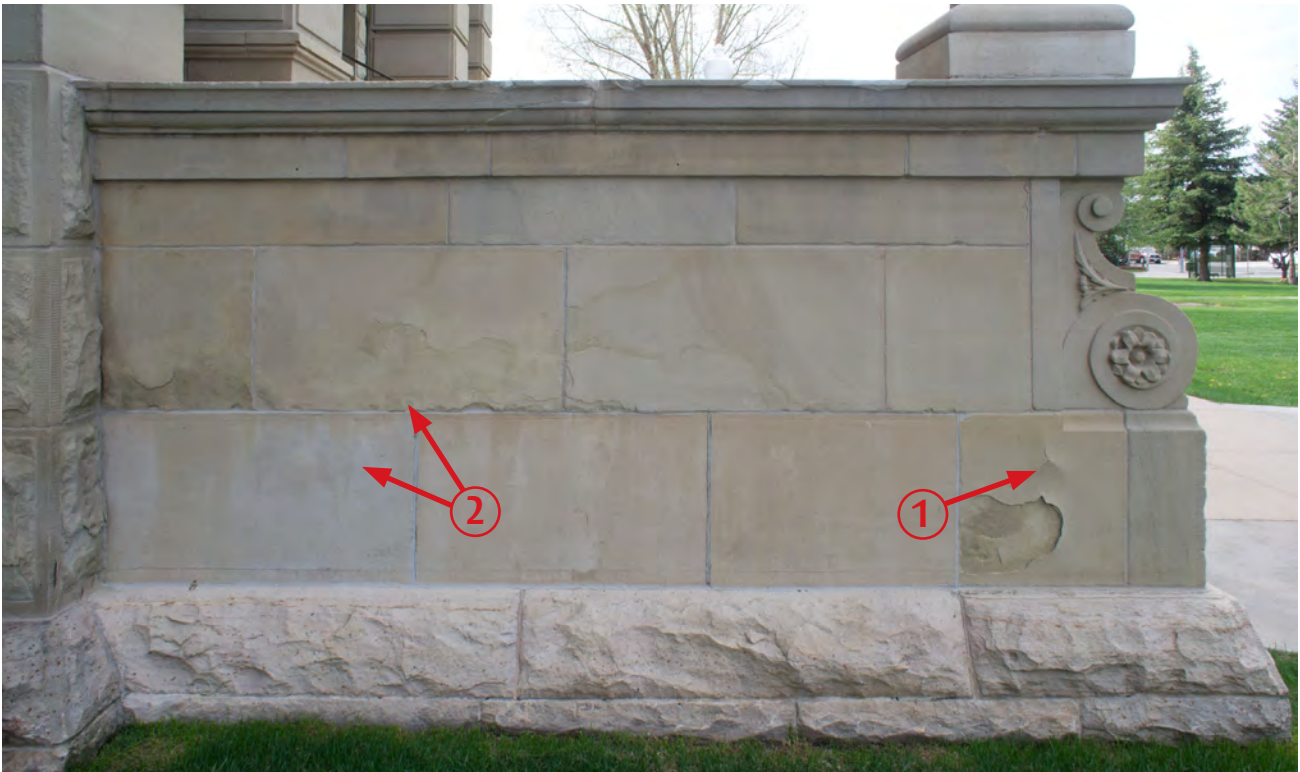
Figure 5.5.9: North Cheek Wall at the West Entrance. 1. Arrow #1 points to blistering sandstone, which eventually results in more extensive surface peeling or delamination as seen below the arrow head. 2. Arrow #2 points to areas of efflorescence caused by the upward migration of groundwater through the stone.

Efflorescence is the formation of soluble salts at the surface, and just below the surface, of the masonry. It is caused by the dissolution, transportation, and deposition of salts in the masonry as water migrates through it and evaporates. The salts are varied and generally exist in the walls as part of the wall constituents, that is, in the stone or the mortar. [Figures 5.5.14, 5.5.27, and 5.5.28] In many cases, the salts are related to the de-icing salts used during the winter months by building personnel to keep the stairs clear. [Figures 5.5.9 and 5.5.15]

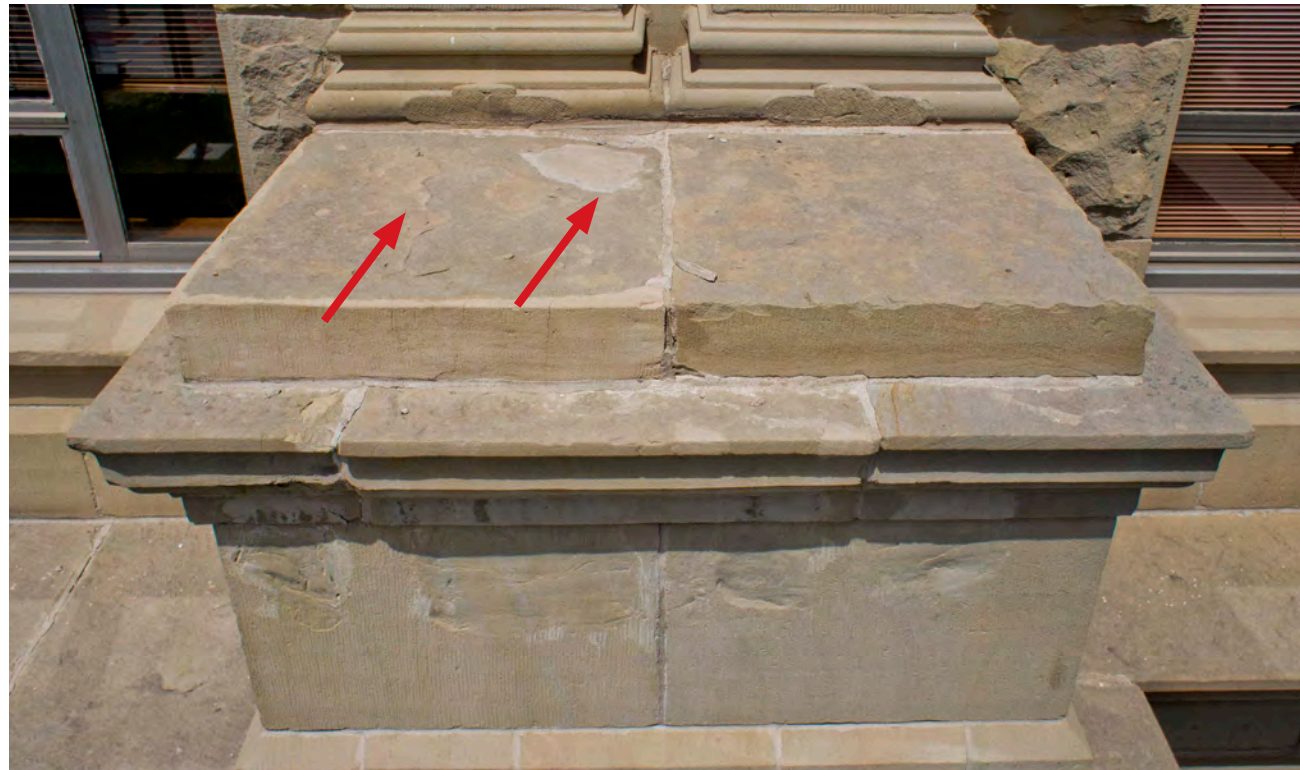
Figure 5.5.10: Delaminated, Eroded Stone at Exposed Horizontal Surfaces at the South Elevation. This exposed sandstone element served as a plinth for two columns constructed as part of the 1890 additions. In 1917 the columns were moved to the new additions at the east and west wings.

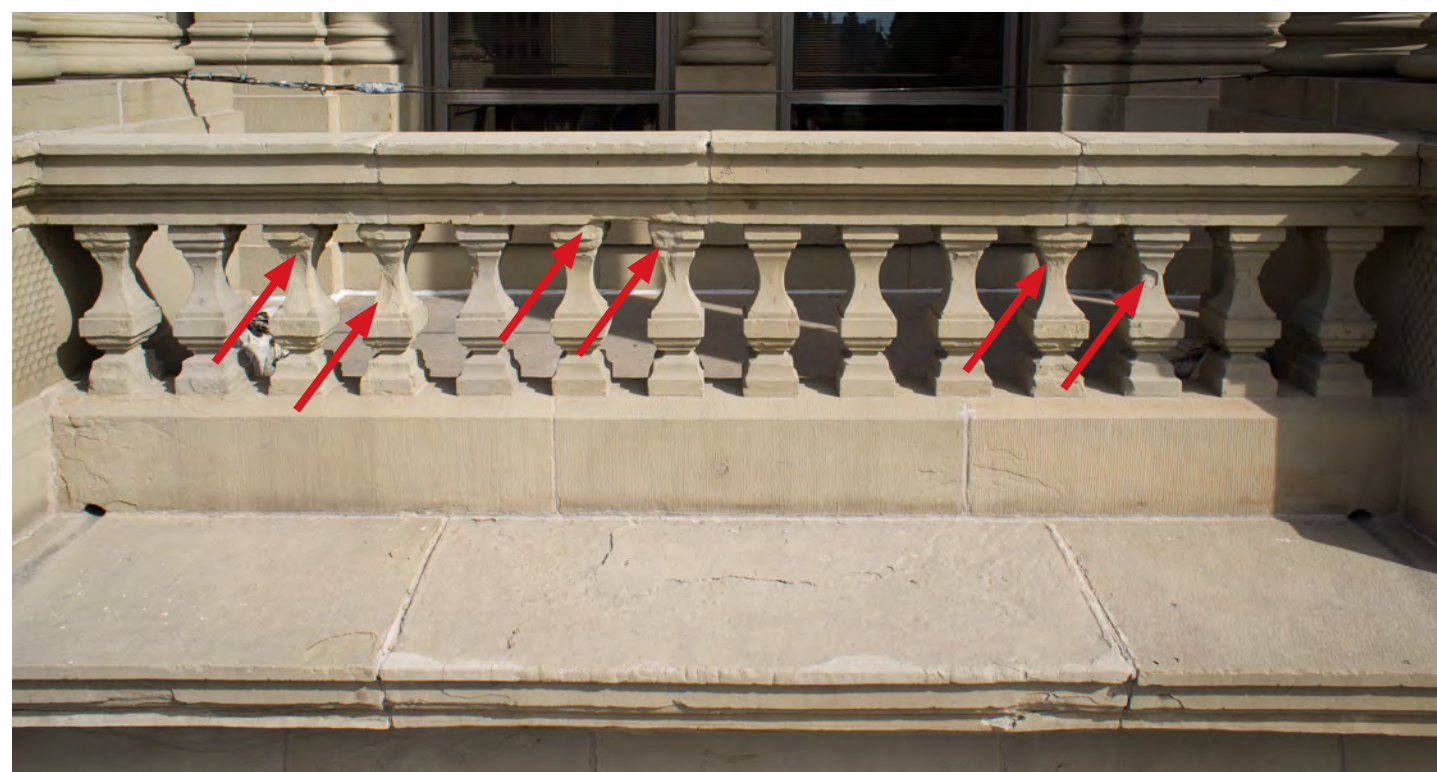
Figure 5.5.13: Delaminated and Eroded Balusters above the South Entrance. Note that the most severe deterioration is at the balusters directly below joints.

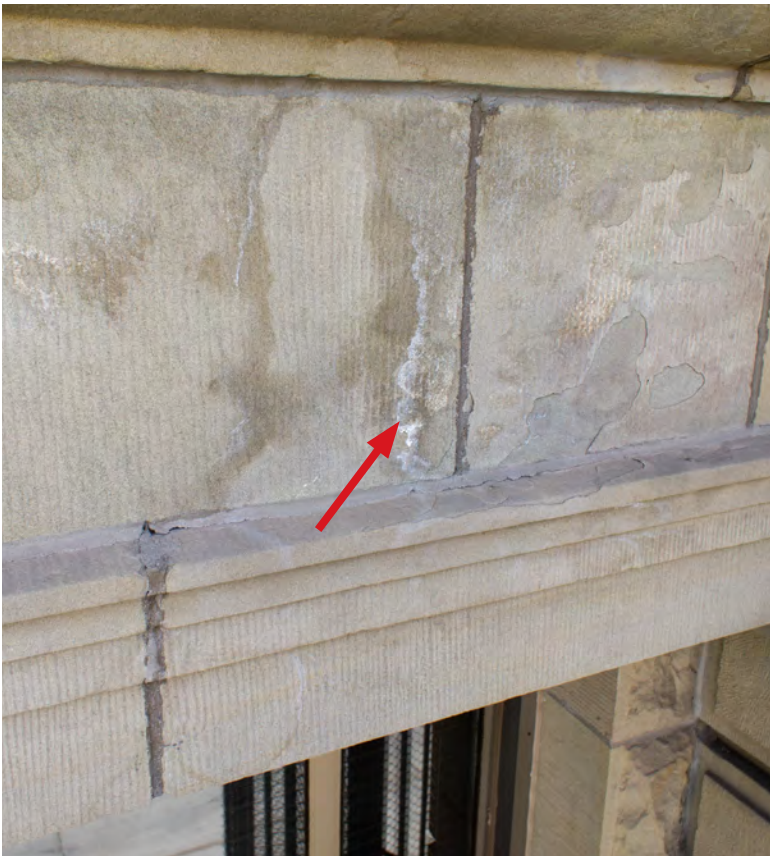
Figure 5.5.14: Efflorescence and Delamination at Some Locations in the Entablature Below the Cornice.

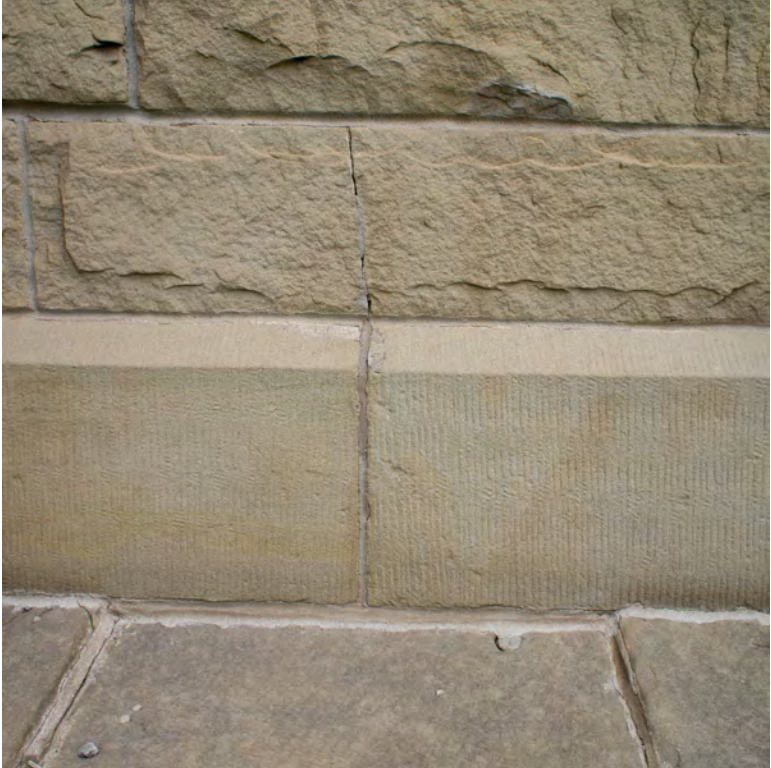
Figure 5.5.17: Cracked Stone Units and Open Joints at the East Elevation. There is a cracked stone unit above a joint that had opened up and was repointed. This is directly above a displaced cornice unit suggesting there may have been some movement at this location.

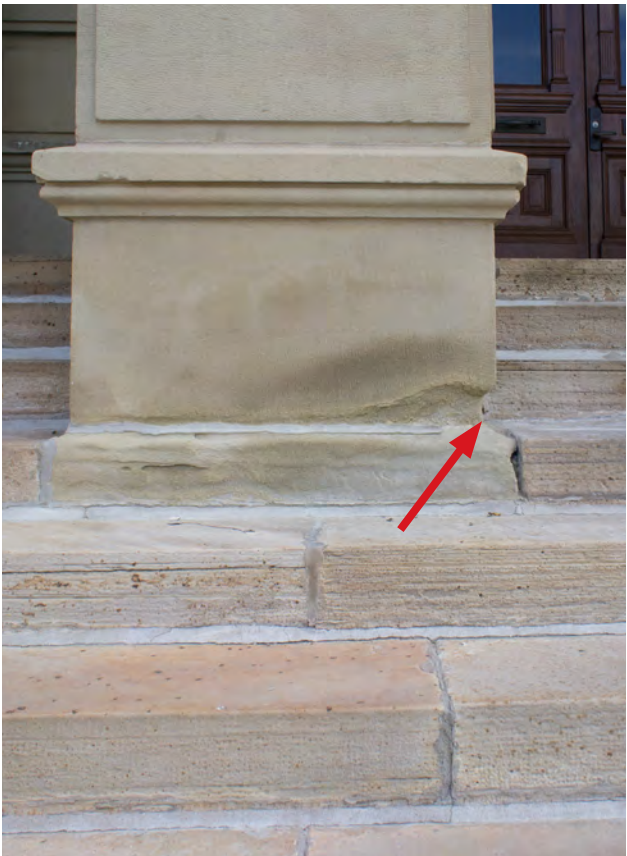
Figure 5.5.15: View of Severe Erosion at West Entrance Due to the Use of De-Icing Salts.

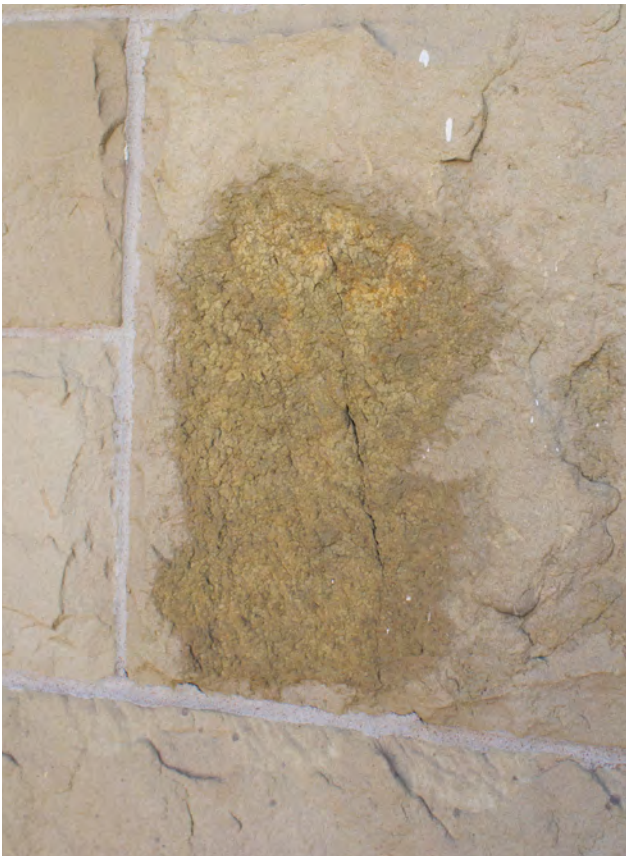
Figure 5.5.16: Typical Staining Where Stone Has Been Treated During Previous Repair Campaigns.

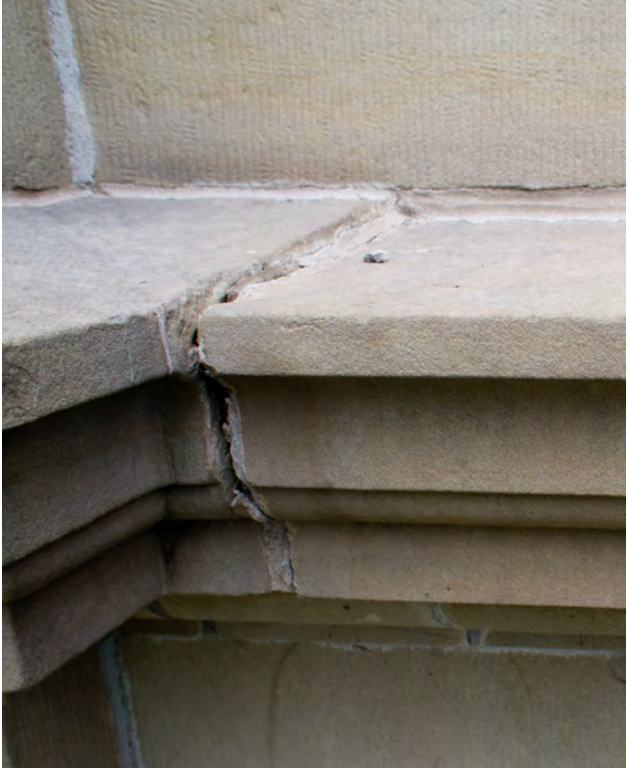
Figure 5.5.19: Displaced Stone Unit at the East Elevation Adjacent to a Wide, Open Joint.

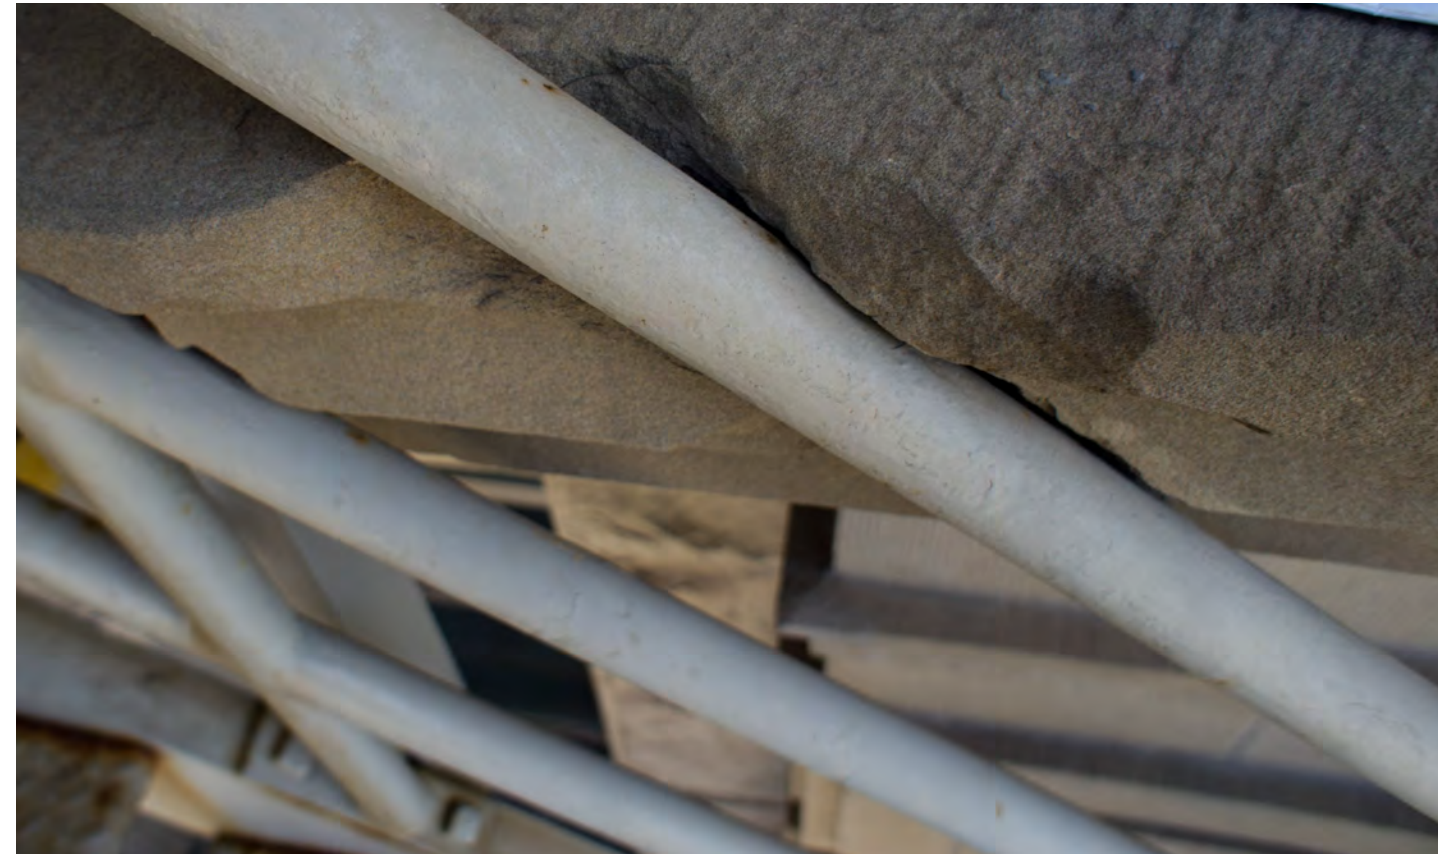
Figure 5.5.20: Masonry Cut and Damaged to Accommodate the Fire Stair Handrails at the North Elevation.

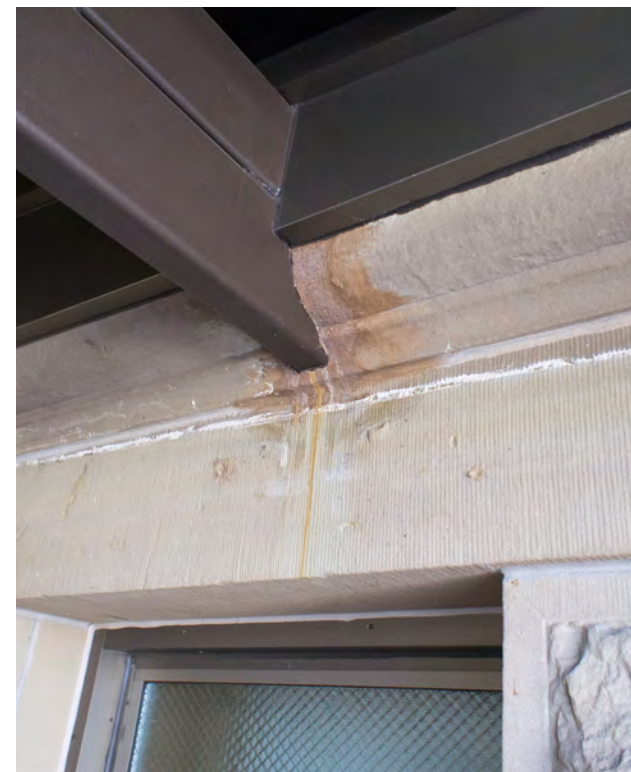
Figure 5.5.22: Damage and Staining to Stone Caused by Installation of Steel Structure at Glass Enclosures at the North Elevation.

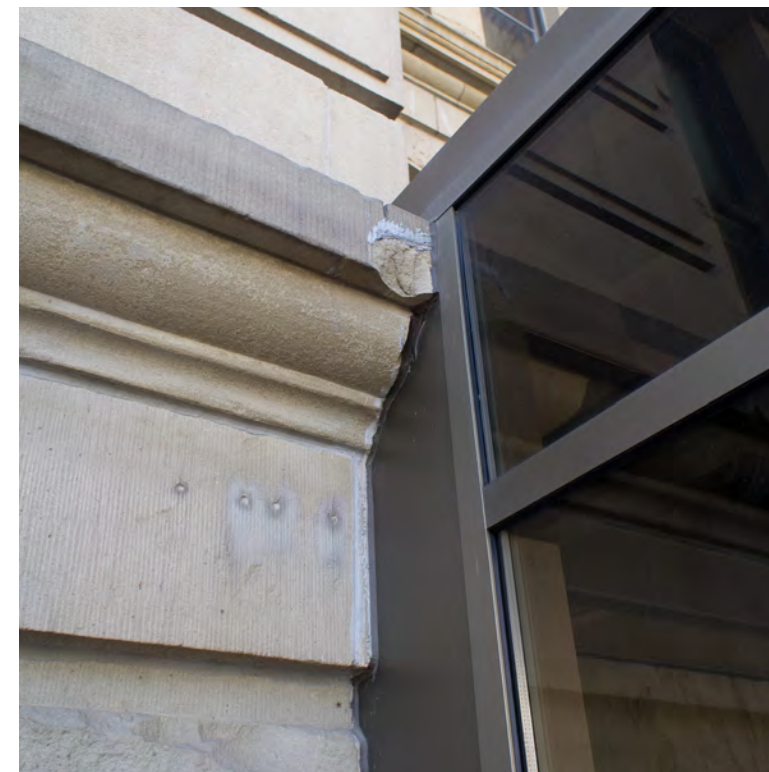
Figure 5.5.23: Spalled Stone Adjacent to Glass Enclosure at the North Elevation.

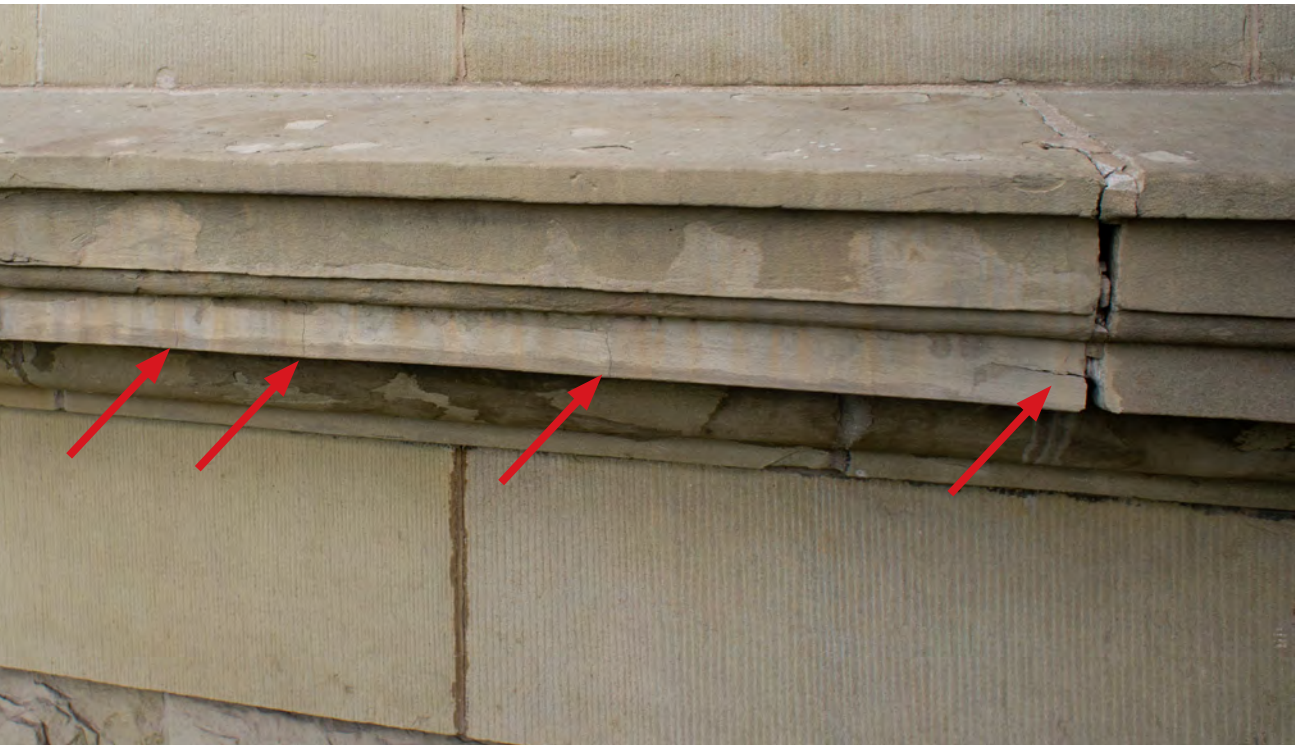
Figure 5.5.26: Cracked and Failed Patch Repair at the Cornice at the South Entrance. Some of the patches are in danger of breaking apart and falling.

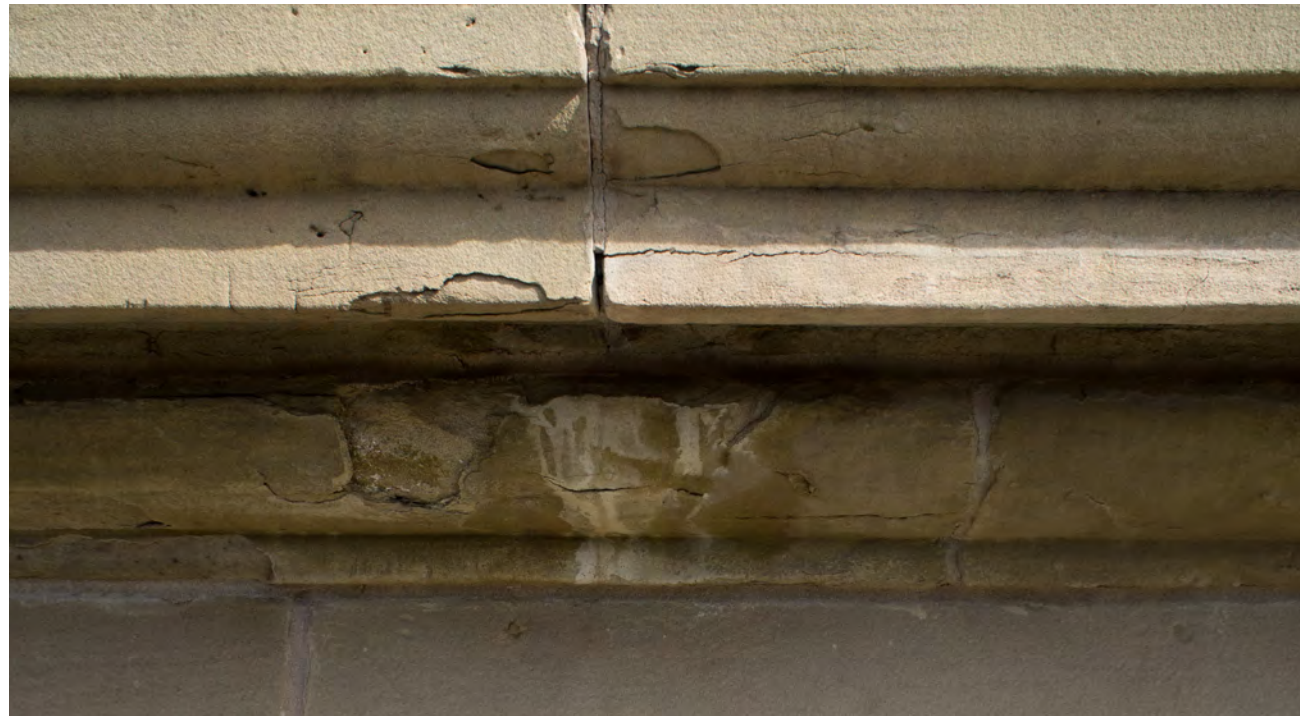
Figure 5.5.27: Severe Distress and Deterioration at the Cornice Units Above the South Entrance. The distress includes delamination, erosion, cracking and efflorescence.

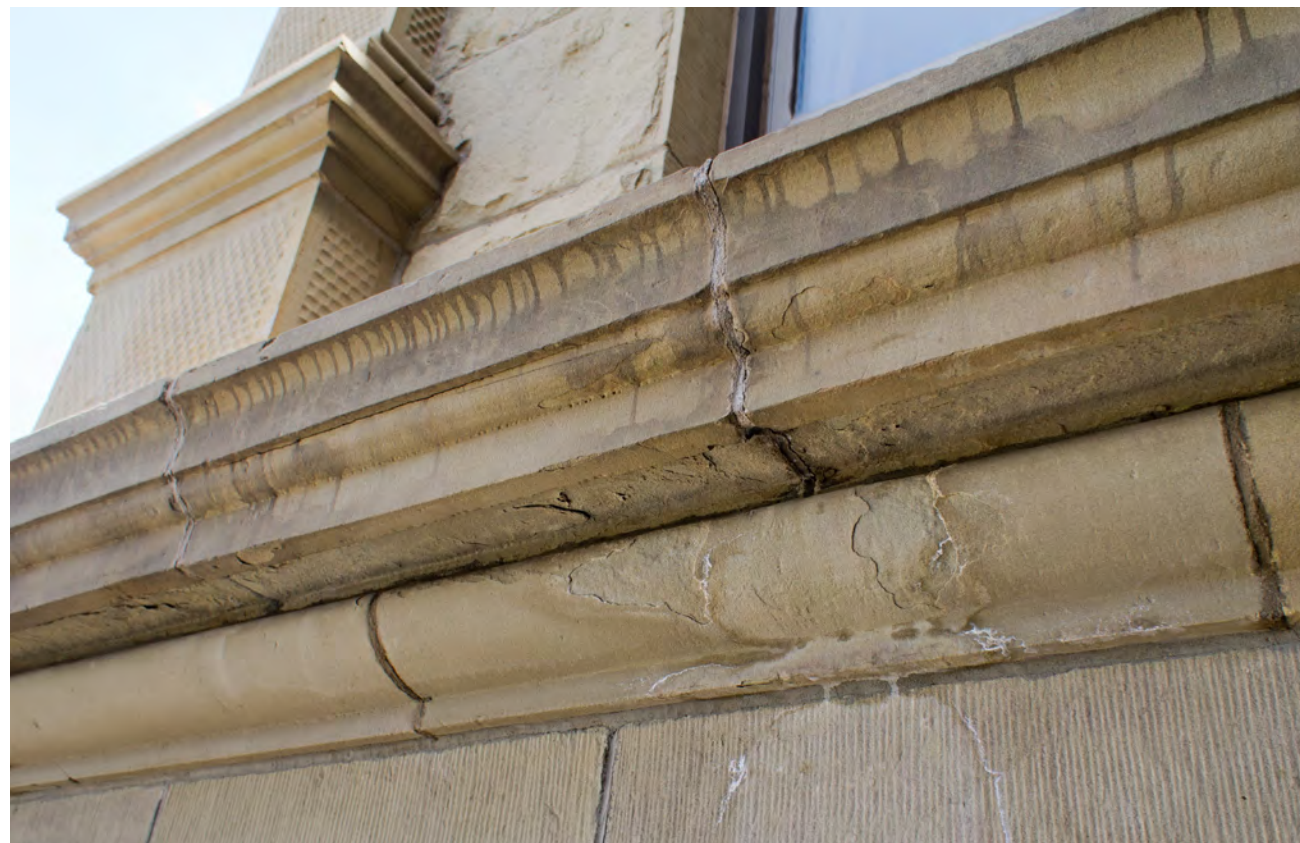
Figure 5.5.28: Sandstone Deterioration adjacent to Open Joints. There is delamination of the ovola [curved surface] directly below the joint as well as efflorescence staining.

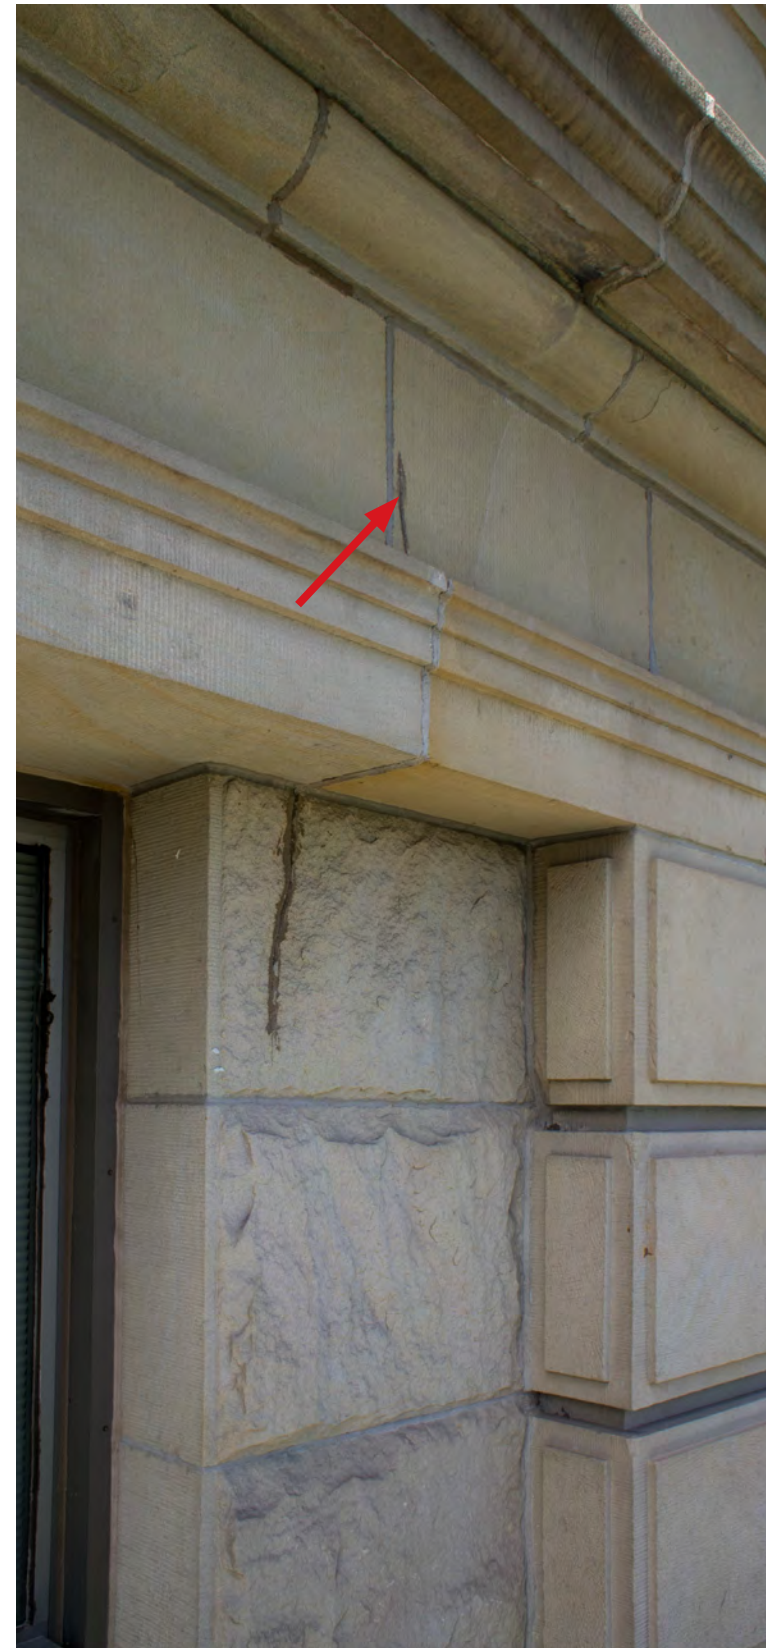
Figure 5.5.29: Typical Pattern of Cracking at the East Elevation. At this location, the cracks have been repaired inappropriately with an epoxy material that stains the masonry.

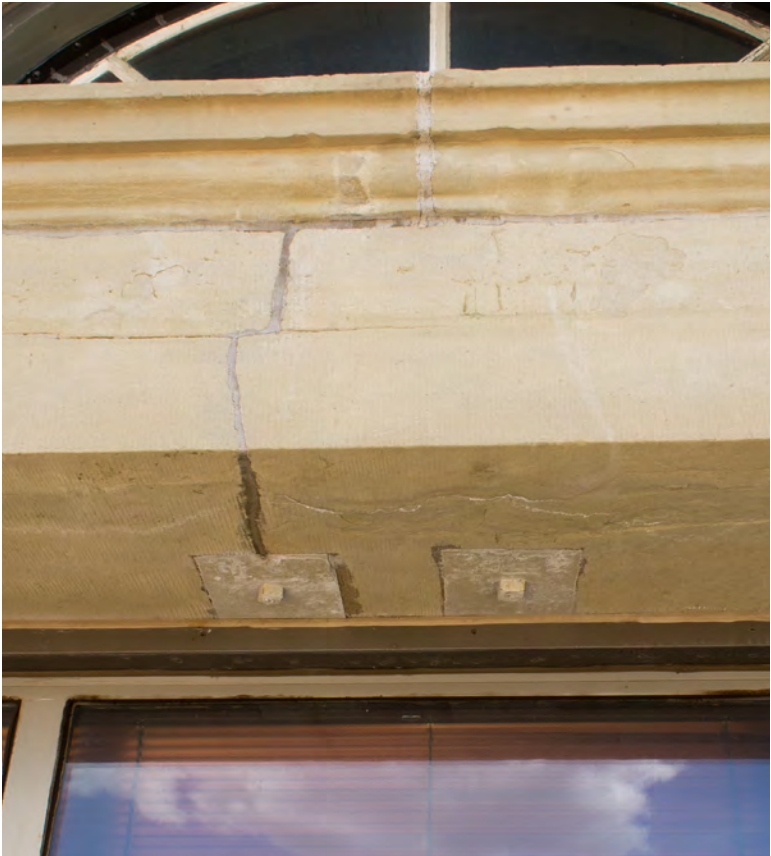
Figure 5.5.30: Previous Repair with Square Plates, Rods, and Bolts [at Cracked Stone Lintels].

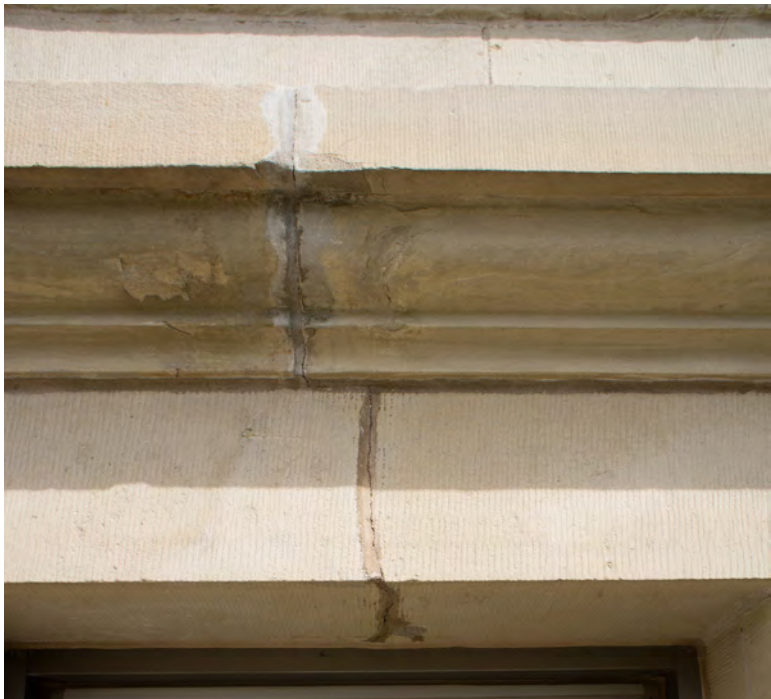
Figure 5.5.32: Cracked Lintel at South Elevation.

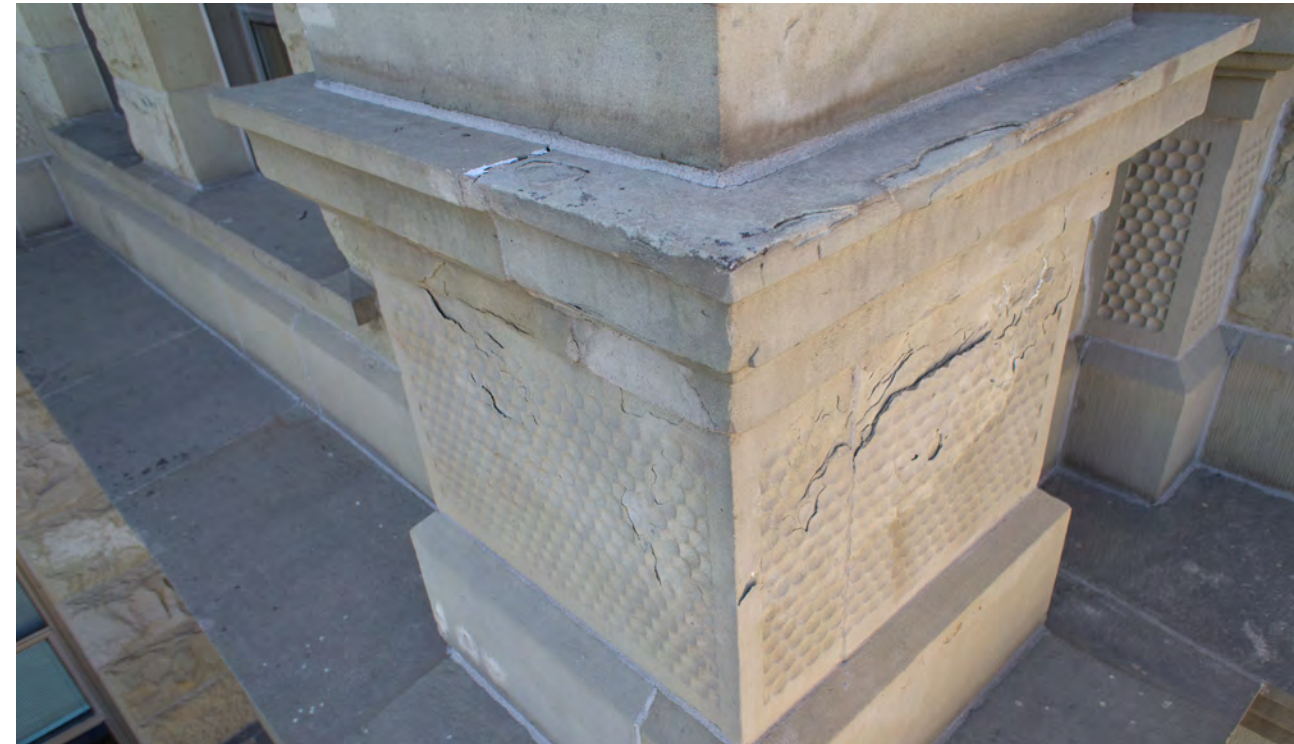
Figure 5.5.35: Delaminated, Eroded Stone at the North Portico Caused by Malfunctioning Rain Leaders.

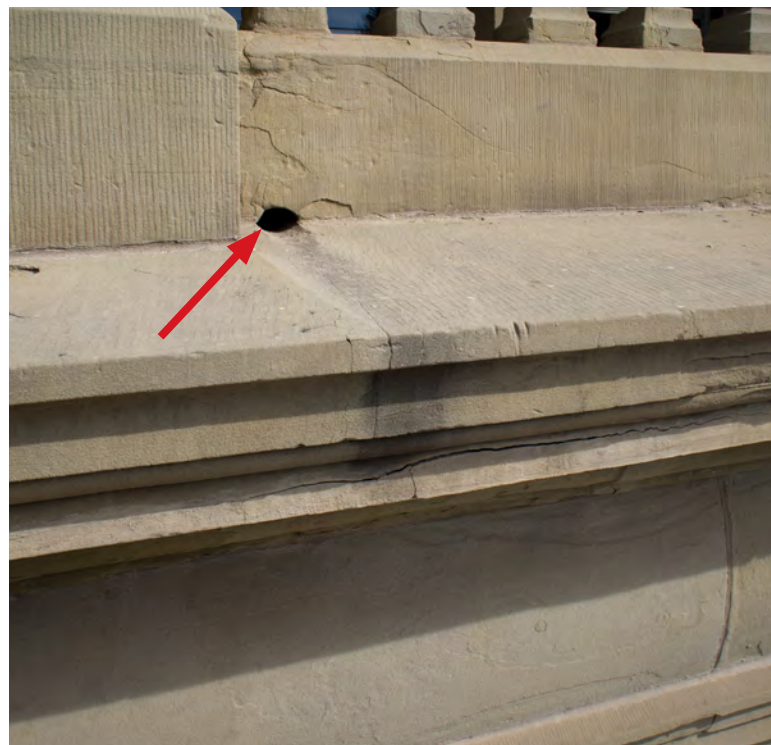
Figure 5.5.36: View of the Scupper at Cornice above South Elevation. Note the Stone Deterioration Adjacent to the Scupper.

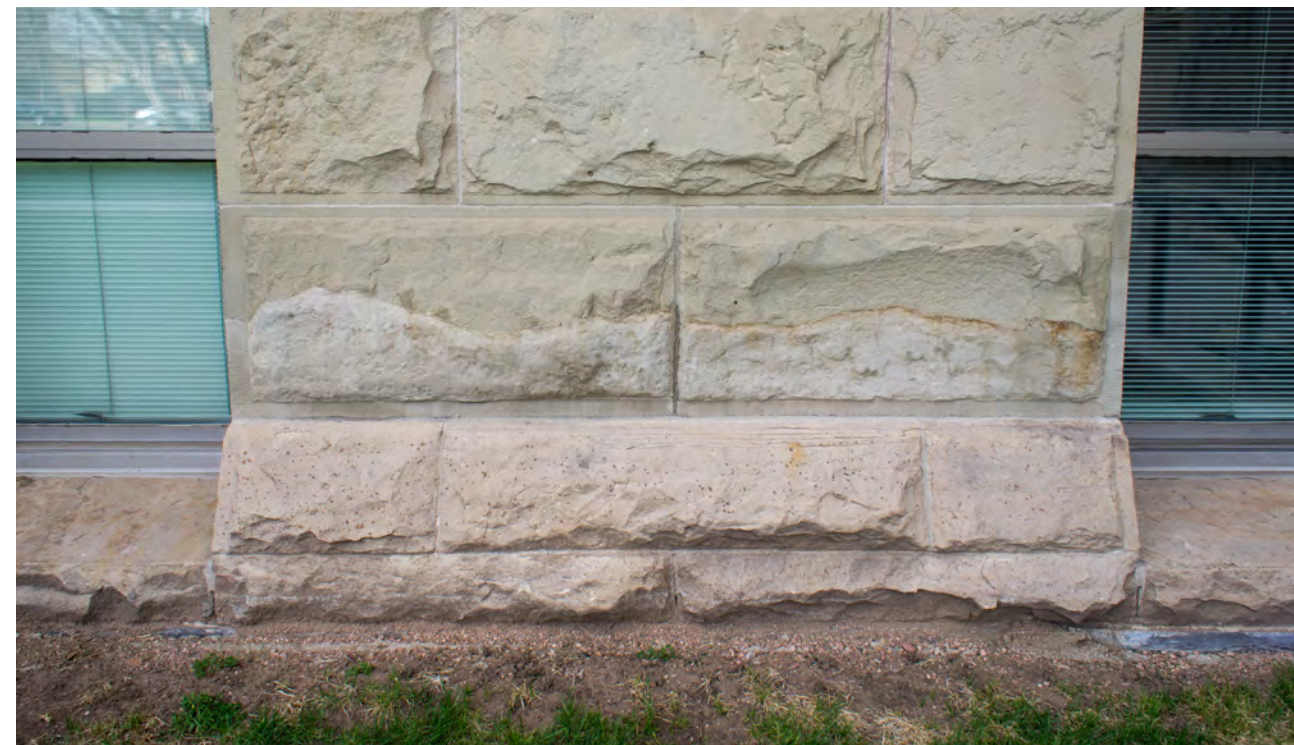
Figure 5.5.37: Rising Damp and Efflorescence at the Base of the South Elevation.

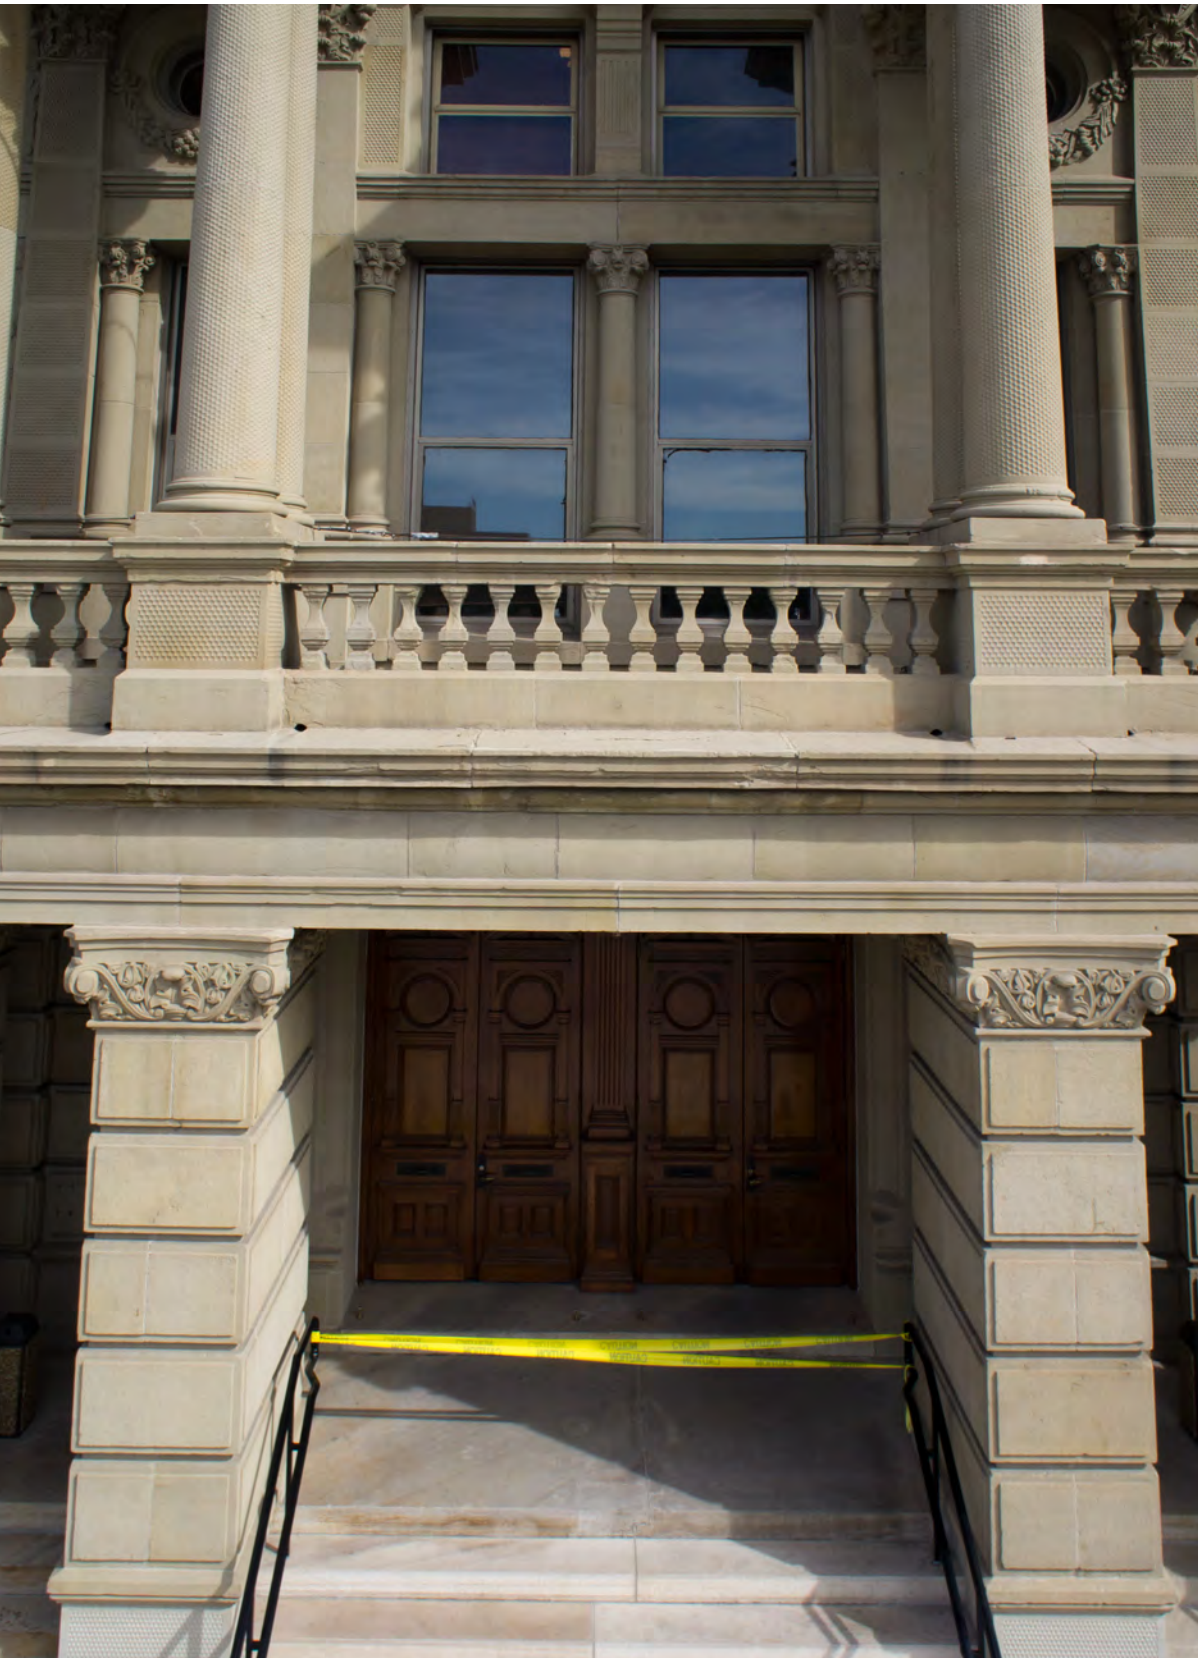
Figure 5.5.38: The Projecting Cornice Above the South Portico Entry Stair, Where Severe Deterioration of the Stone Was Observed.
