Section 5: Site & Building Assessment

As part of the **Level I / Level II Study** for the Wyoming State Capitol, members of the **HDR/PDP/Plan1 Design Team** performed a comprehensive visual assessment of the exterior and interior of the Capitol Building and Site. Multiple site visits were made by the Design Team from March, 2013 through October, 2013 to conduct an intensive assessment of the building interior and exterior, including the existing building systems. With the assistance of members of the **State of Wyoming Department of Administration and Information Division of Construction Management [AICM]** and the Capitol facilities team, up-close visual access to the building was conducted using 125’ and 80’ high portable lifts and ladders. In addition, visual assessment of the Dome exterior and interior was performed using industrial rope access techniques. Interior assessments and building surveys were also conducted during this period.

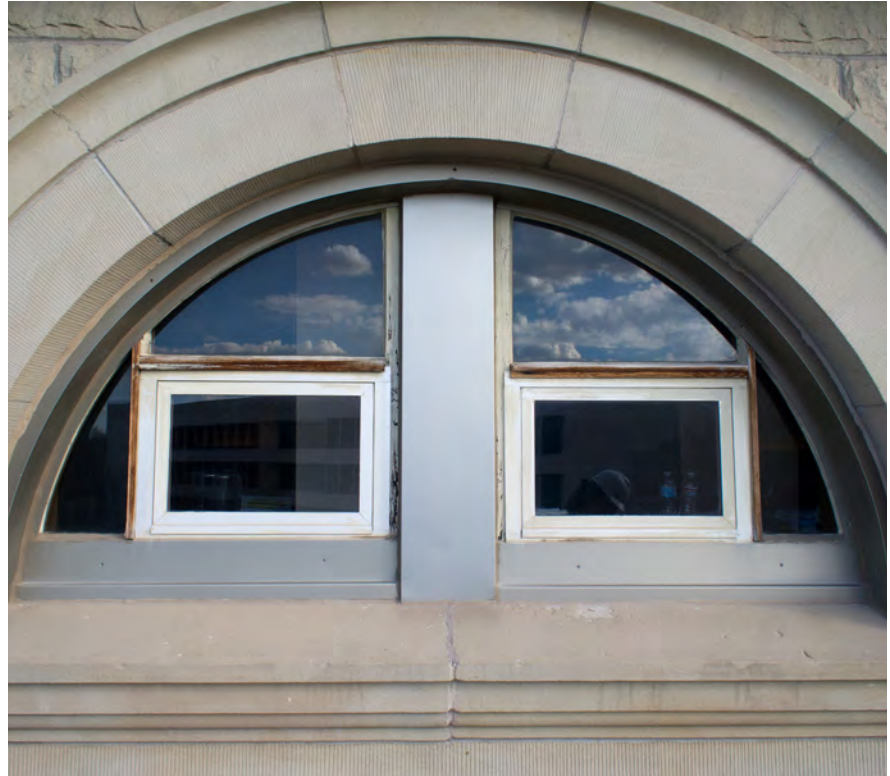
Figure 5.6.4 Detail of Replacement Window at the Third Floor. It appears that the original wood frames have been capped in metal.
