5.7.2 Building Interior Architectural Description

5.7.5 Building Interior

5.7.6 Building Interior Building Systems

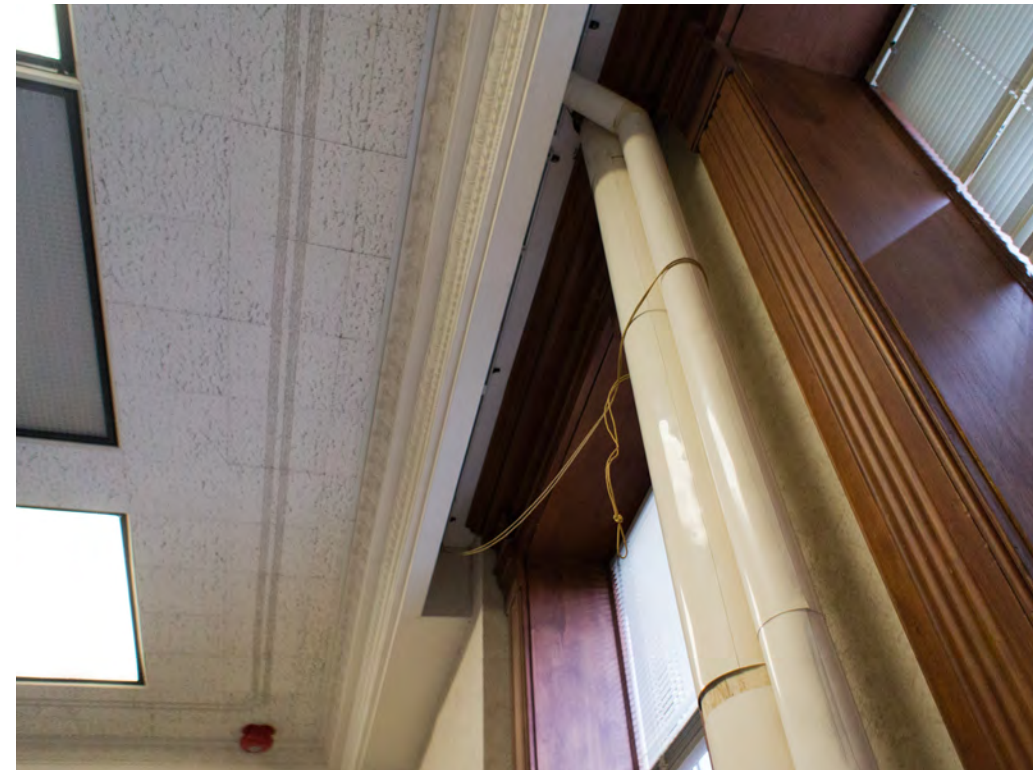
Figure 5.7.2.3: Non-Historic Modifications Within Room 118, Including Exposed Piping, Inappropriate Architectural Lighting Fixtures, and Drapery Boxes.

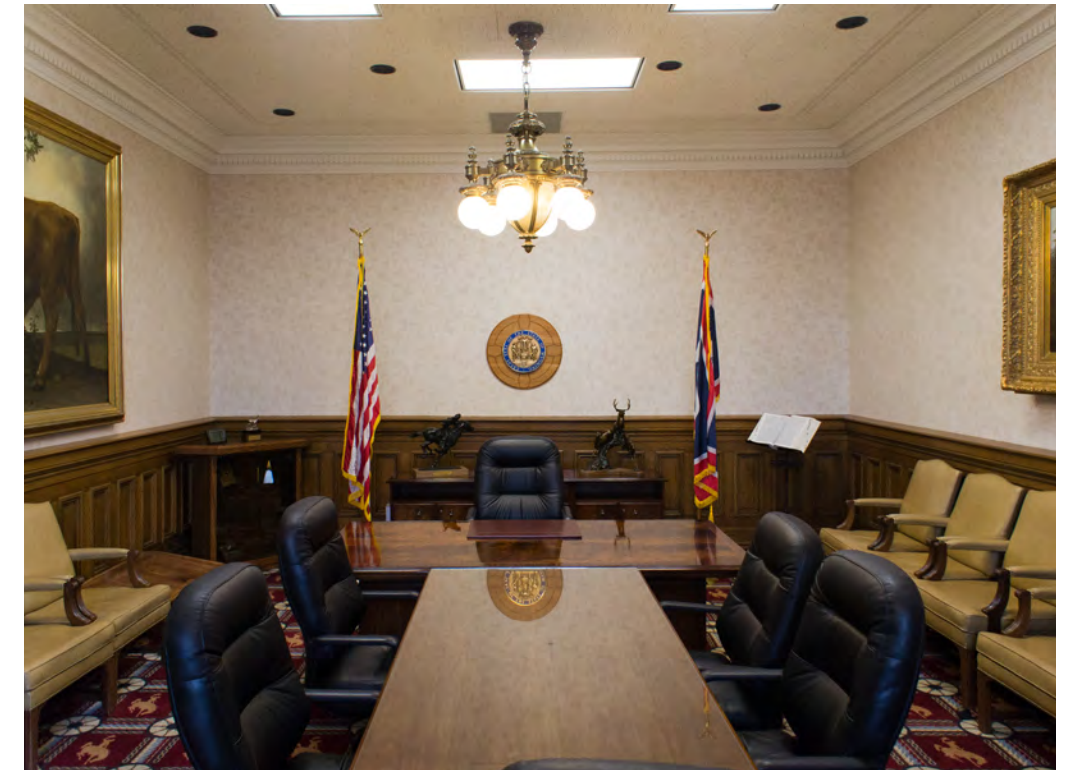
Figure 5.7.2.4: Governor's Ceremonial Conference Room, Which Has a Mix of Original and Inappropriate Interior Finishes.

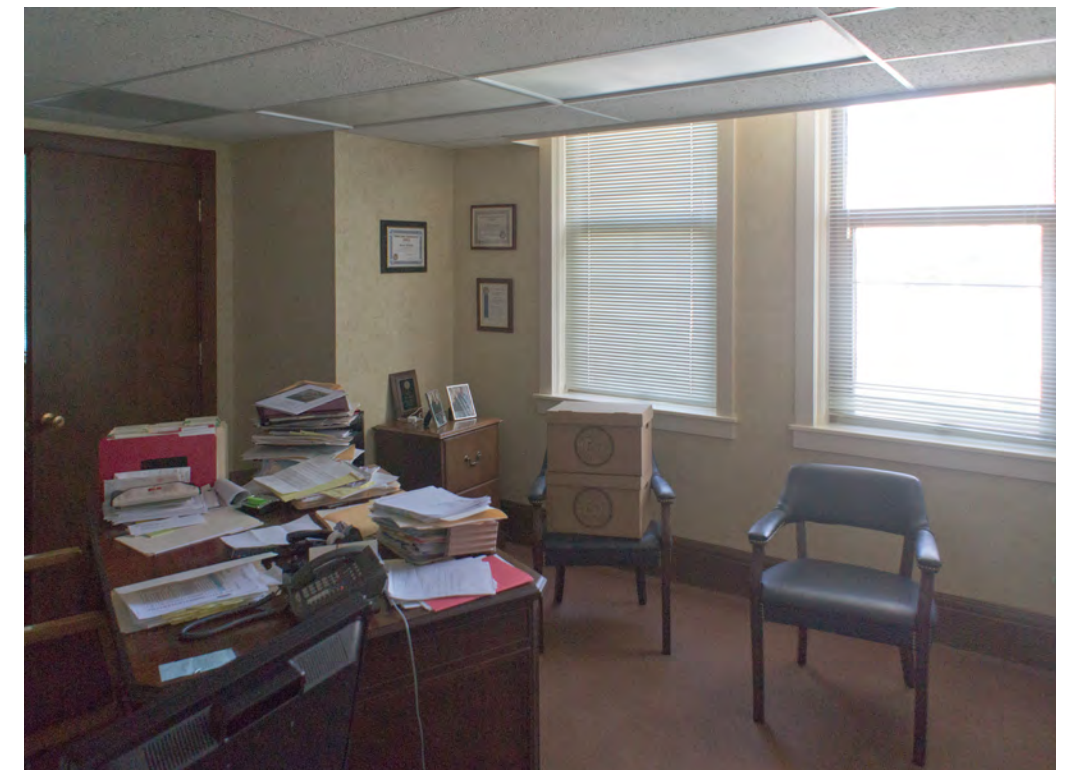
Figure 5.7.2.6: Perimeter Office Space at the Basement Level. Suspended acoustical tile ceilings with inappropriate fluorescent light fixtures are hung below the interior window heads, decreasing daylight penetration.

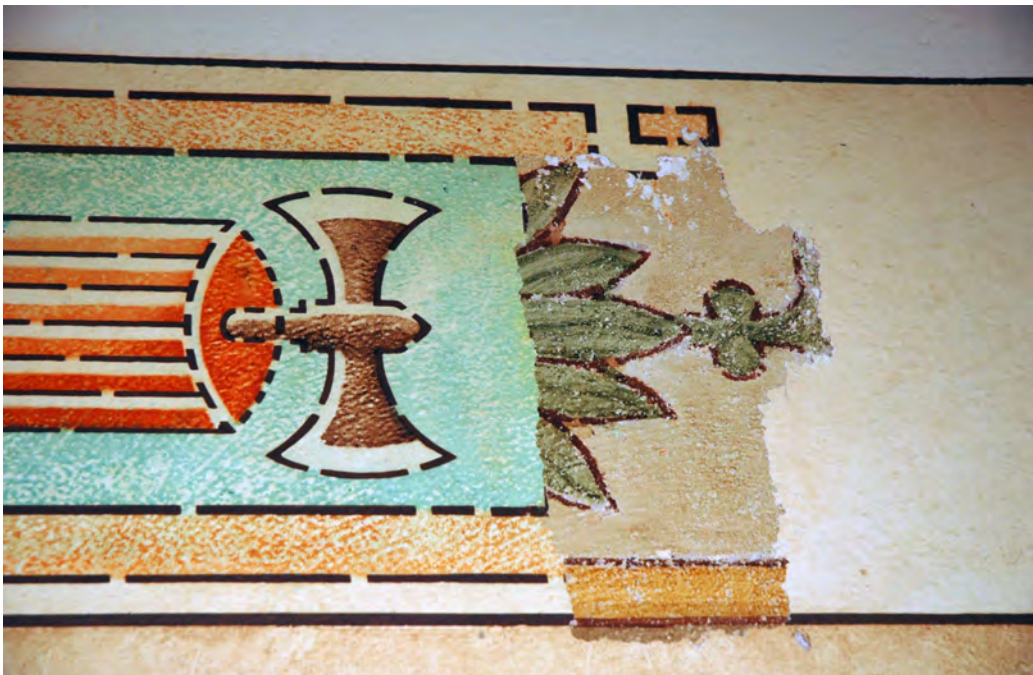
Figure 5.7.3.16: Finishes Exposure at the Third Floor Corridor. The existing decorative fasces design is seen on the left, and a historic motif at the right.

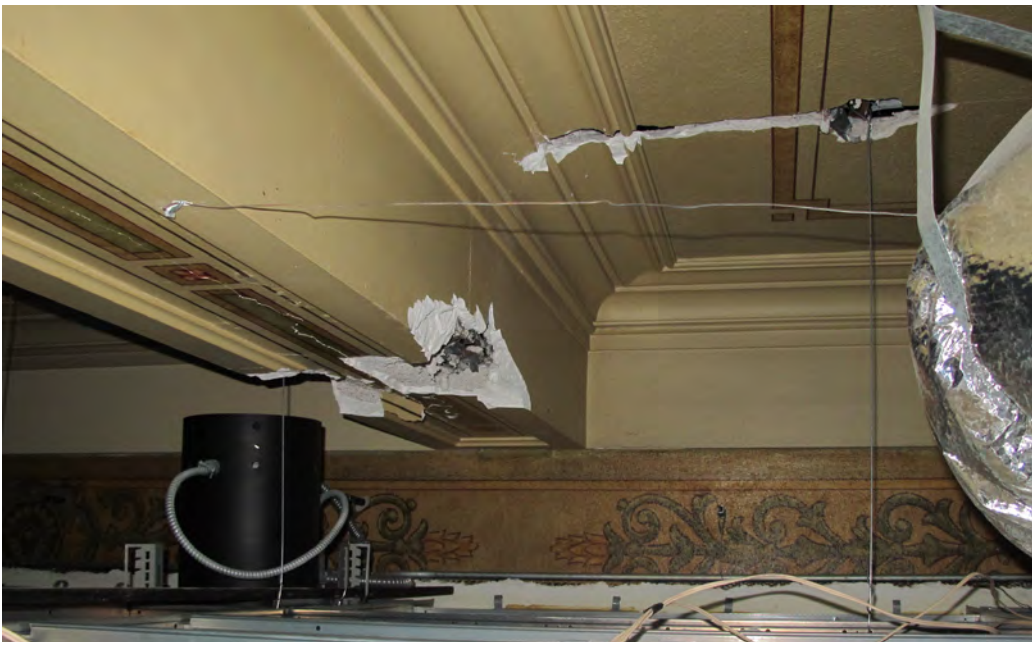
Figure 5.7.3.18: Photograph of Existing Decorative Border, Painted Plaster Ceiling and Painted Underside of Beam Above Drop Ceiling at Governor’s Portrait Gallery.

- Provide further information as to whether or not they match the finishes depicted in the 1929 and 1935 Rotunda photographs
- Determine if this scheme was continuous throughout the First Floor corridors and Rotunda

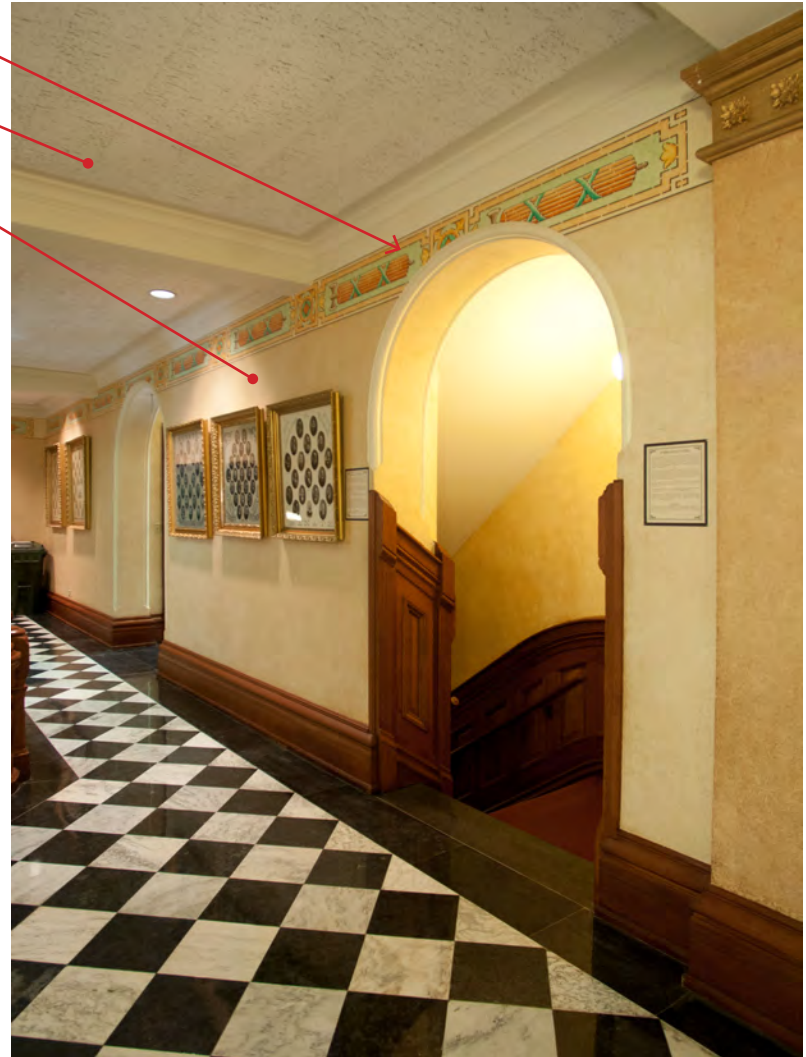
Figure 5.7.3.23: Third Floor Corridor and East Stair Portal, 2013.

Roman Fasces Motif

Acoustical Tile Panels at Ceiling

No Stenciling Pattern

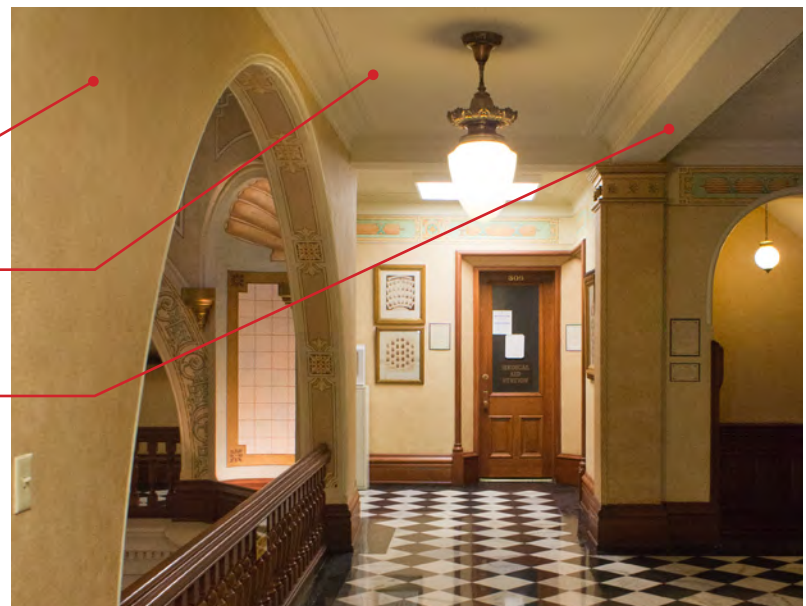
Figure 5.7.3.24: Third Floor Corridor, Adjacent to Rotunda, 2013.

No Decorative Pattern

No Stenciling Pattern at Ceiling

No Decorative Painting at Underside of Beam

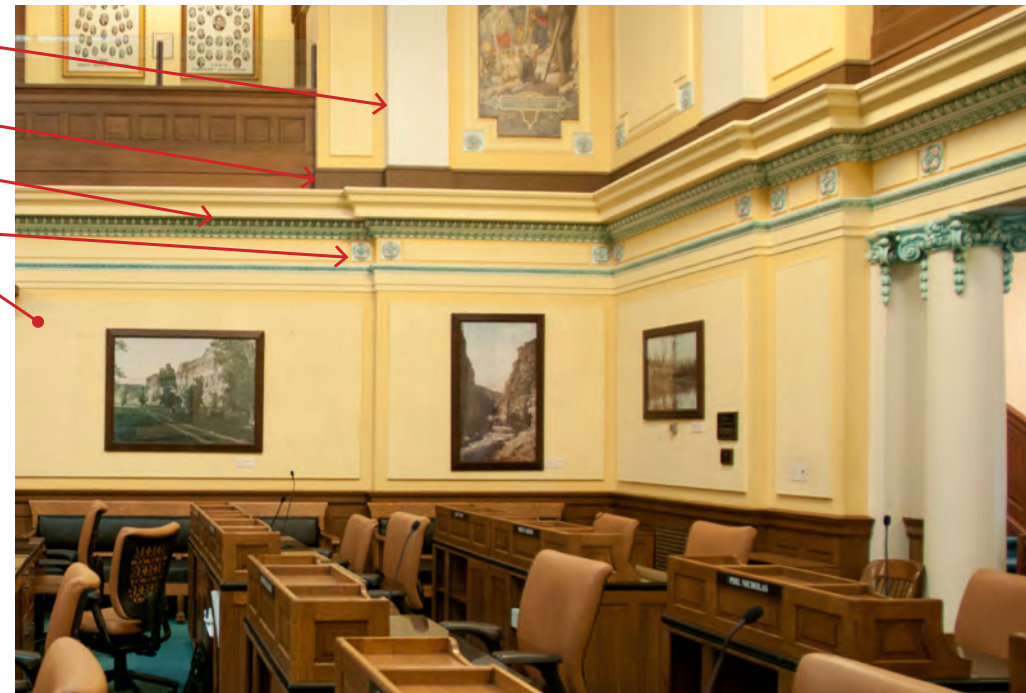
Figure 5.7.3.31: Senate Chamber, 2013.

Atypical Pilaster Color

Accented Rosettes

Acoustical Tile Wall Panels

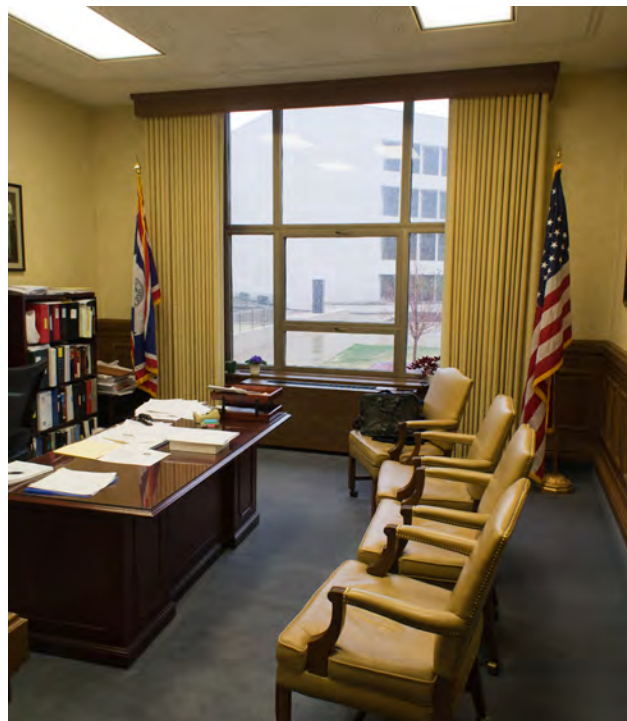
Figure 5.7.4.7: Non-Historic Fluorescent Lighting at a Perimeter Office.

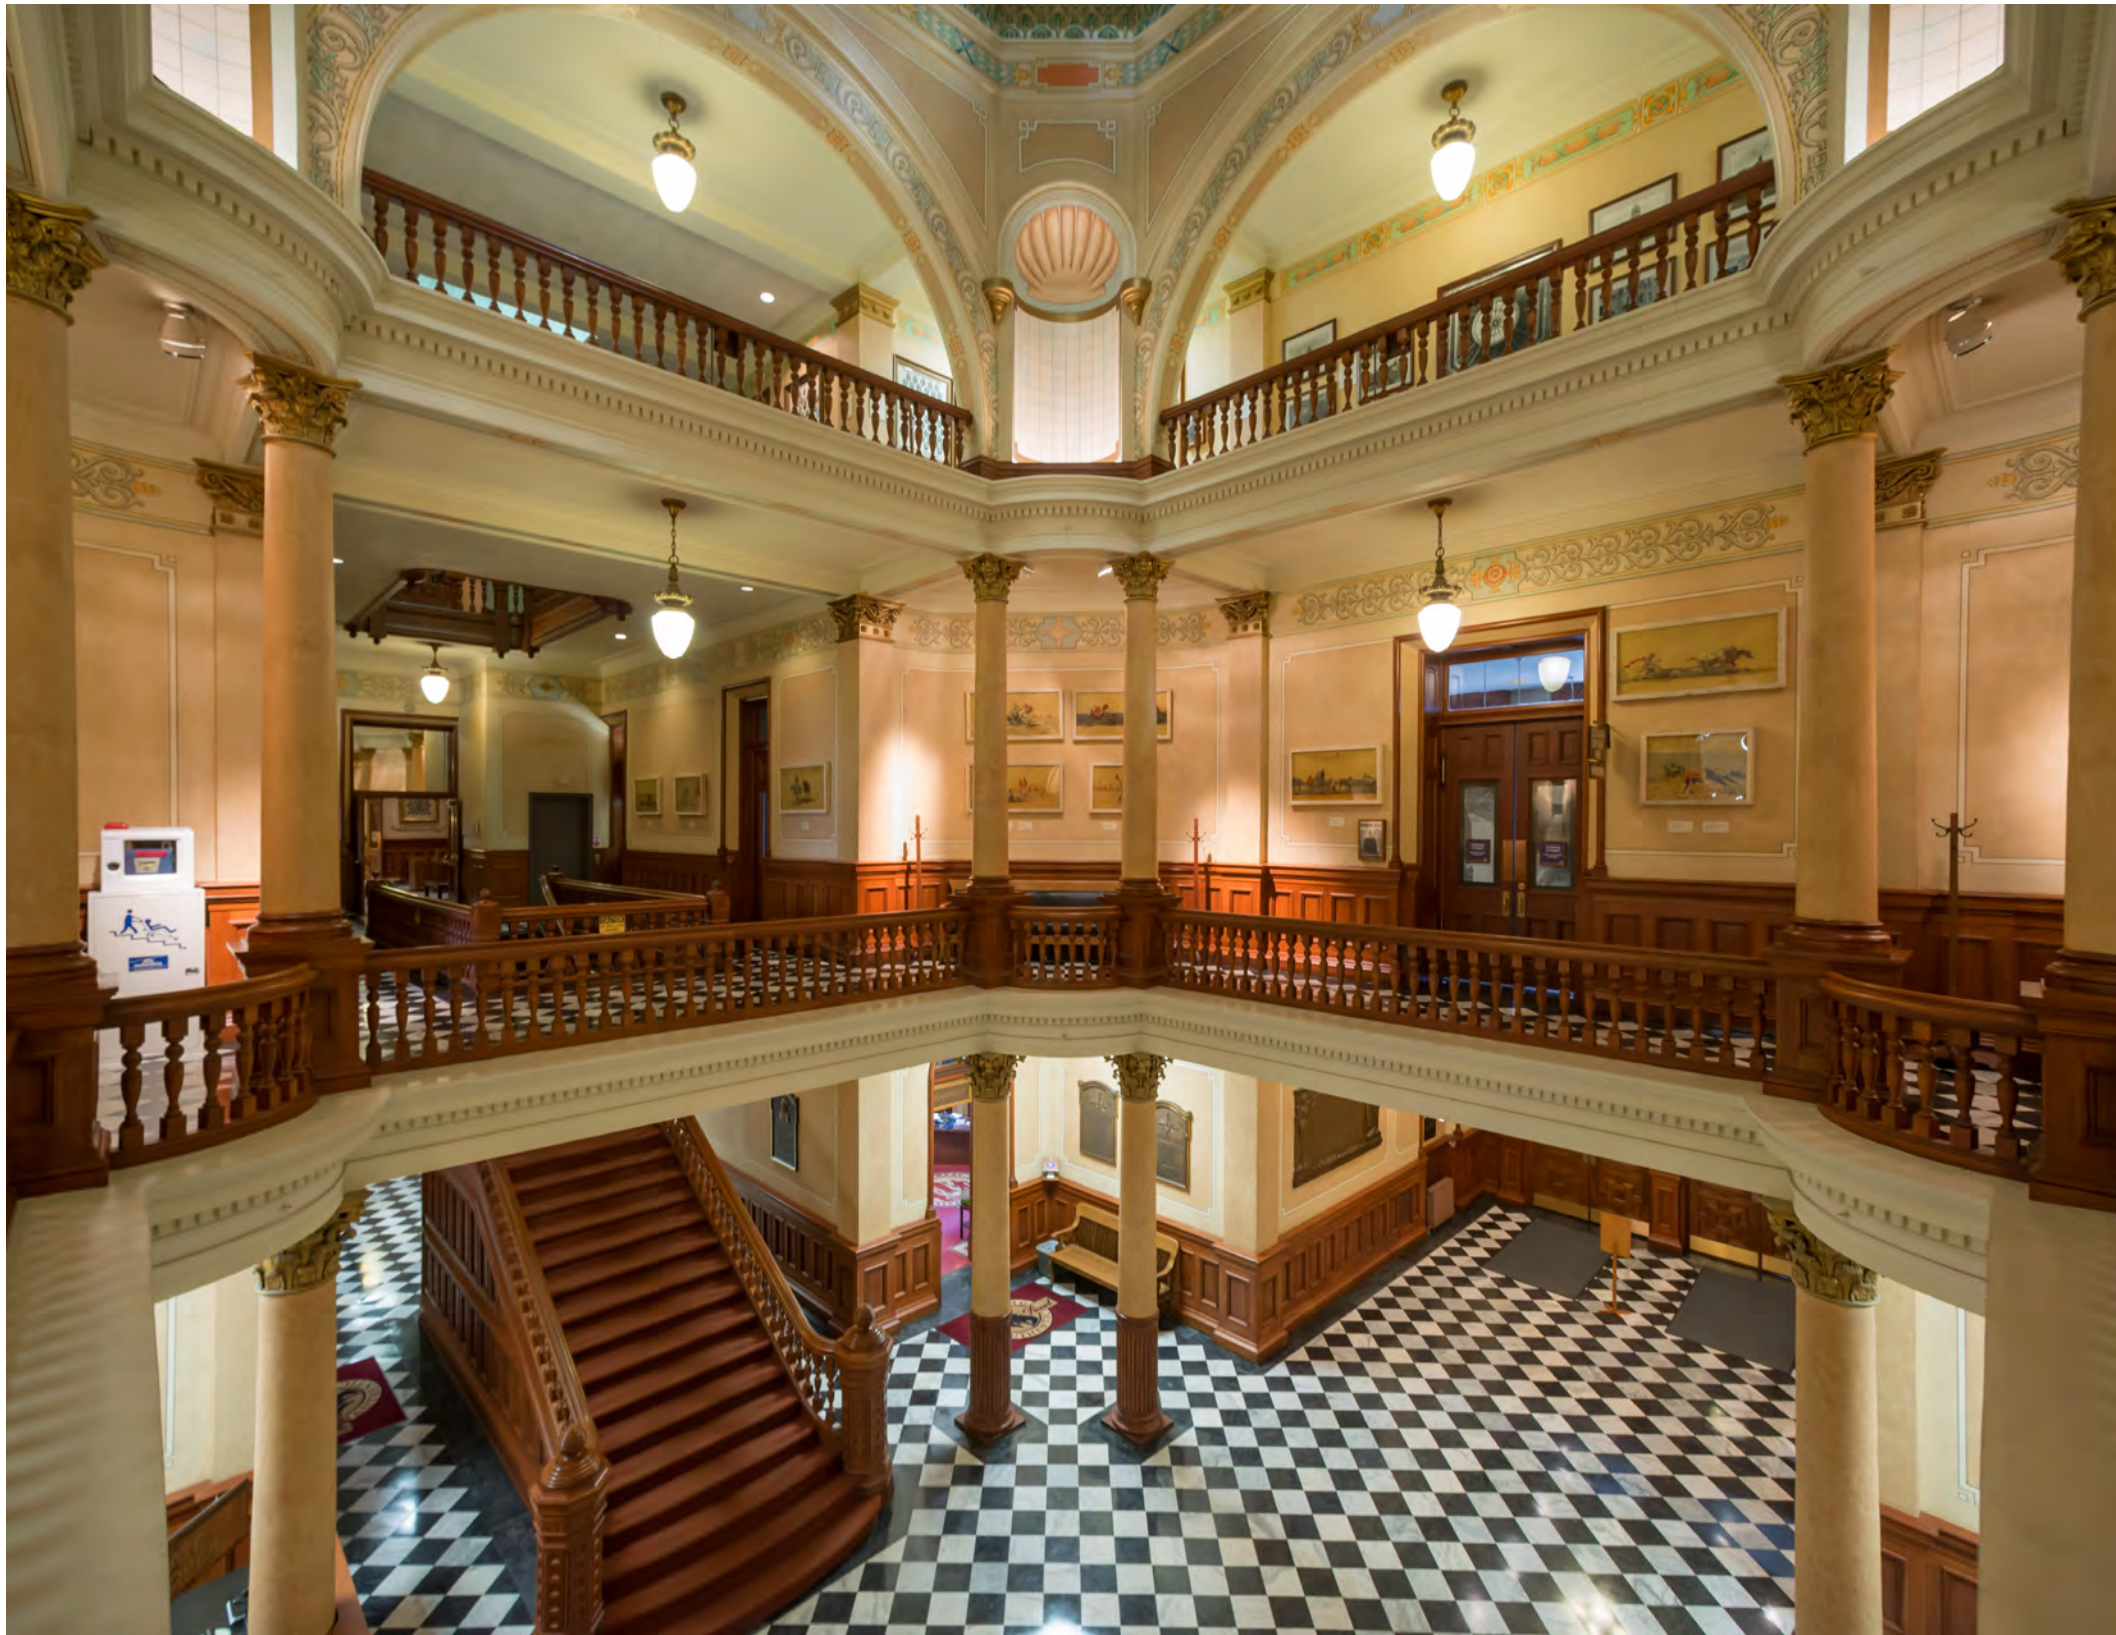
Figure 5.7.5.1: Rotunda From the Second Floor Balcony.

- Historic railings in the Rotunda and the monumental stairs are well below the code-required heights, constituting a life safety risk. Similar conditions exist in the House and Senate Chambers. [Figure 5.7.5.1]

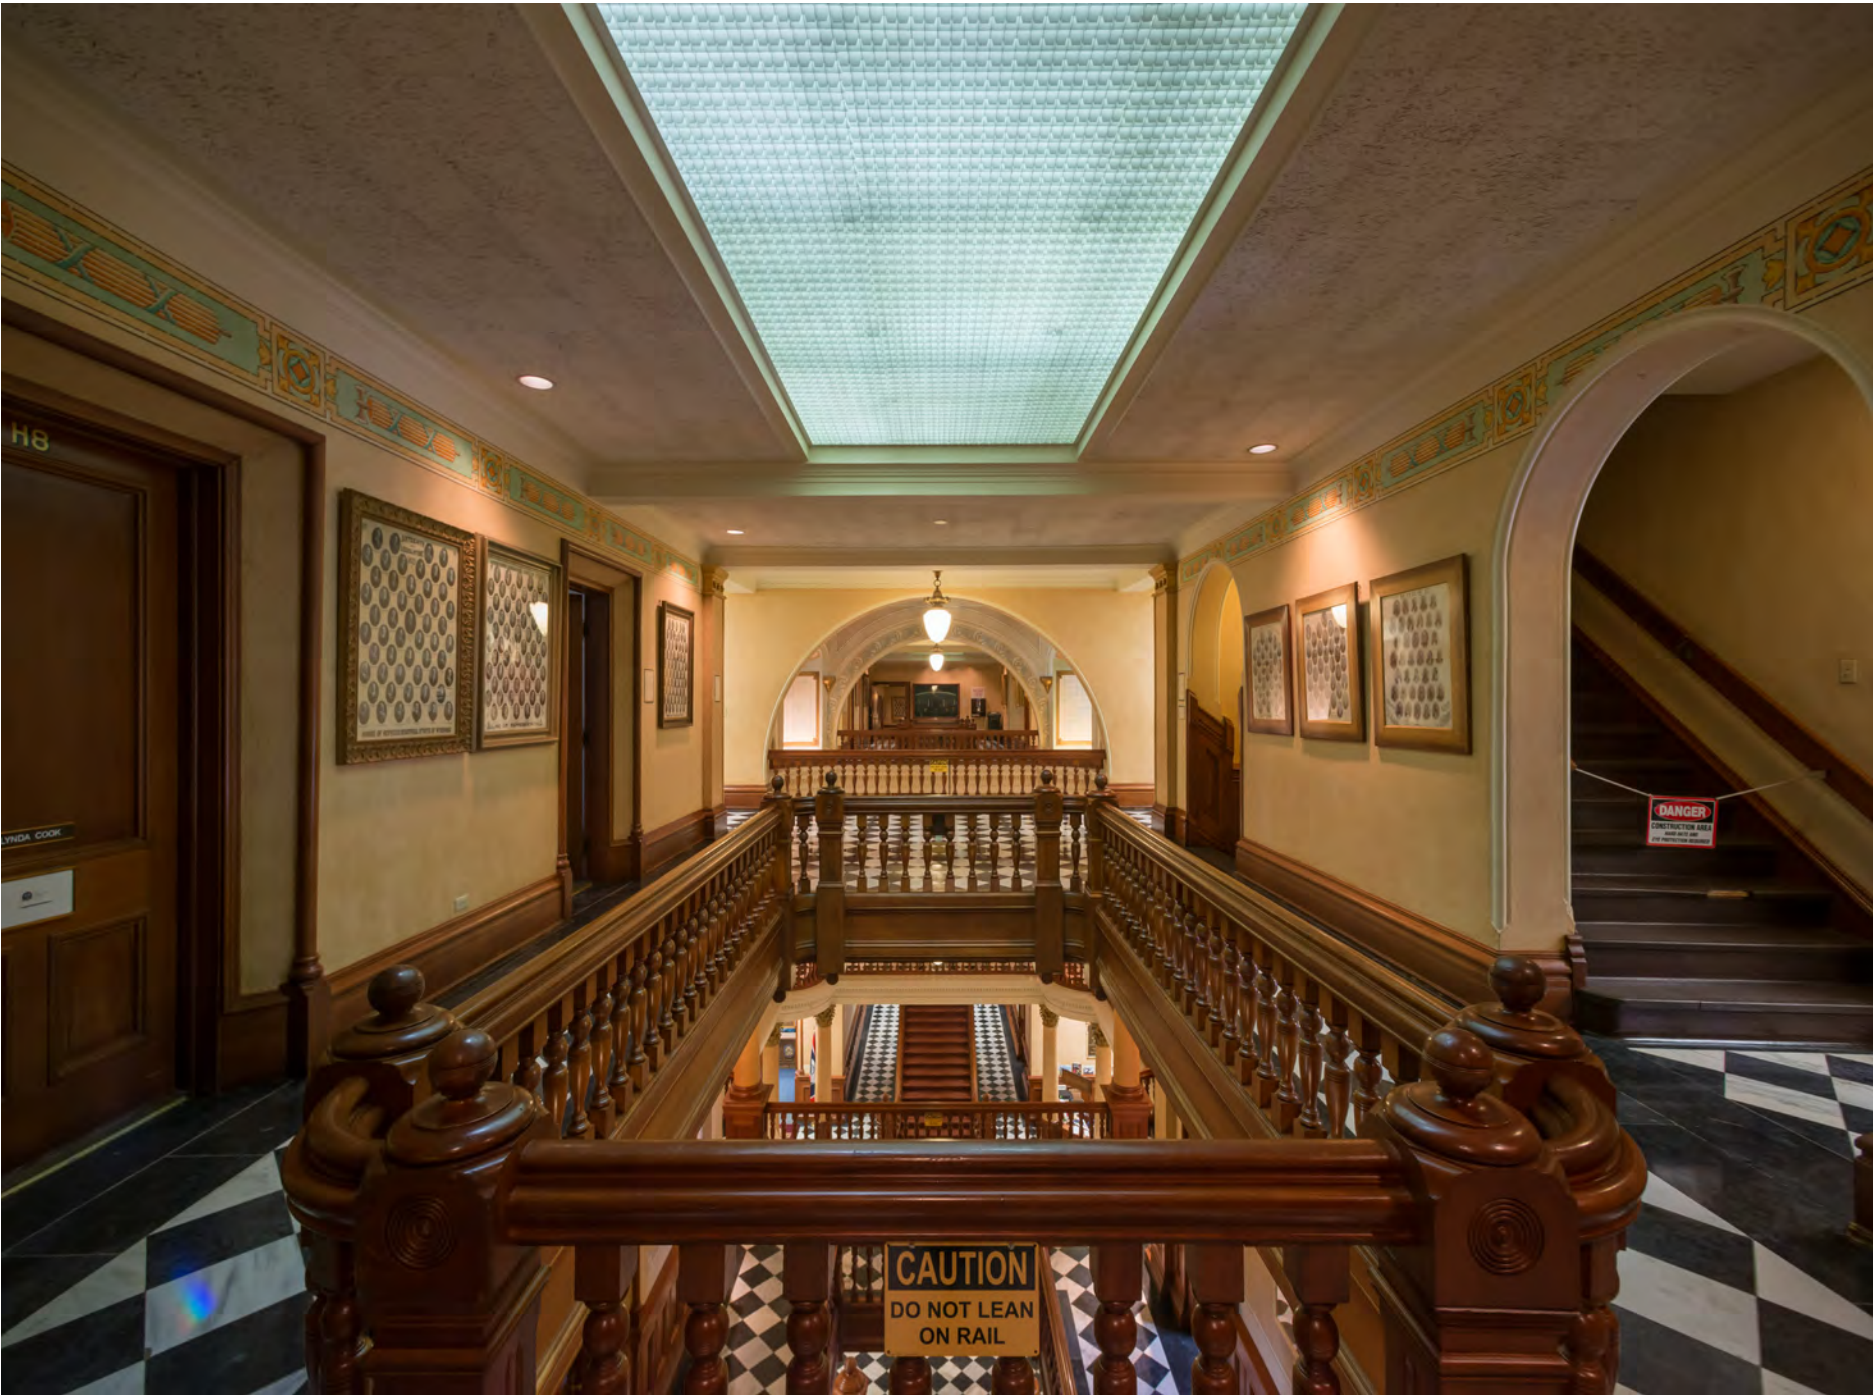
Figure 5.7.5.3: Existing Non-ADA Compliant Railing at the Third Floor House Balcony.

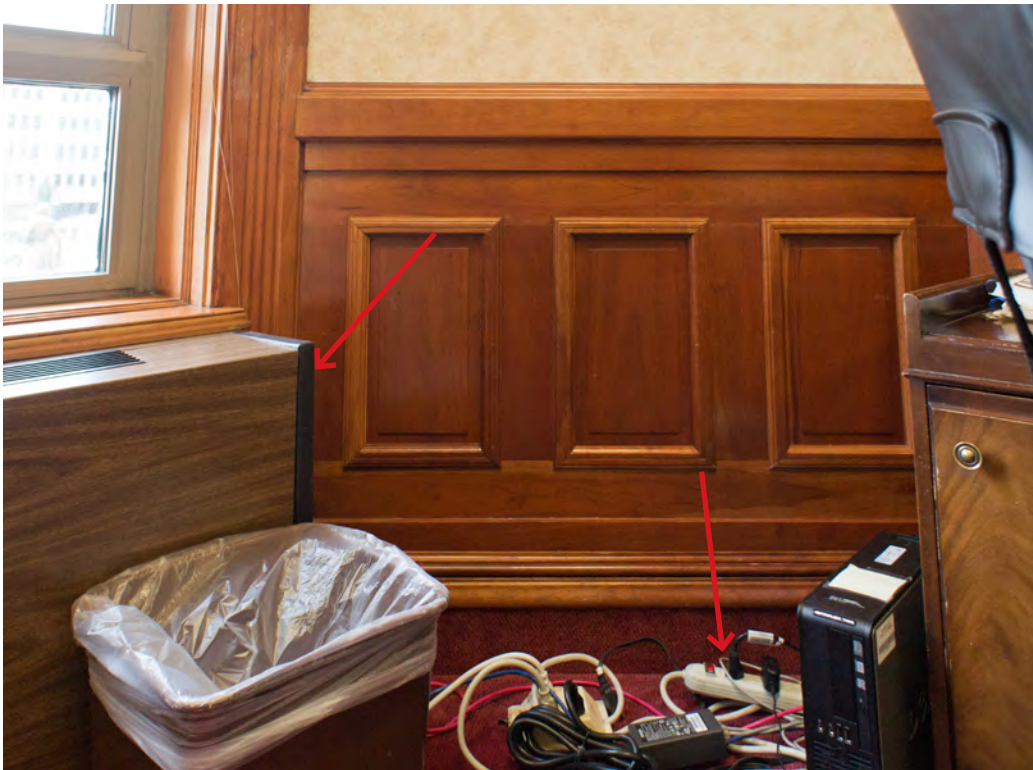
Figure 5.7.6.1: Disorganized Nature of the Existing Building Systems as a Result of the Ad Hoc Installation Over the Last 30+ Years, As Illustrated in Room 102 With Exposed Cords and the Non-Historic Fan Coil Unit.

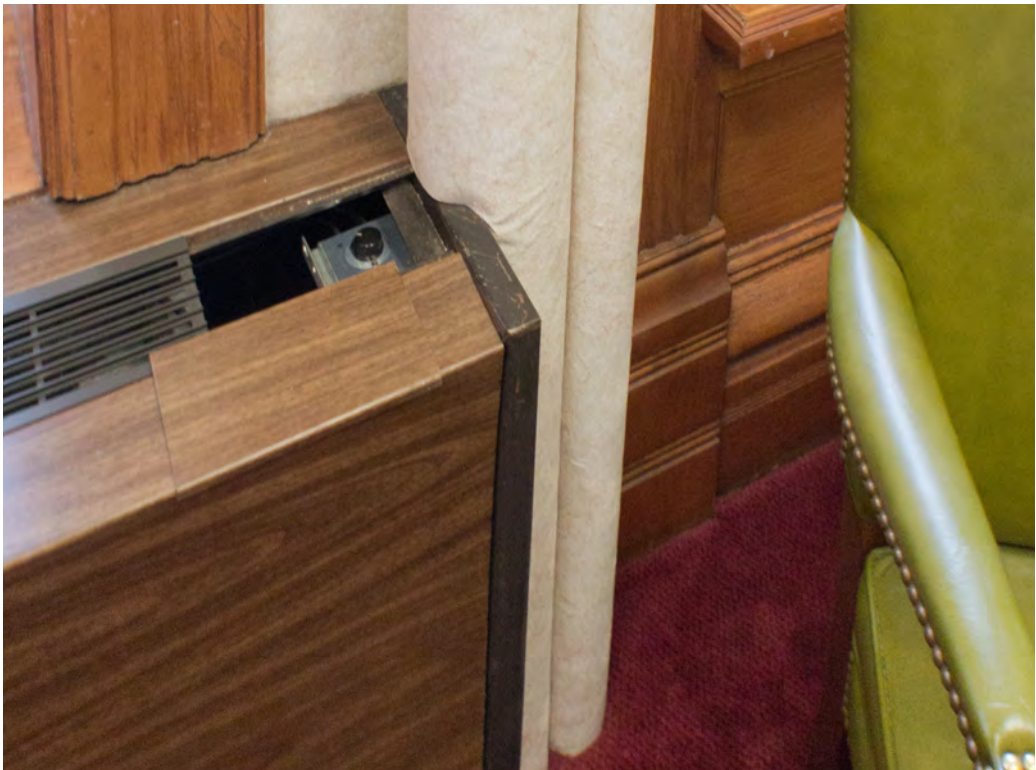
Figure 5.7.6.2: Example of the Historically Insensitive Installation of Building Systems in Room 104. Here the fan coil unit installation resulted in the removal of the historic wood window frame and plumbing chases are exposed at the interior.

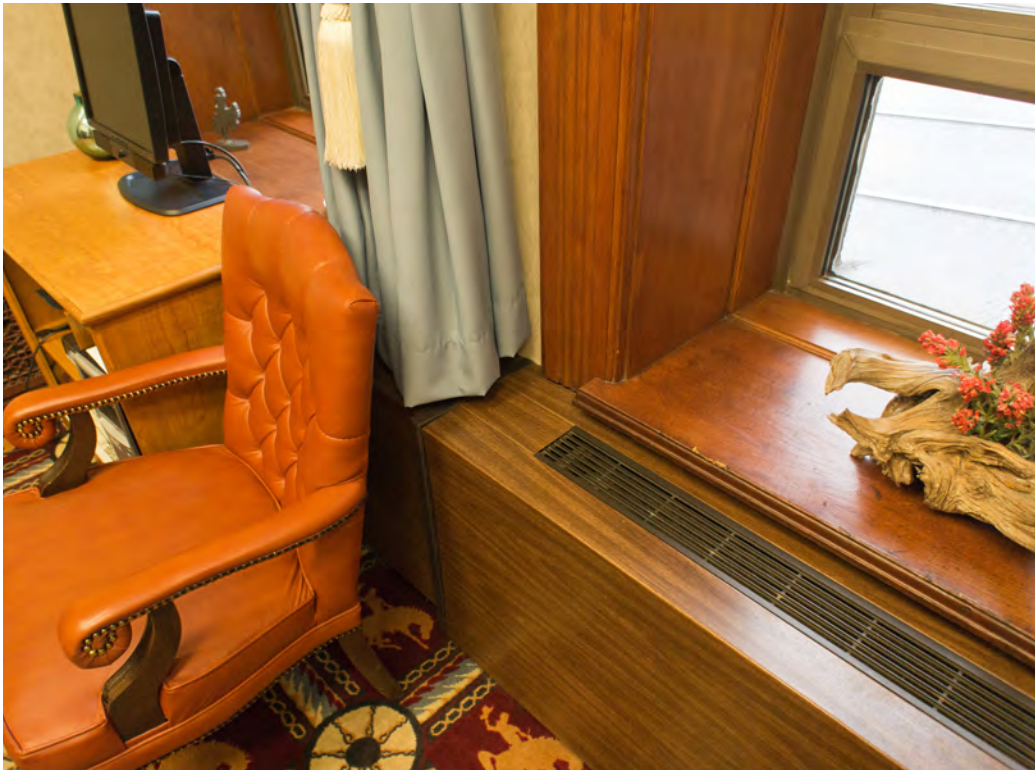
Figure 5.7.6.5: Existing Fan Coil Unit in Room 119, Where the FCU Installation Resulted in the Removal of the Historic Wood Window Frame.

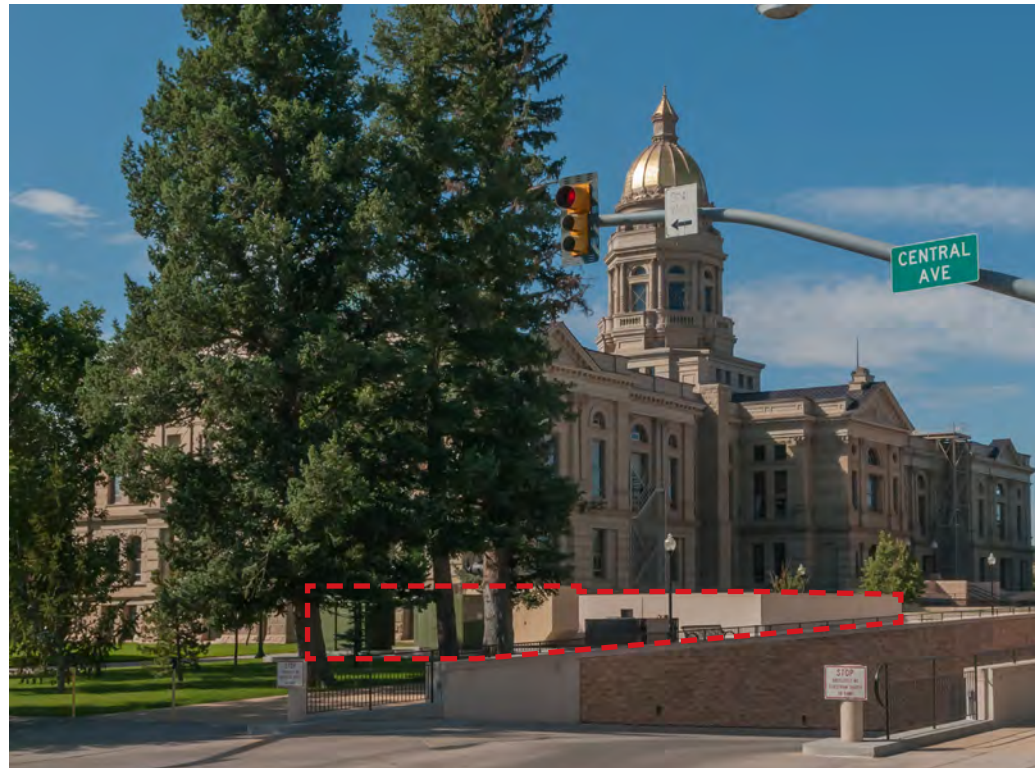
Figure 5.7.6.10: Existing “Intrusions” Along the Northwest Side of the Capitol Site. These “intrusions” include an enclosure housing a series of cooling towers, as well as utility transformers.

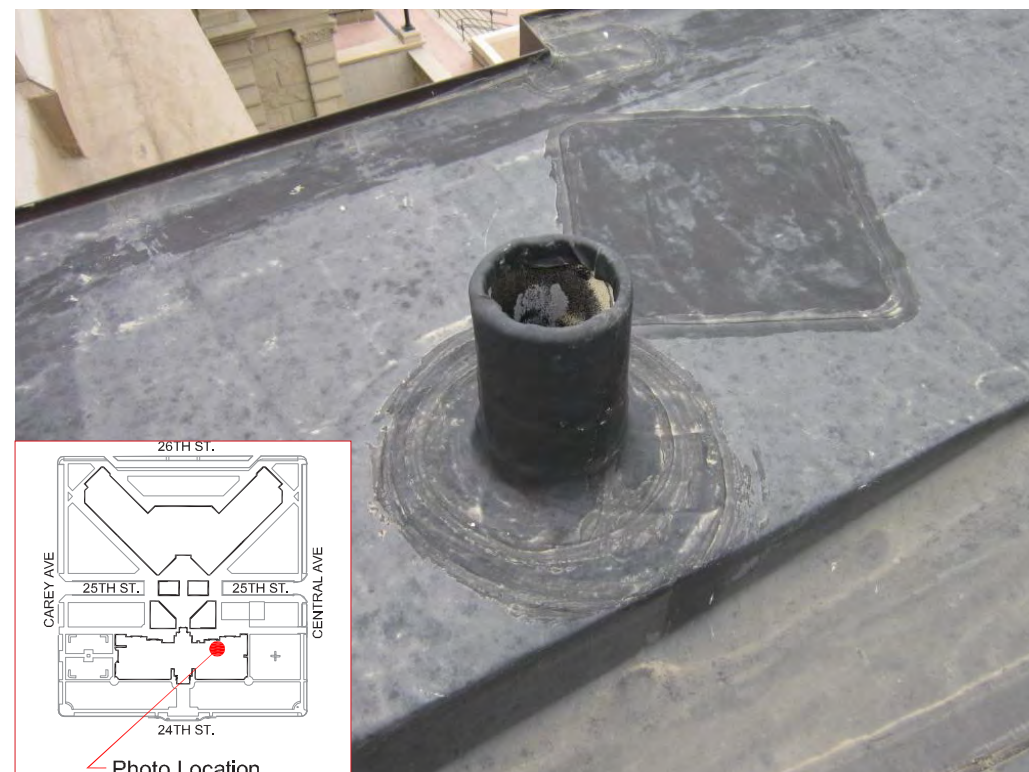
Figure 5.7.6.13: Existing Sanitary Vent Penetration at Roof Level. Building Codes states that all new vent stacks must extend minimum of twelve inches above the roof level.
