Section 7 : Proposed Scope of Work

7. Proposed Scope of Work

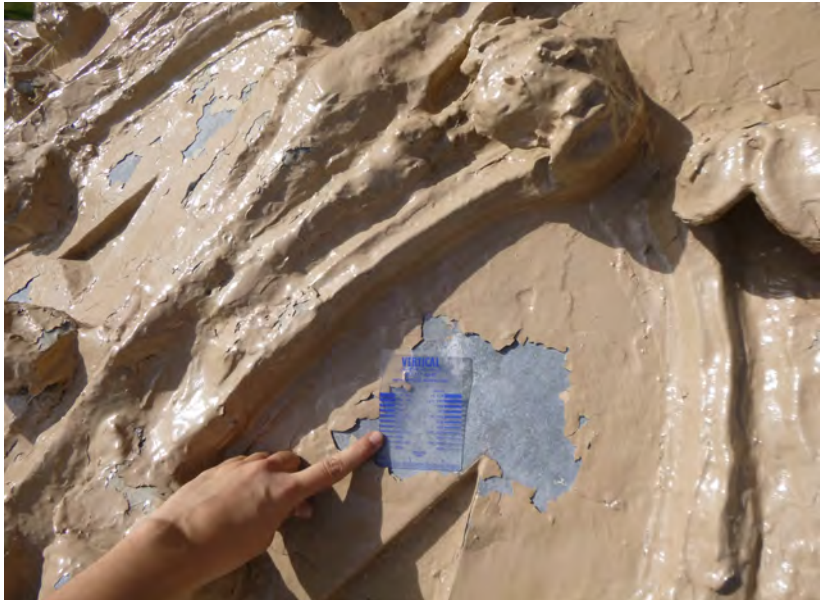
Figure 7.2.1: Coatings Failure Measured at the Dome Top. Multiple layers of coatings are visible, as are locations of deterioration and damage that need to be addressed as part of the restoration.

- a. Dome:
- Comprehensive Restoration Program including:
- Complete paint removal to bare metal.
 - Repair of metal surfaces and selective replacement.
 - Re-prime and repaint dome.

- Notes:
- a. The existing gold leafed areas need to be carefully assessed. Removal of the gold leaf may be warranted and reinstallation may be required, depending on the condition of the substrates
- b. A paint analysis is needed to ensure that accurate colors are produced based on the historic specifications and the proper placement of colors

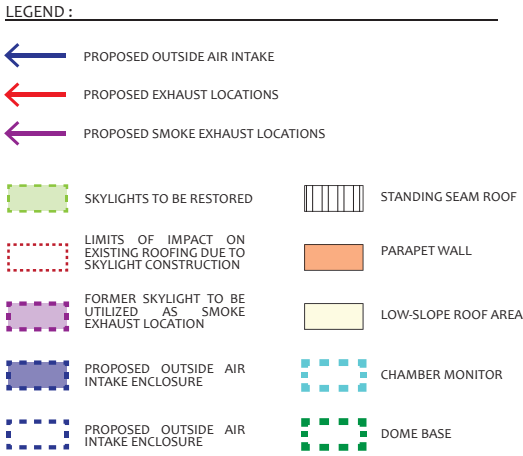
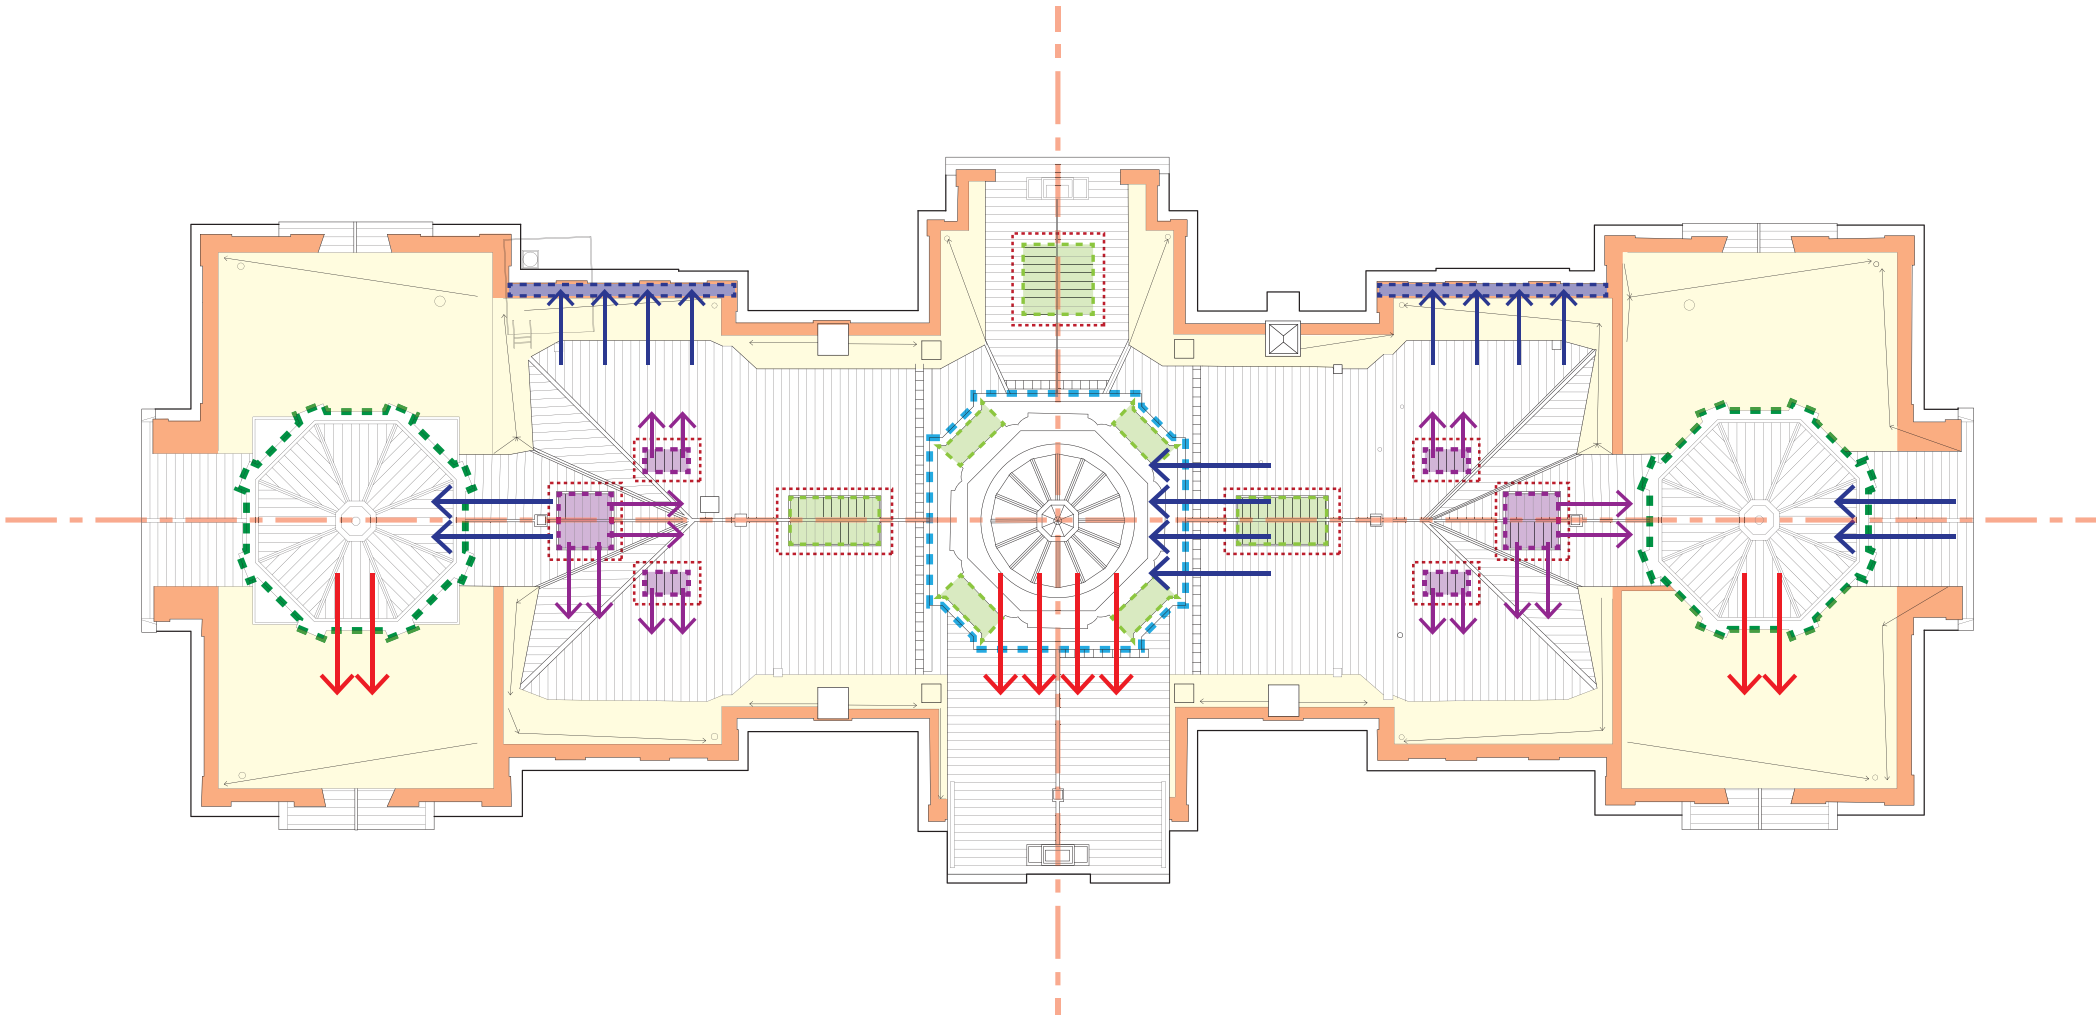
- There are several areas where the existing roofing has been compromised and there is moisture penetration [All EPDM areas are in need of replacement anyway, having exceeded their useful lives and having failures at multiple locations].

Figure 7.2.2: Diagrammatic Roof Plan Indicating Historic Skylights to be Restored [Green], Historic Skylight Locations to be Repurposed as Smoke Evacuation Points [Purple], and Outside Air Intake [Blue Arrows] and Exhaust Air [Red Arrows] Locations. The areas that are impacted by this work are extensive necessitating complete roof replacement.

All existing roofing systems are to be removed and replaced with new for several reasons:

If all of the above items are undertaken, a new roofing system will be needed that will last at least 30 years and would be fully warranted.

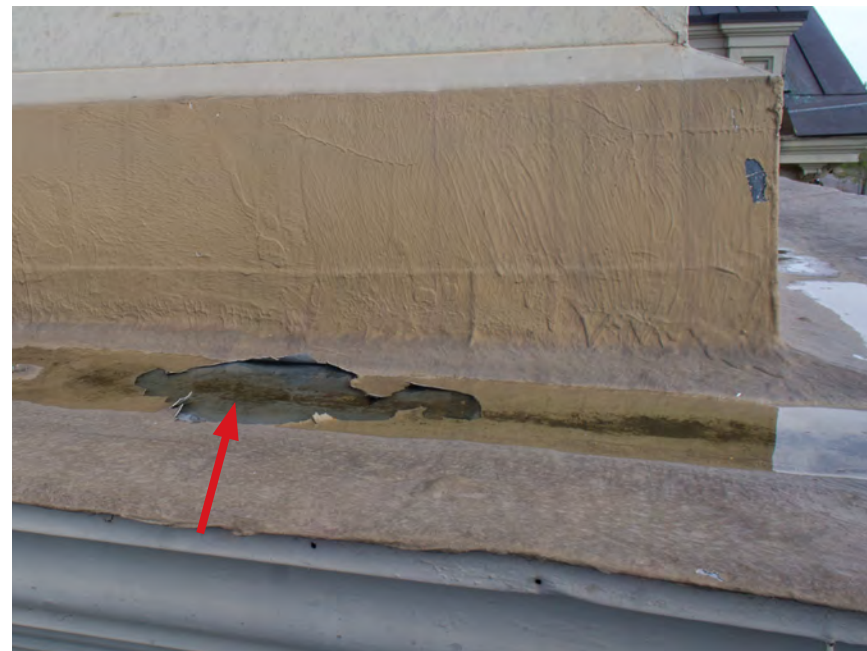
Figure 7.2.4: Detail of waterproofing membrane applied on the metal cornice. A well-intended intervention with an adverse effect.

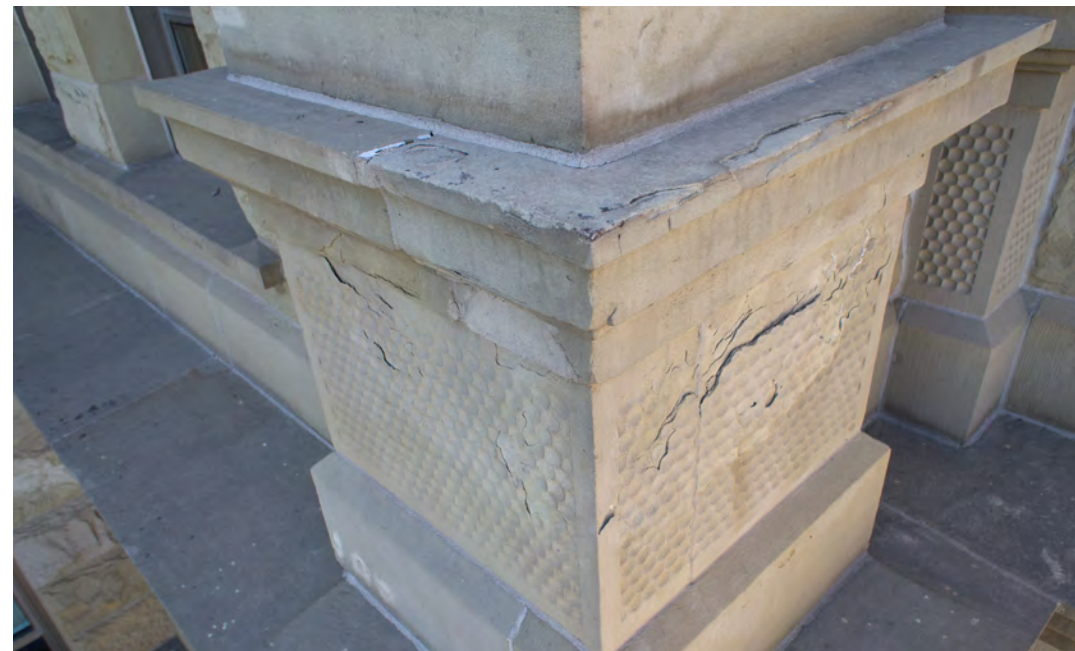
Figure 7.2.5: Delaminated, Eroded Stone at the North Portico Caused by Malfunctioning Rain Leaders.

Based on the Design Team’s assessment, a **comprehensive masonry repair, restoration and conservation program** is needed that would address:

- Inappropriate coatings installed in the recent past.
- Comprehensive repairs of joints [proper repointing program].
- Stone cracking, exfoliation and delamination.
- Damaged stone by additions and attachments [chimneys, enclosures, exterior stairs, etc.].
- Cleaning of soiled areas.

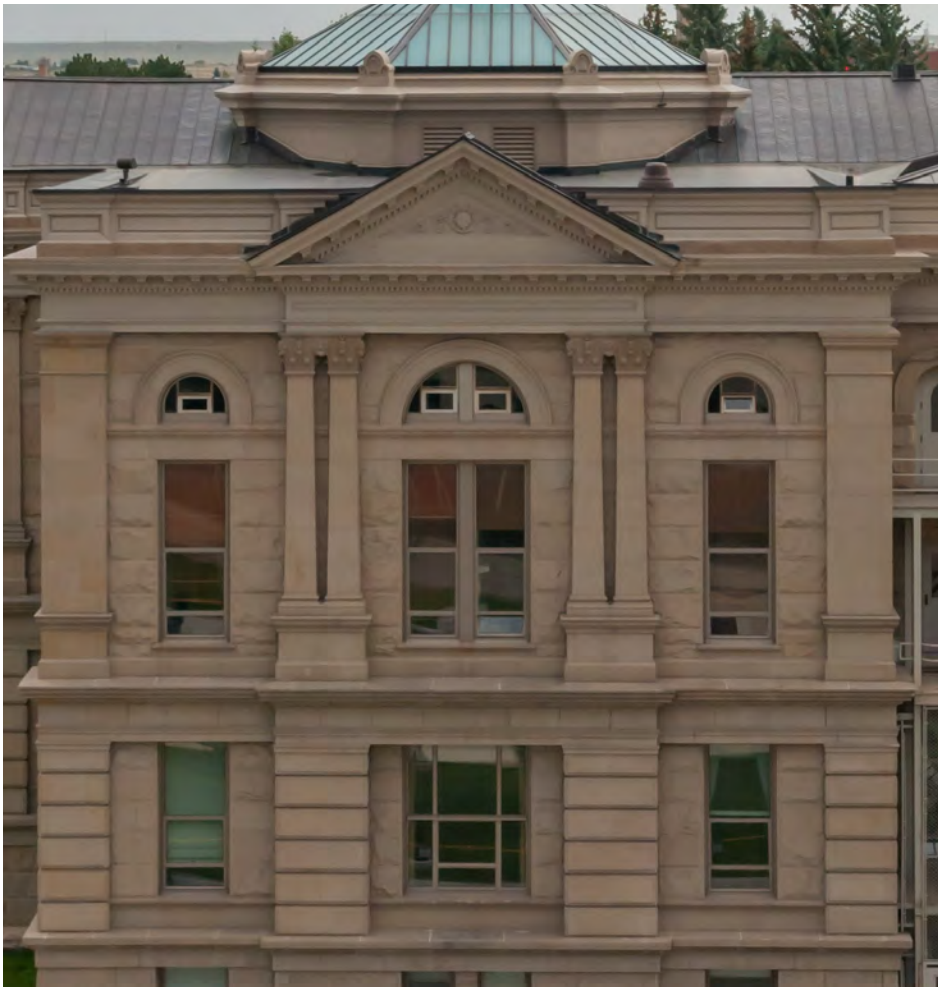
As indicated in *Volume I Section 5.6*, the existing typical [rectangular] windows are replacement units that were part of a replacement program that started as early as 1960. They represent early double glazing technology that has far exceeded its projected useful life, and a replacement program would be needed.

Figure 7.2.7: Detail of North Elevation Looking South. Note Replacement Windows.

- Detailed documentation of all frames.
- Classification of frames in the following categories:
 - Original frame in place, not covered;
 - Original frame in place, covered;
 - Replaced sash;
 - Original sash;
 - Insertions.
- Frames to be exposed and stripped to bare wood.
- Repairs to wood frames.
- Refinishing of wood frames.
- Installation of new custom made sash with double glazing.
- Caulking of joints.
- Refinishing of frames and windows.

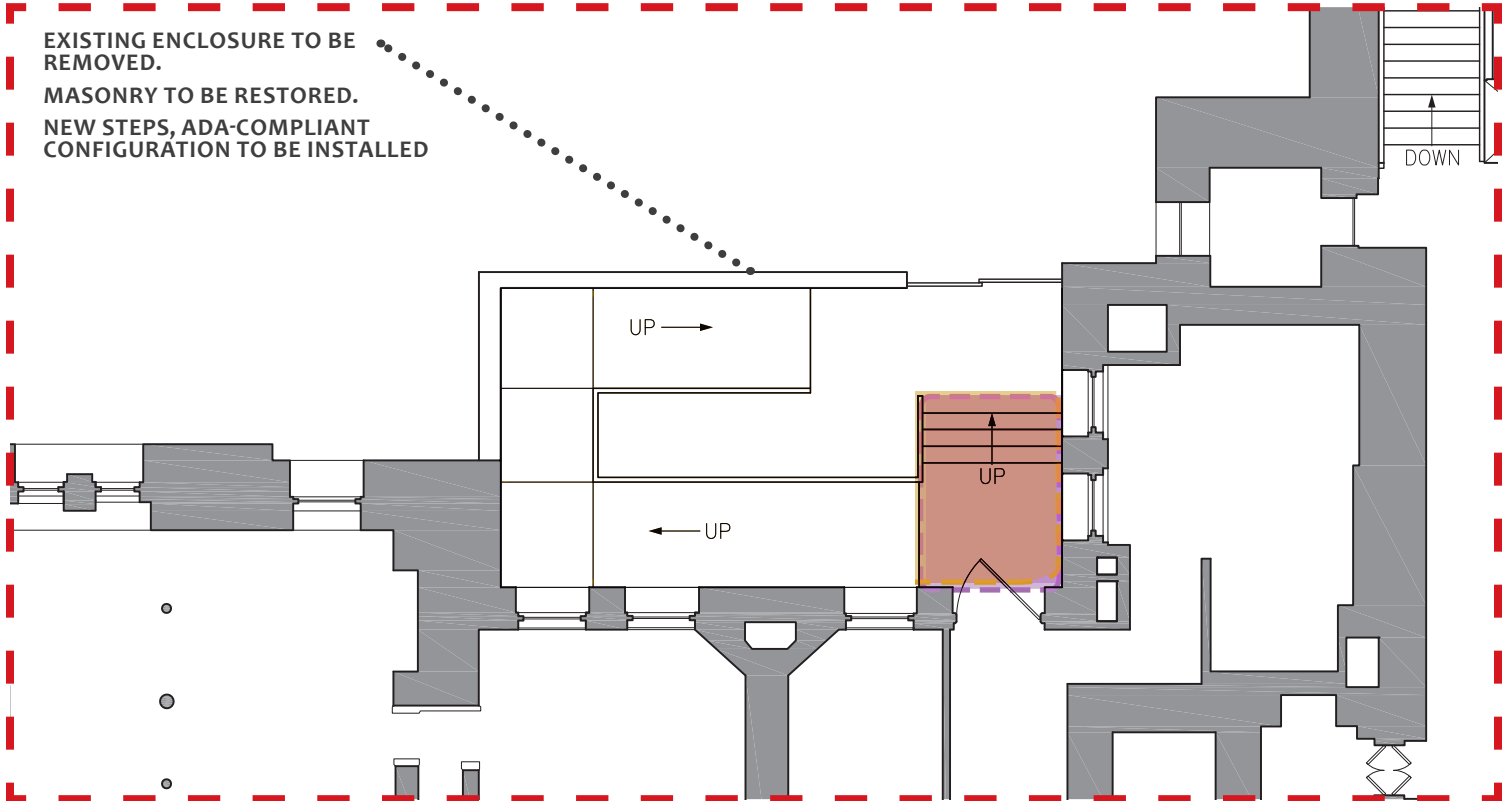
The monumental doors are still in place, albeit modified. The Basement / Lower Level Doors have been replaced with inappropriate storefront-type aluminum and glass doors.

Figure 7.2.13: Enlarged “As-Found” Basement Level Floor Plan and the Northwest Exterior Storefront Entrance.

- All access points to be retrofitted – in an unobtrusive way – with security hardware [card access] and ADA-compliant hardware / mechanisms to allow for the doors to be operated easily.
- All historic finishes to be restored.
- New doors to be installed at the Basement / Lower Level, capturing the original design intent based on historic photographs.
- A new service / egress door and frame to be installed under the West Monumental Stair.

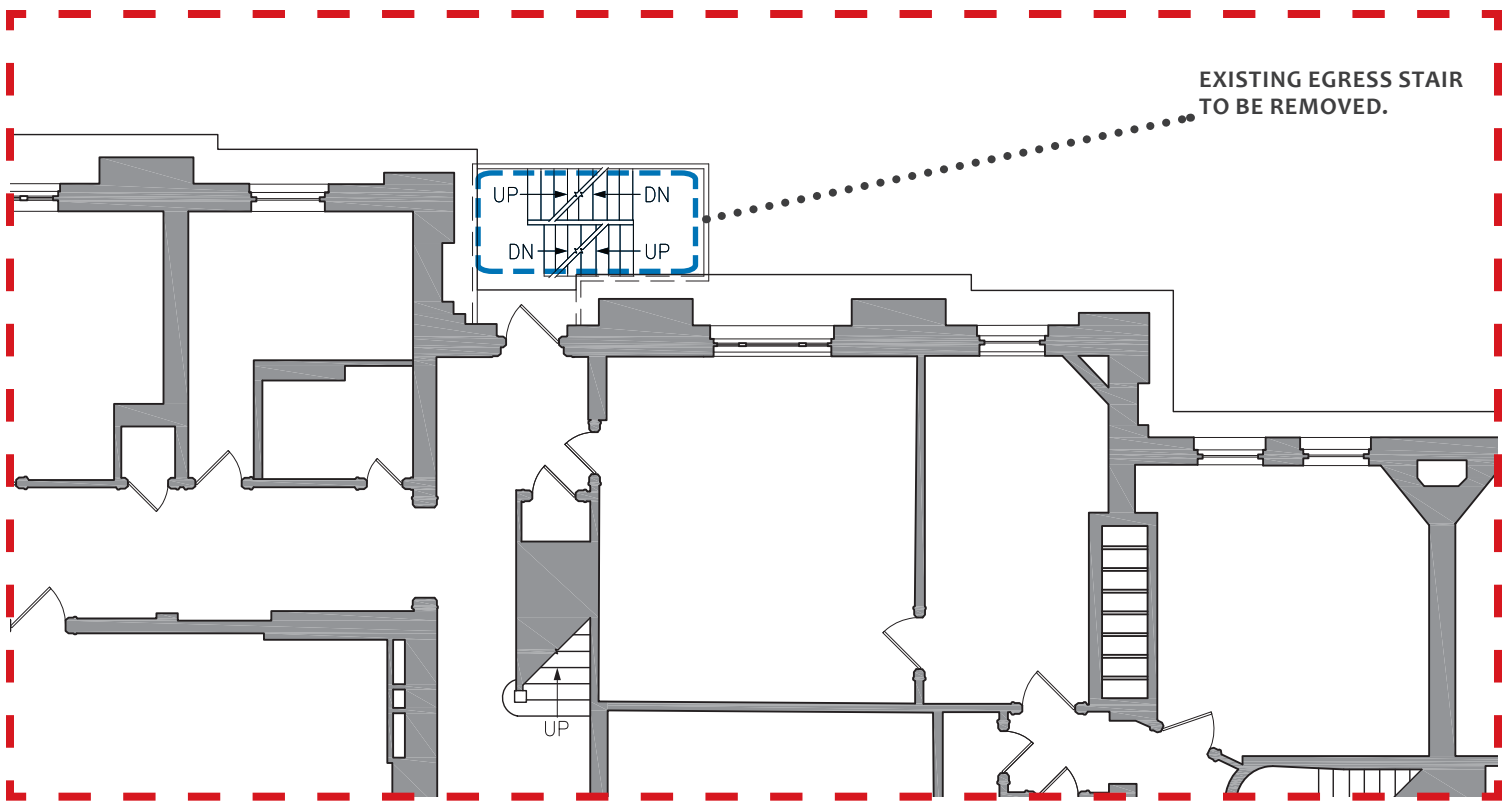
In addition to the aforementioned alterations to the original north stair, several additions / attachments were made over the years to the North Elevation, including a chimney, two metal egress stairs and two enclosures with ramps.

Figure 7.2.14: Enlarged “As-Found” Basement Level Plan and the Northwest Exterior Egress Stair.

All of these items are proposed to be removed and the north masonry facade to be fully restored. *Pages 7.6 and 7.7* delineate these items.

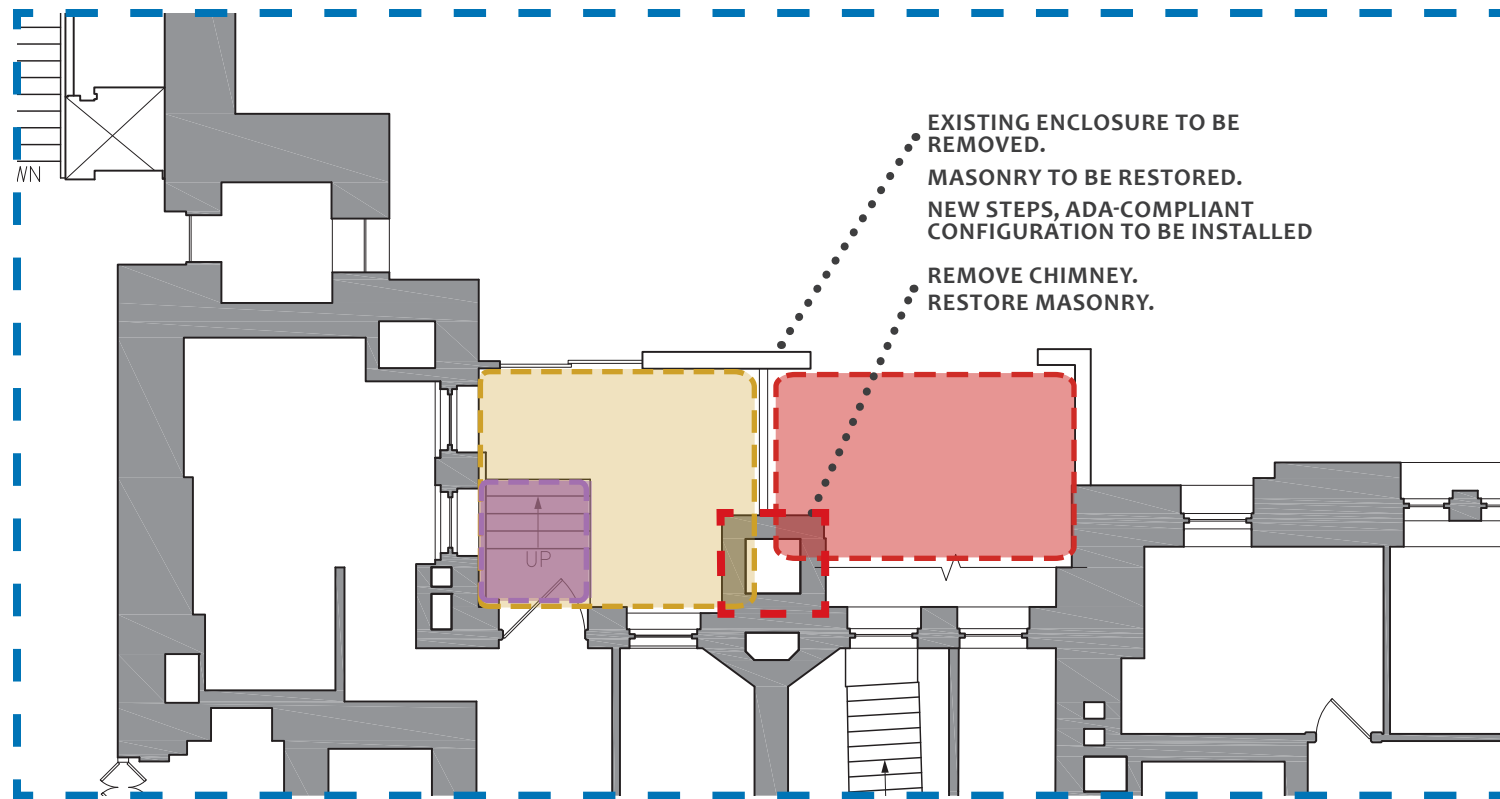
Figure 7.2.15: Enlarged "As-Found" Basement Level Floor Plan and the Northeast Exterior Storefront Entrance.

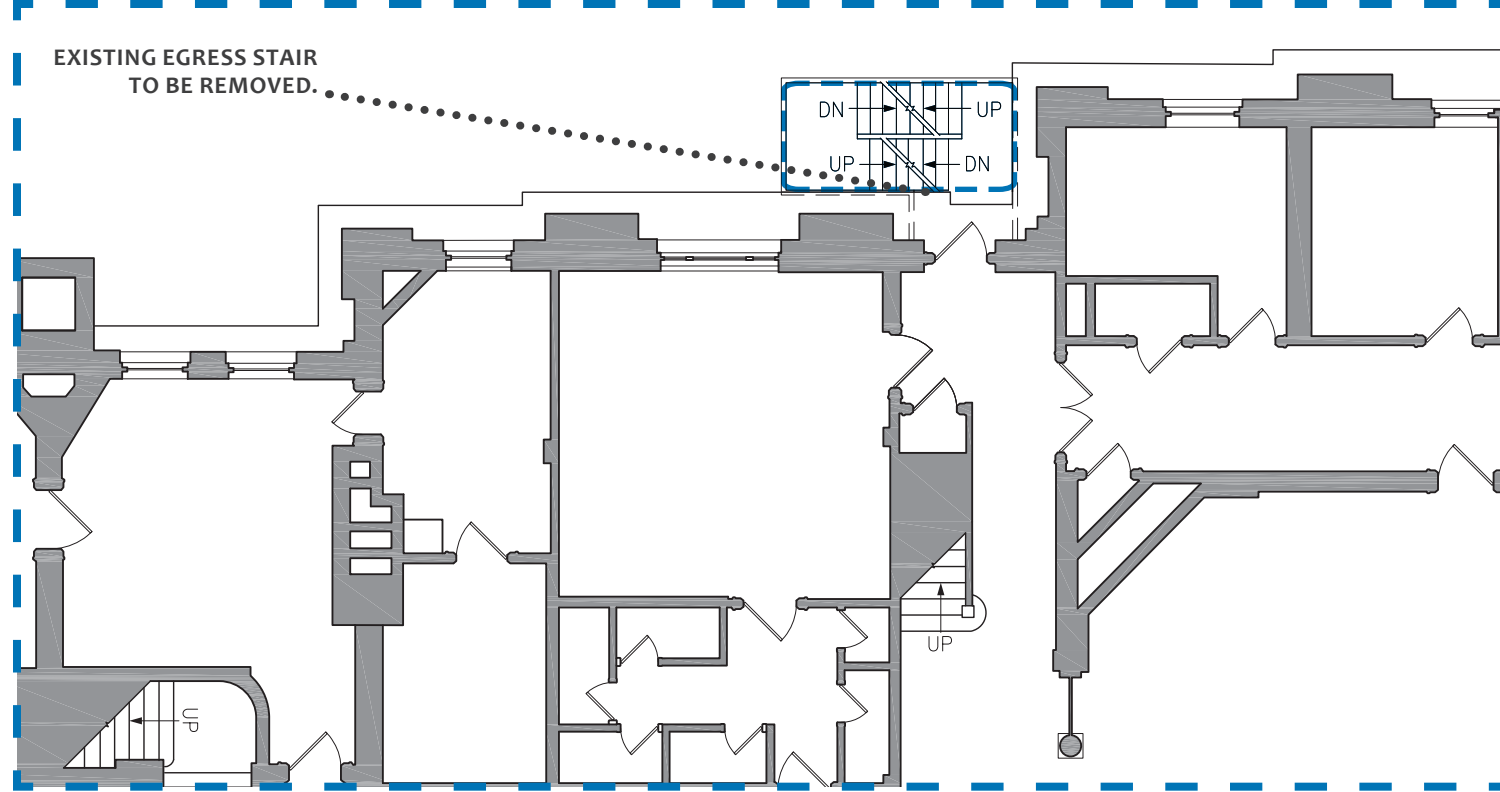
Figure 7.2.16: Enlarged "As-Found" Basement Level Plan and the Northeast Exterior Egress Stair.
