**WYOMING STATE CAPITOL
REHABILITATION & RESTORATION**

**LEVEL I RECONNAISSANCE /
LEVEL II FEASIBILITY STUDY**

**EXECUTIVE SUMMARY
AND
FREQUENTLY ASKED QUESTIONS**

17 FEBRUARY 2014

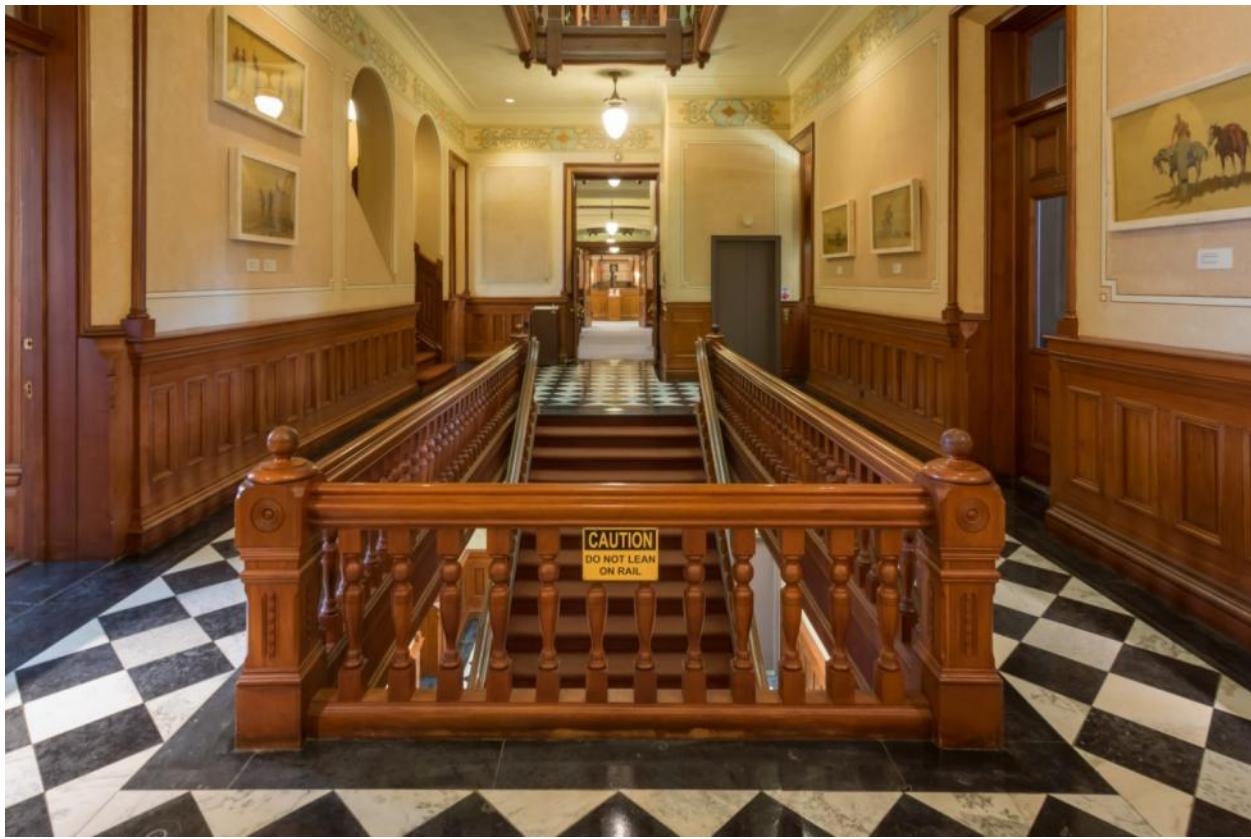
- Non – compliant exterior egress stairs
- Low railings
- Multiple ADA deficiencies at several locations
- Inadequate restrooms and related amenities

Figure 9.2: Low Railings, 2013.

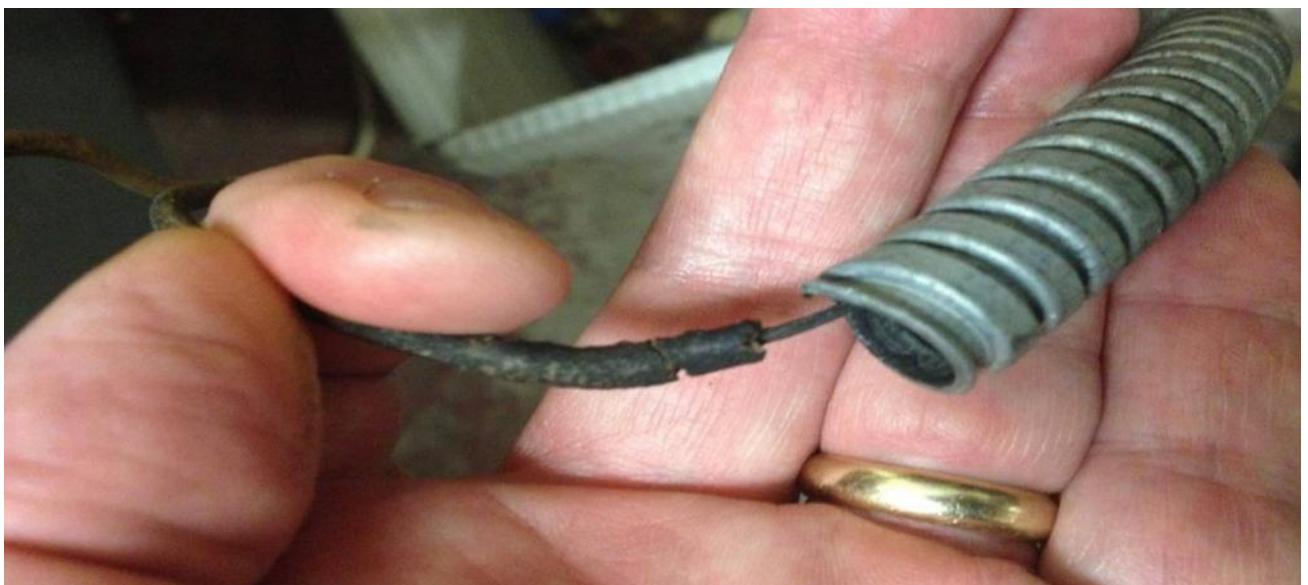
Figure 9.3: Failed Wiring, 2013.

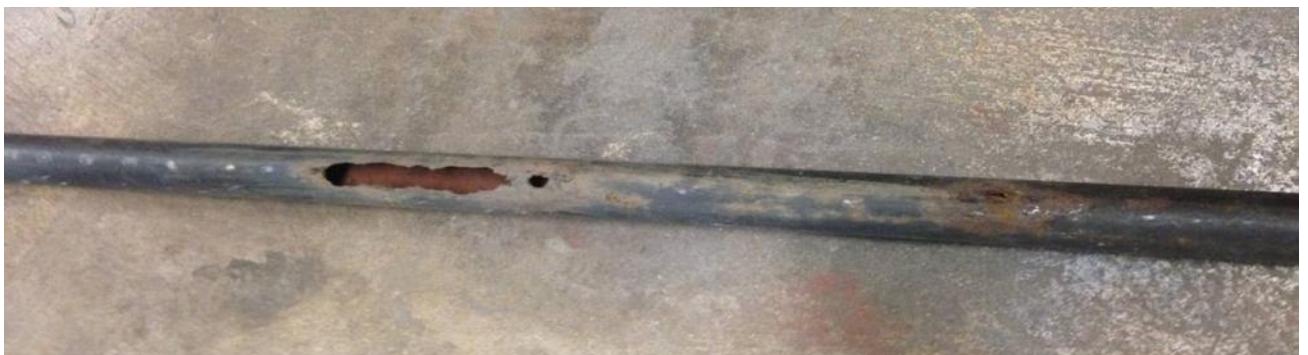
Figure 9.4: Corroded Conduit, 2013.

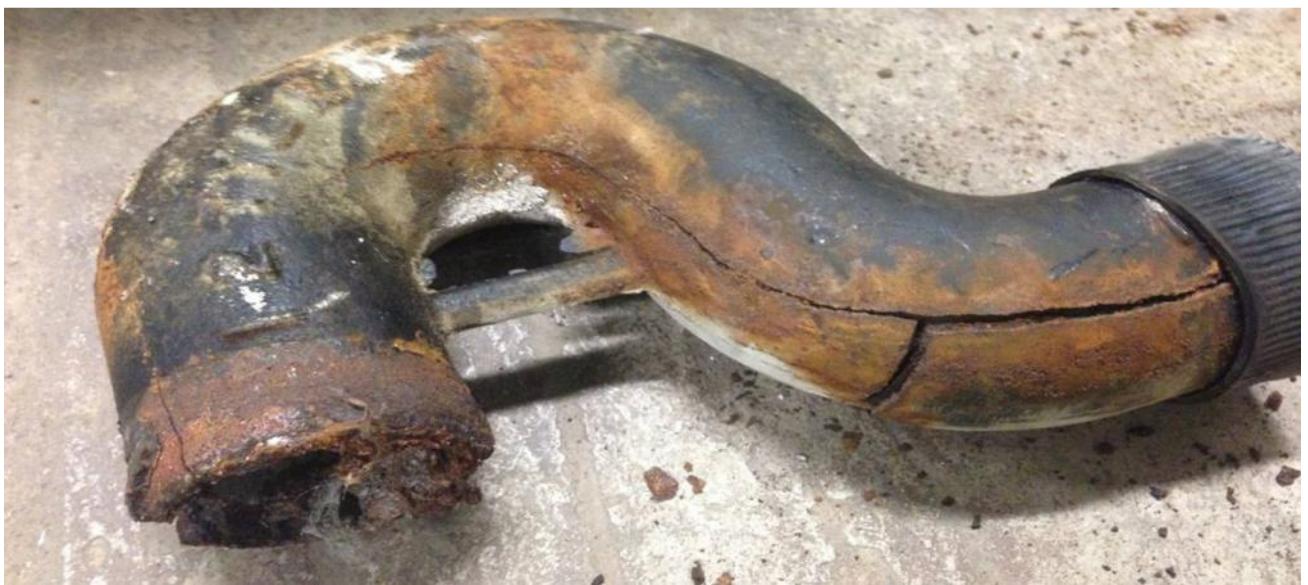
Figure 9.5: Rusted and Failed Pipe, 2013.

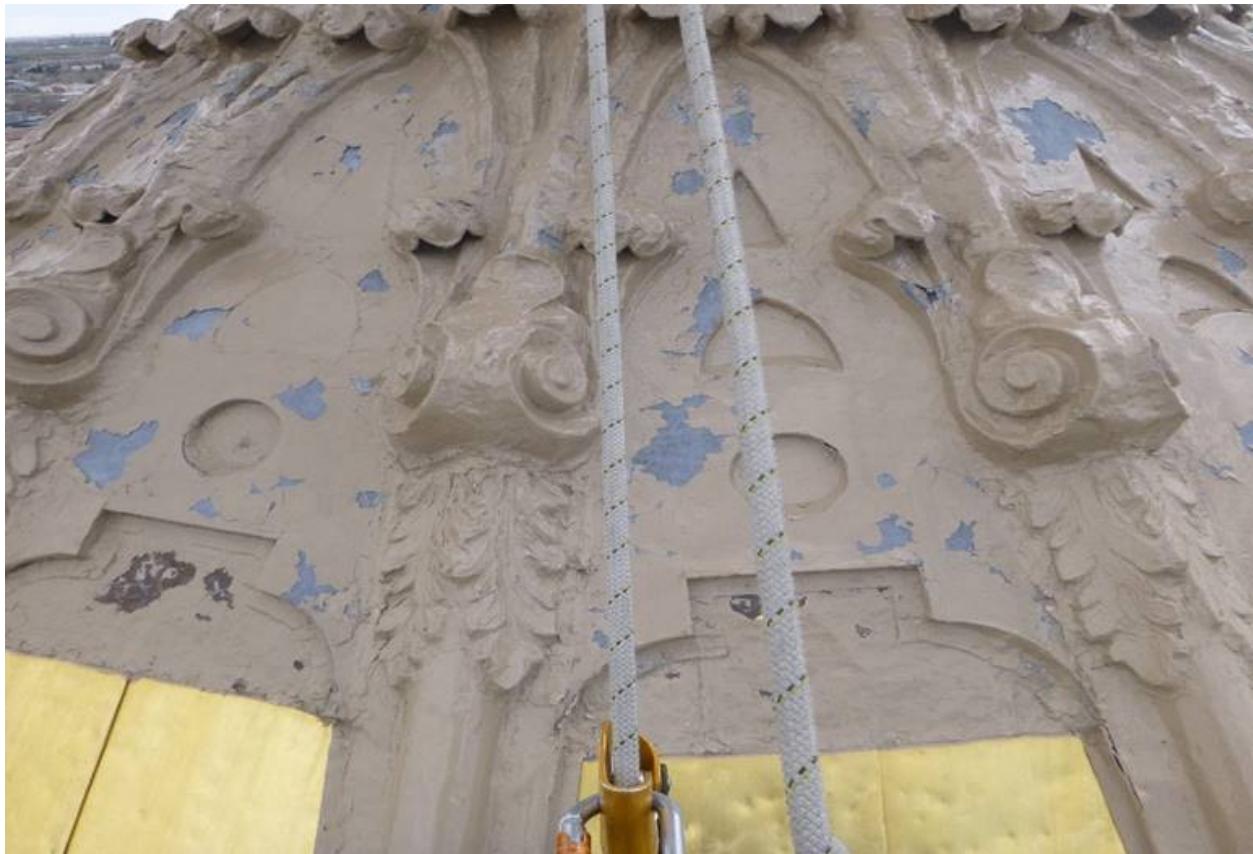
Figure 9.6: Exterior Dome, Multiple Paint Failures and Hail Damage, 2013.

- The Dome metal skin has several tears and water infiltration occurs at several locations
- Supplemental steel maybe needed to strengthen the Dome

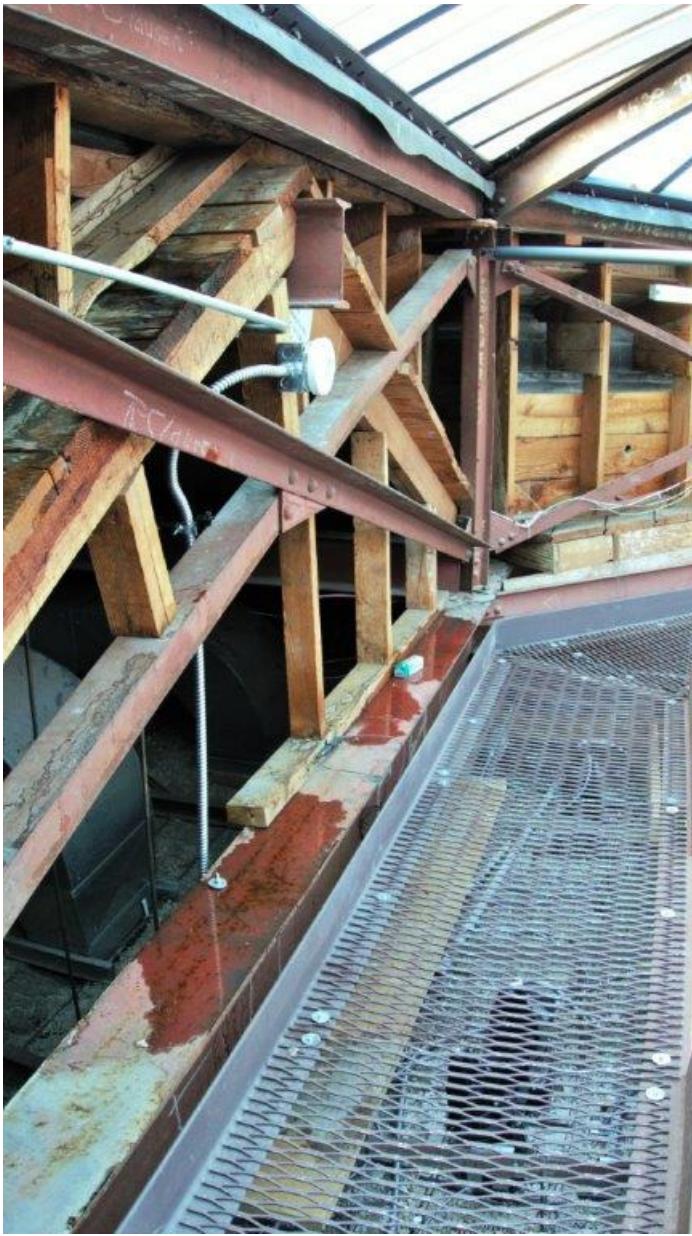
- **Water infiltration is an on-going issue,** with active leaks above the chambers, placing valuable historic building fabric, materials, finishes and murals at risk.

Figure 10.1: Water Infiltration in Attic Above Chambers, 2014.

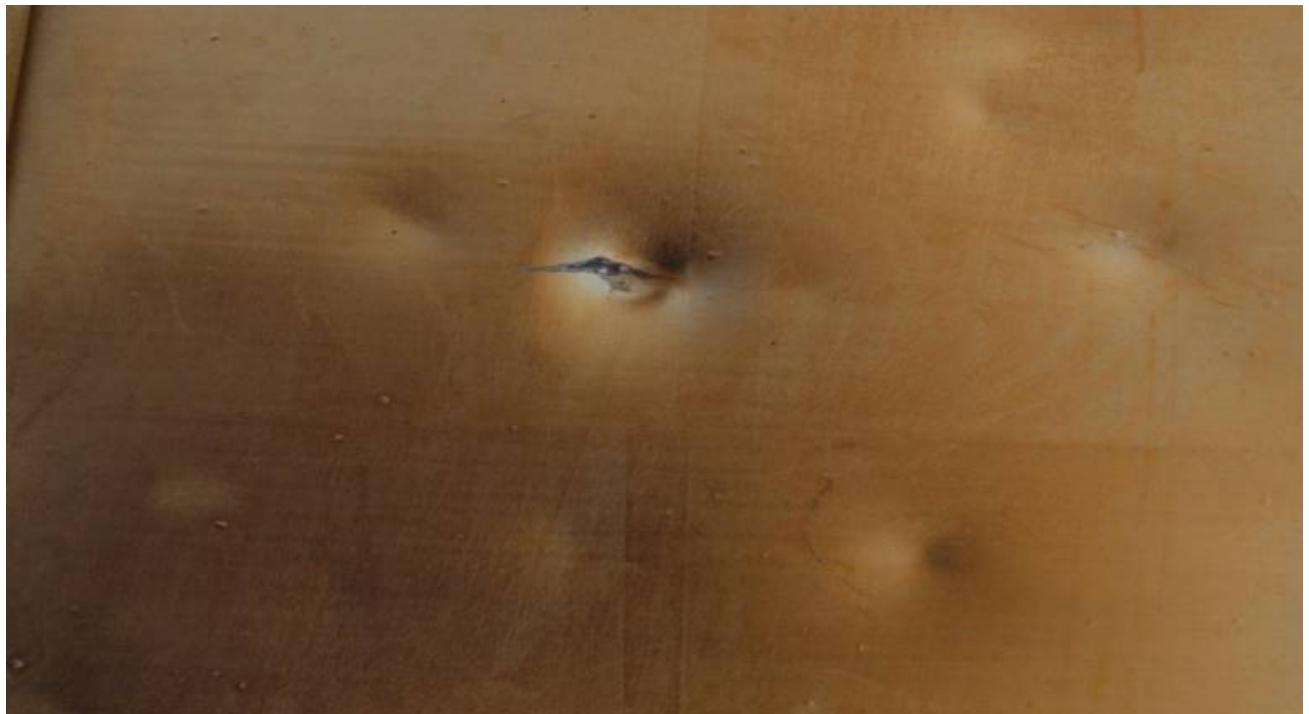
1. Coating failures over large portions of the exterior, exposing the metal to the elements.
2. Dents, tears and punctures to virtually all metal surfaces across the dome envelope, including the gilded copper panels.
3. Poor condition of the lead ornament. The temporary repairs installed in 2010 and 2011 included clear silicone sealant and automotive metal patching compound need to be removed and the area properly repaired.
4. Spot corrosion at cast iron and galvanized sheet metal elements needs to be repaired.
5. All open areas need to be repaired to prevent further moisture infiltration.
6. Moisture damage in the interior of the dome, specifically at the wood roof decking, exposed wood structural members [e.g. outriggers], and wood flooring.

Figure 11.1: One of Several Tears and Hail Damage in Dome Cladding, 2013.

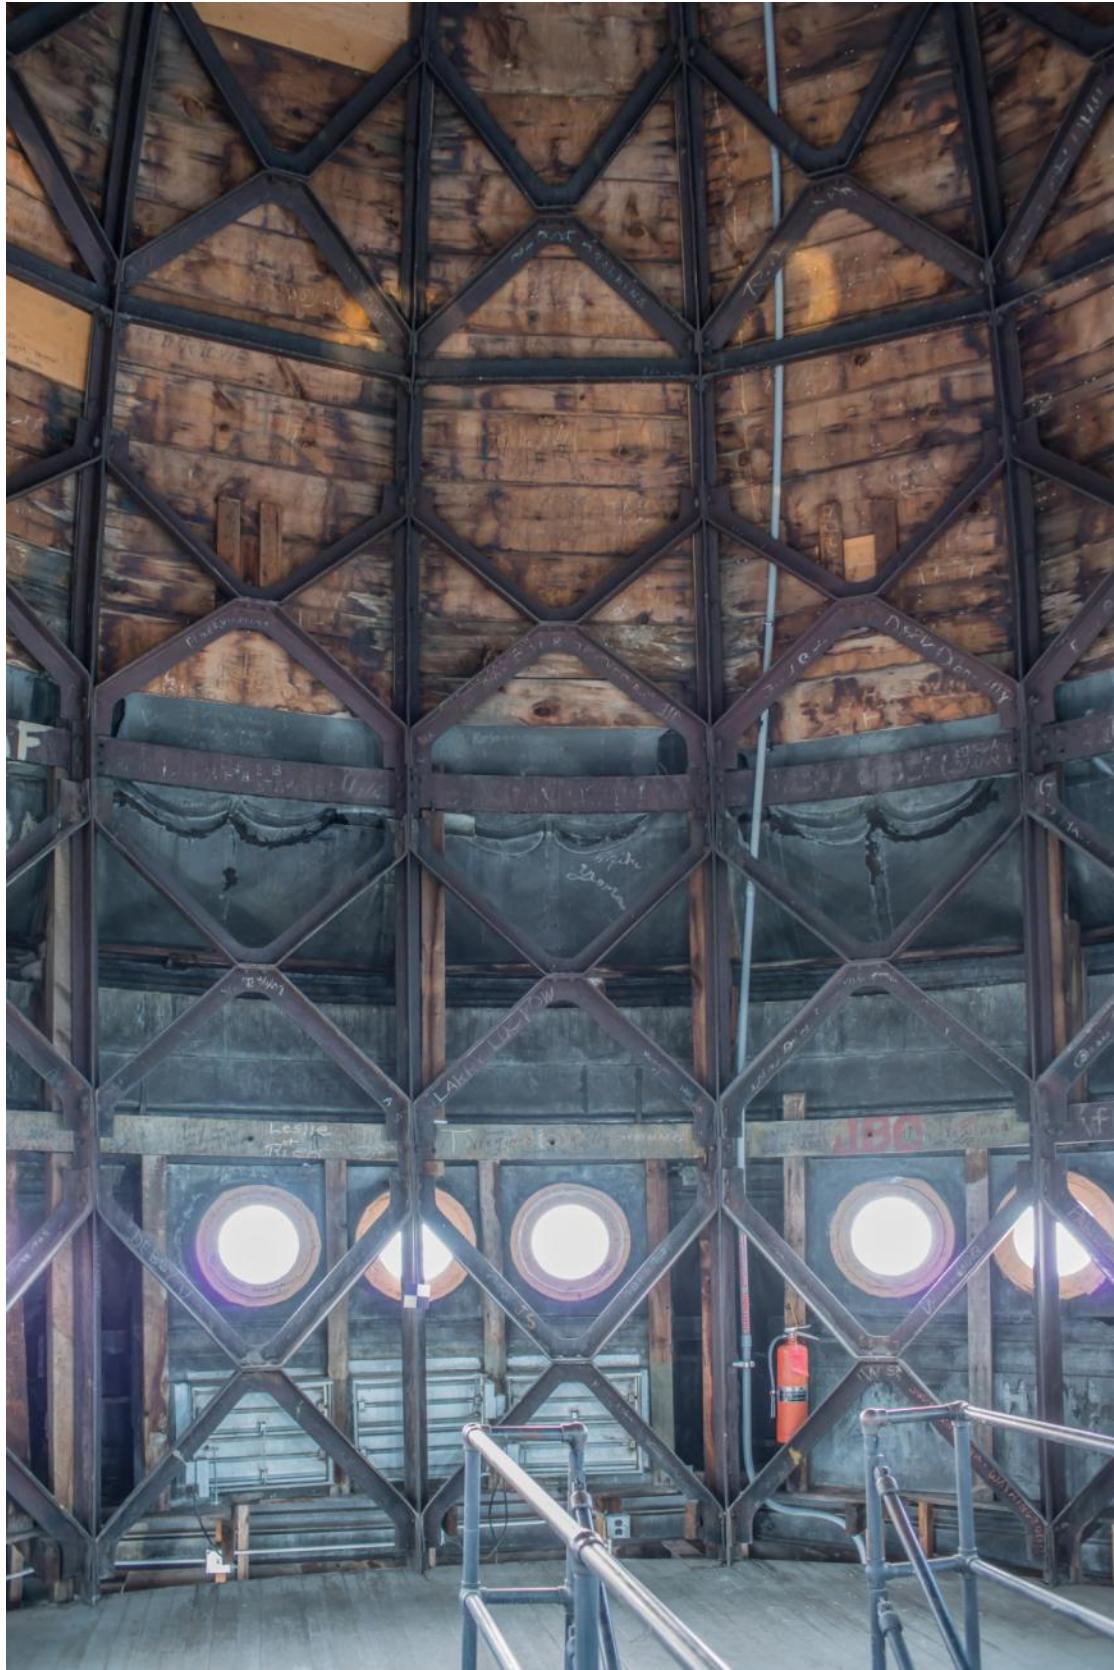
Figure 11.2: Interior Dome View, Several Areas Require Structural Repairs and Reinforcing, 2013.

The Dome's structural behavior is an important issue. The cracks that exist in the Rotunda, appear to be related to the structural behavior of the Dome. This is an important issue that needs to be addressed carefully.

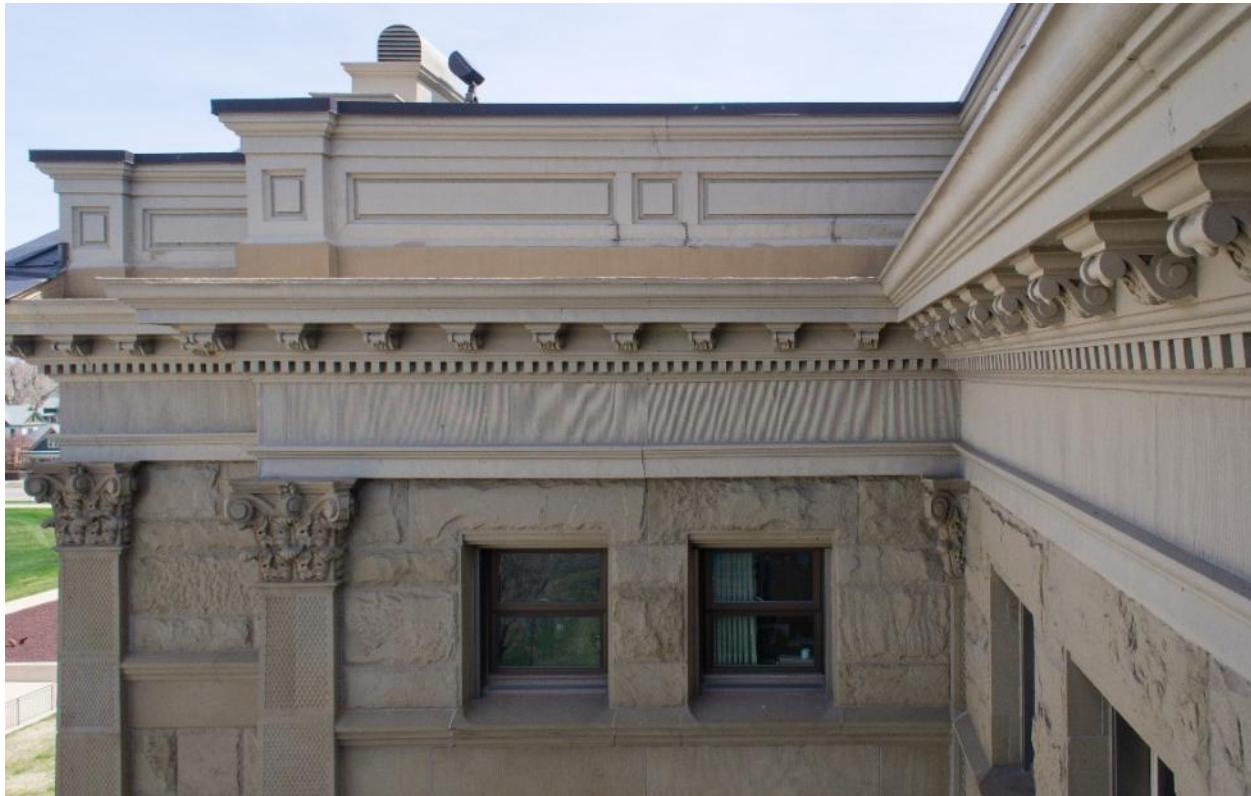
Figure 11.4: Galvanized Metal Entablature, Cornice, and Parapet Walls at the North Elevation, 2013.

While the galvanized metal appears to be in fair to good condition, there are several observations that indicate that this area needs to be repaired carefully to avoid future risk. More specifically:

1. Bent and deformed metal panels.
2. Cracked metal panels.
3. Poorly executed joints and joints that have been sealed with sealant.
4. Poorly executed repairs.
5. Peeling paint exposing the bare metal underneath.
6. It appears that a waterproofing membrane was applied to the cornice recently to protect from moisture infiltration.

The application of sealants and waterproofing membranes on metal surfaces in general has an adverse effect, i.e. opposite of the intended purpose to protect the building. Sealants on metal surfaces and waterproofing membranes tend to create separations of the paint layers below from the metal, thereby exposing the metal surfaces to the elements and making them susceptible to corrosion. This is a critical issue that needs to be addressed throughout all parapets of the Capitol.

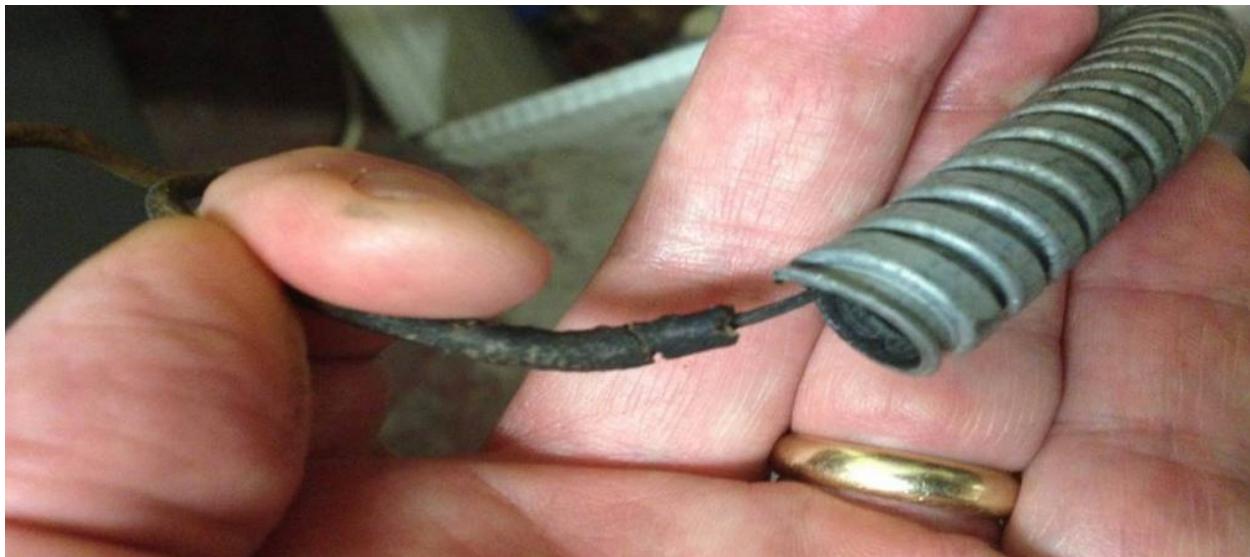
During the recent years, the Capitol has experienced failures of several electrical components, including obsolete and dangerous wiring.

Figure 12.1: Failed Wiring, 2013.

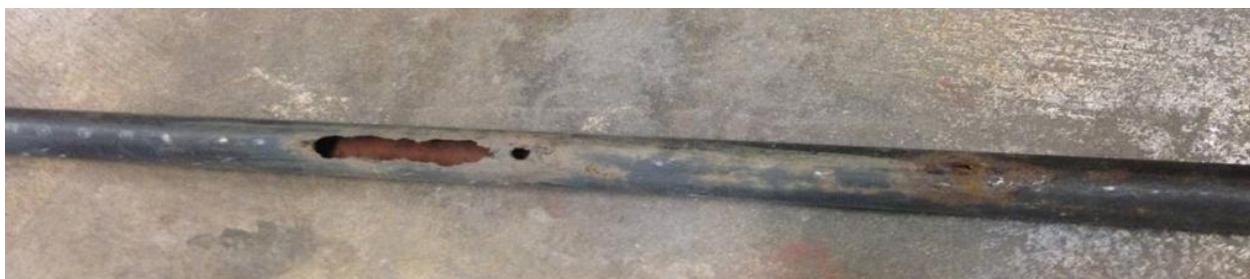
Figure 12.2: Corroded Conduit, 2013.

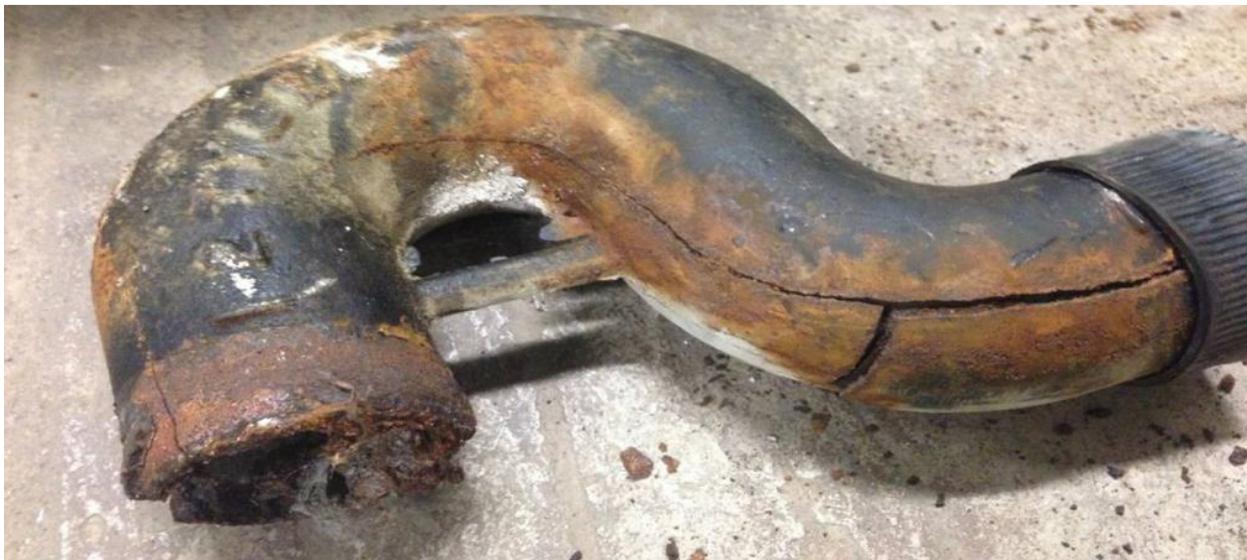
The same is true for plumbing systems where several failures have occurred in several locations of the building.

Figure 12.3: Rusted and Failed Pipe, 2013.

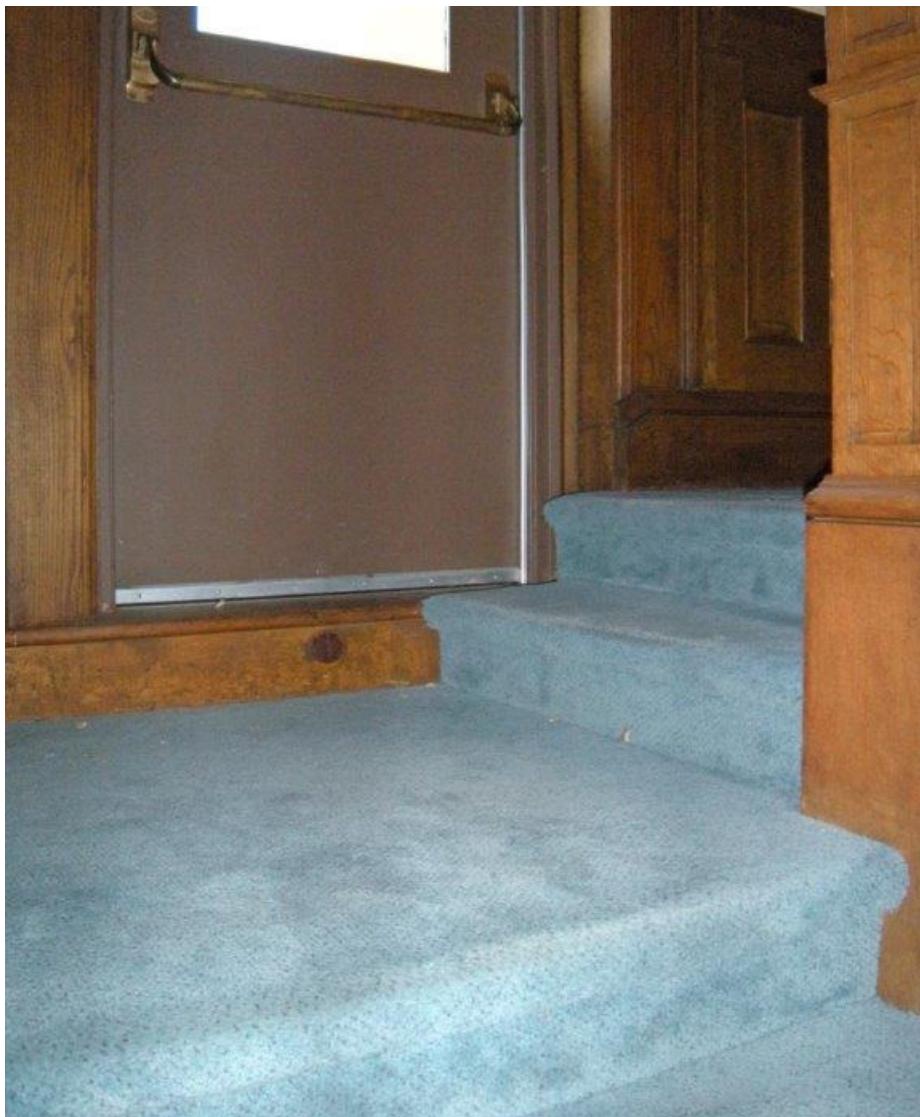
- ✓ The egress path from the third floor balcony to the stairs has potential tripping hazards.
- ✓ The stairs are not protected from the weather and during adverse weather conditions, which normally occur at peak loads during sessions, can be slippery and dangerous to use.
- ✓ The details of the stairs do not meet code in several areas.

Figure 13.2: Third Floor Egress from Chamber's Balcony; Hazardous Condition / Tripping Hazard, 2013.

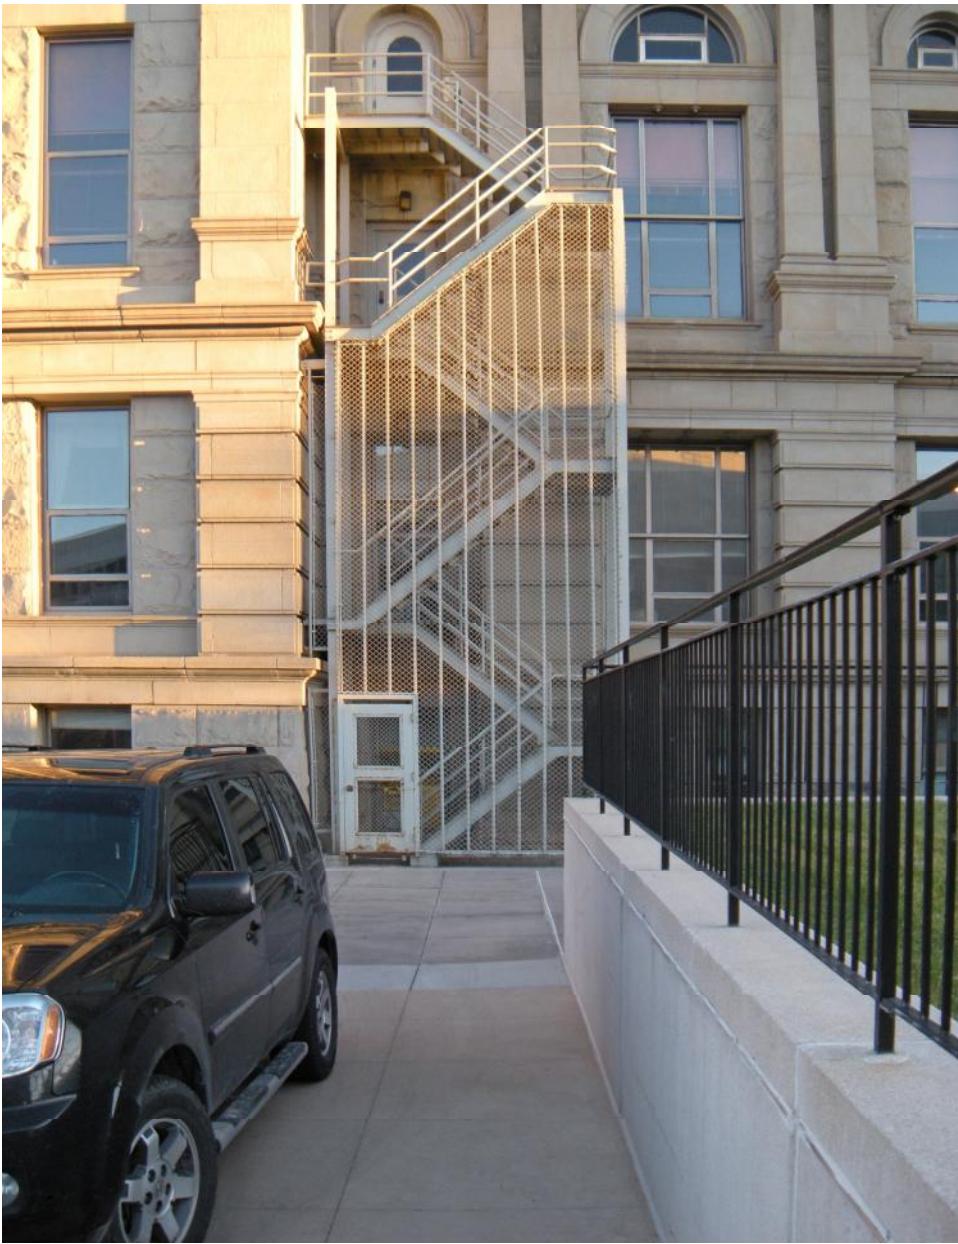
Figure 13.3: Exterior Egress Stair, 2013.

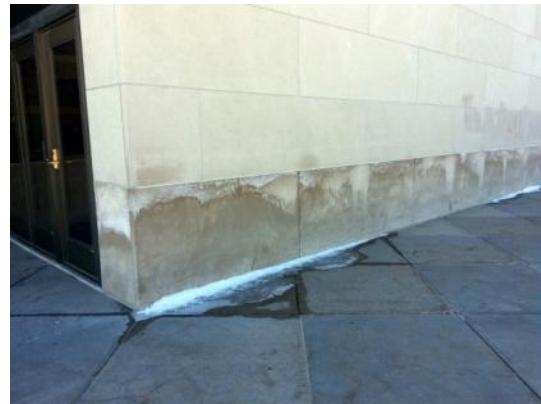
The existing exterior window system contains glass setting blocks that are in a current state of deterioration and in many cases are allowing the glazing to slide down in the window frames creating physical openings in the system allowing for outside elements such as wind, rain, and snow to penetrate the building.

View of Existing Damage, Herschler Façade

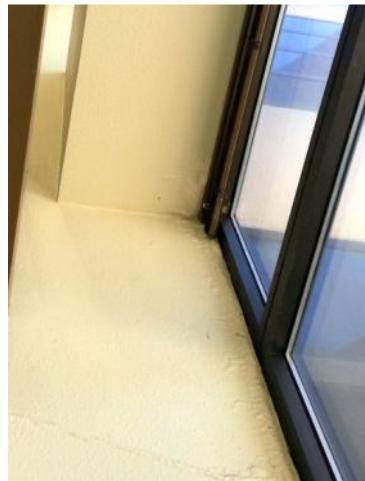
View of Existing Damage at Exterior Envelope, Herschler Façade

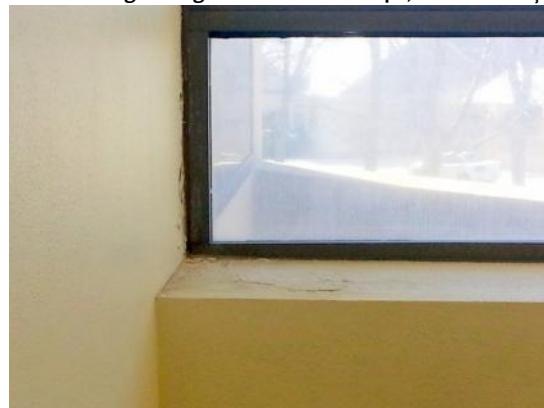
View of Existing Damage at Exterior Envelope, Herschler Façade

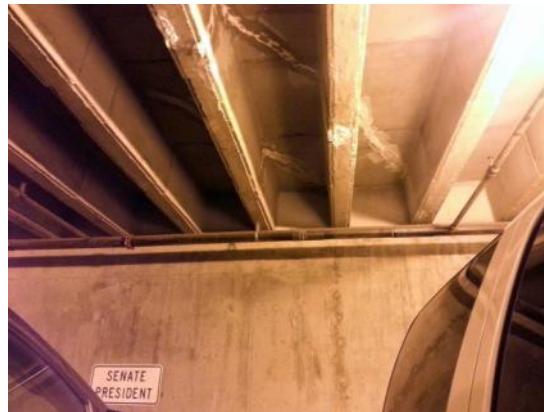
View of Damage at Existing Structural Slab Above Garage Level

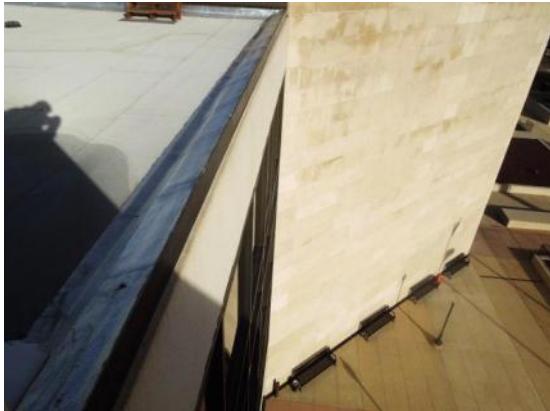
Several areas on the exterior of the building indicate a dis-coloration of the limestone and precast cladding indicating a presence of moisture. An in depth investigation is required to confirm this issue by utilizing a series of non-destructive probes to penetrate the exterior wall system for visual confirmation of the design team's concerns.

View of Potential Water Damage at Existing South Herschler Façade
