WYOMING STATE CAPITOL REHABILITATION & RESTORATION

LEVEL I /LEVEL II ARCHITECTURAL LIGHTING REPORT

24 FEBRUARY 2014

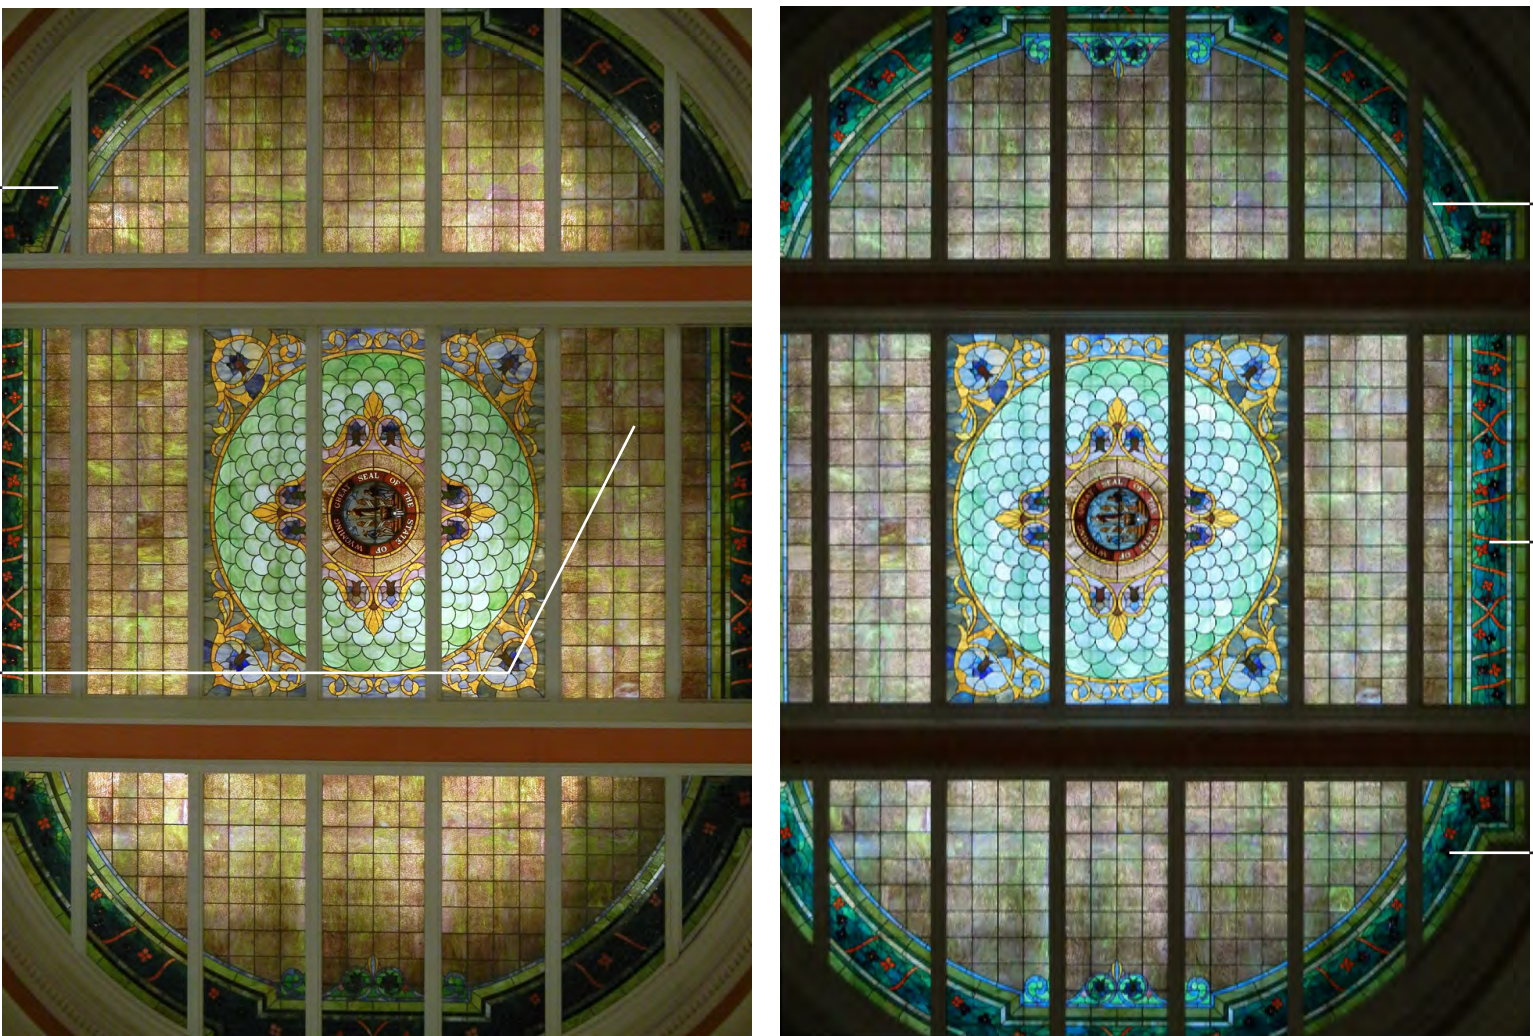
Figure O.1. House Chamber Lantern – Nighttime Electric Accent Lighting (left) and Daytime Daylighting (right)

The historic stained glass lantern is electrically lighted for nighttime effect (left) with a museum-like presentation. Little functional light is provided by this approach. Daylighting of the historic stained glass lantern (right) provides some basic-to-moderate functional light depending on season, time-of-day, and sky conditions. During the day, the lantern is more fully illuminated and contributes to the chamber’s historic architectural composition and character. The maintenance platform is “parked” at the east end above the lantern and does not appear to cause shadowing.

A recently-installed system of opal “greenhouse” protective diffusing panels just above the backside of the stained glass lantern acts as dust covers and accommodates periodic cleaning from a movable catwalk-like platform while reducing risk of damage to the stained glass. The protective covering above the stained glass may diffuse daylight too well. This combined with the skylight and stained glass transmission properties and the unfinished nature of the interstitial attic, modulates daylight too aggressively. At night, a series of ceramic metal halide PAR-lamp trackheads arranged on tracks mounted just below the skylight backlight the lantern, but little functional light is provided. *Figure O.1* illustrates night and daytime lighting conditions of the House lantern.

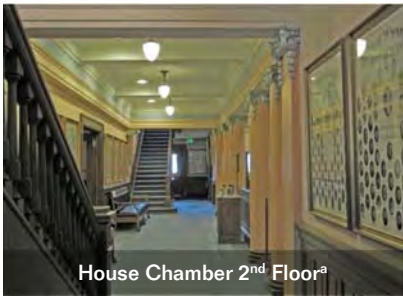
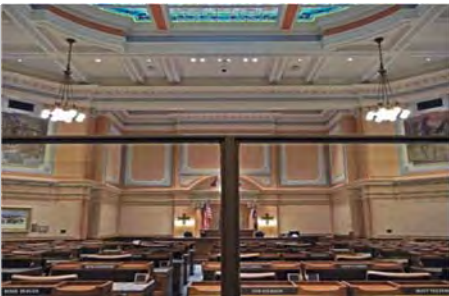
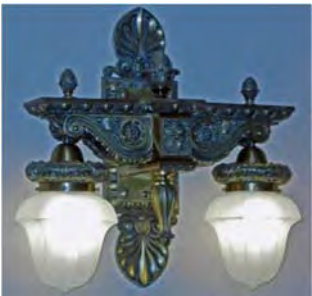
House Chamber 2 nd Floor ^a	<ul style="list-style-type: none">▶ 10 to 18 fc on circulation floor▶ Chamber illuminances<ul style="list-style-type: none">▷ daylighting only (representative)<ul style="list-style-type: none">• 2 to 4 fc @desks, 8 a.m. cloudy• 10 to 16 fc @desks, 10:30 a.m. ptly cloudy▷ electric ambient lighting only (representative)<ul style="list-style-type: none">• 25 to 60 fc @desks, max ambient scene• 105 to 130 fc @dais w/17 fc vertical▷ electric task lighting only (representative)<ul style="list-style-type: none">• 50 fc @desks	<ul style="list-style-type: none">▶ Historic incandescent decorative luminaires<ul style="list-style-type: none">▷ retrofitted with non-dim CFLs▷ very good condition for age (ca. 1918)▷ CFLs create more diffuse, flat appearance▶ Circulation downlights retrofitted w/non-dim CFLs▶ Modern quartz halogen downlights and accents<ul style="list-style-type: none">▷ 400W T4 minican lamps; 100W PAR38 lamps▷ dimmable▶ Modern fluorescent tasklights<ul style="list-style-type: none">▷ T2 linear lamps, non-dim, locally switched	<ul style="list-style-type: none">▶ Illuminances satisfactory for typical legislative functions<ul style="list-style-type: none">▷ brightnesses flat and uninspiring; upper area dingy▶ Downlight and accent strategy arguable<ul style="list-style-type: none">▷ obvious and distracting modern intrusion▶ Tasklights create reflected glare<ul style="list-style-type: none">▷ polished stone desk top is unforgiving▶ Lantern/skylight electric light strategy arguable<ul style="list-style-type: none">▷ provides aesthetic glow w/o functional light to chamber▶ Preset controls provide some functional range<ul style="list-style-type: none">▷ existing "Interim" scene excludes downlights

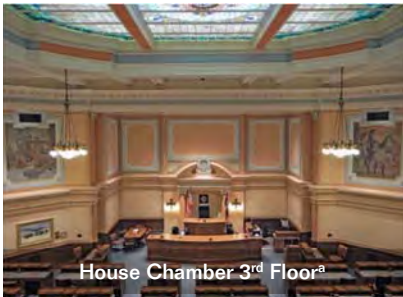
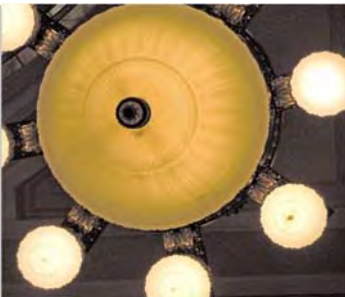
House Chamber 3 rd Floor ^a	<ul style="list-style-type: none">▶ 5 to 12 fc on circulation floor<ul style="list-style-type: none">▷ daylight estimated to contribute 1 to 2 fc▶ 9 to 36 fc on stair treads<ul style="list-style-type: none">▷ daylight estimated to contribute 1 to 25 fc	<ul style="list-style-type: none">▶ Historic incandescent decorative luminaires<ul style="list-style-type: none">▷ retrofitted with non-dim CFL lamps▷ very good condition for age (ca. 1918)▷ CFLs create more diffuse, flat appearance▶ Circulation downlights retrofitted w/non-dim CFLs	<ul style="list-style-type: none">▶ Illuminances satisfactory<ul style="list-style-type: none">▷ brightnesses very flat and uninspiring▶ Downlight strategy arguable<ul style="list-style-type: none">▷ obvious and distracting modern intrusion

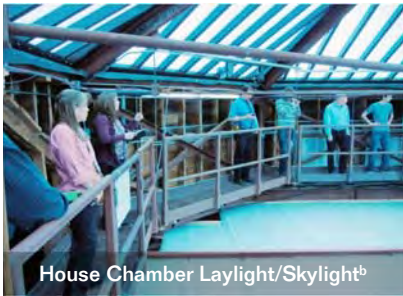
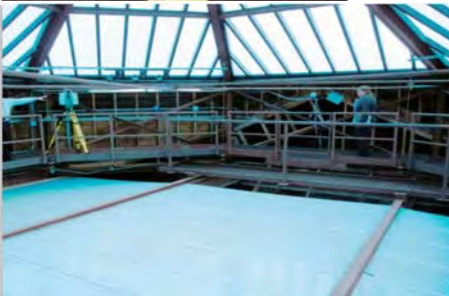
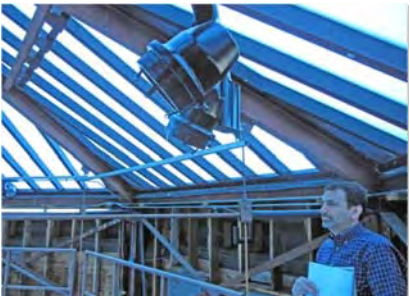
House Chamber Laylight/Skylight ^b	<ul style="list-style-type: none">▶ No illuminance measurements made▶ Fluorescent linear work lights<ul style="list-style-type: none">▷ basic maintenance lighting▶ Metal halide nighttime lantern fill<ul style="list-style-type: none">▷ lantern backlighting for aesthetic effect▶ Full top glazing skylight over lantern<ul style="list-style-type: none">▷ introduces daylight▶ Translucent polycarbonate lantern dust cover<ul style="list-style-type: none">▷ facilitates cleaning while reducing damage risk	<ul style="list-style-type: none">▶ Fluorescent linear work lights<ul style="list-style-type: none">▷ bare striplights<ul style="list-style-type: none">• independently switched on/off locally▶ Metal halide fill lights<ul style="list-style-type: none">▷ strategically placed/aimed trackheads<ul style="list-style-type: none">• ceramic metal halide PAR30/PAR38• switched on/off via house preset system▶ Glazing and polycarb skylight/lantern system<ul style="list-style-type: none">▷ transmittance greatly limits daylight availability▷ diffusion further diminishes daylight and dazzle	<ul style="list-style-type: none">▶ Illuminances satisfactory for day time maintenance▶ Fluorescent striplight strategy arguable<ul style="list-style-type: none">▷ not placed consistently around perimeter▷ no lamp protection provided▷ not tied to vacancy sensors▶ Metal halide strategy arguable<ul style="list-style-type: none">▷ provides aesthetic glow w/o functional light to chamber▶ Glazing and polycarbonate selections might yield $\tau^c < 0.05$<ul style="list-style-type: none">▷ with stained glass total τ^c might be < 0.007▶ Dark walls/voids and structure diminish effect of daylighting

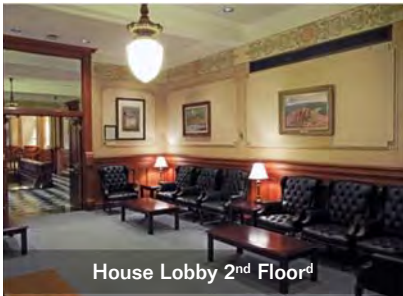
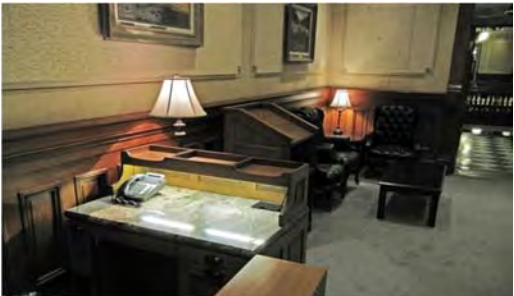
House Lobby 2 nd Floor ^d	<ul style="list-style-type: none">▶ 6 to 8 fc on circulation floor (all lights energized)▶ 35 to 58 fc on desk▶ No daylight access▶ 3rd Floor Lobby serves as circulation<ul style="list-style-type: none">▷ 3 to 4 fc on circulation floor	<ul style="list-style-type: none">▶ Historic incandescent decorative luminaires<ul style="list-style-type: none">▷ retrofitted with non-dim CFL lamps▷ very good condition for age (ca. 1918)▷ CFLs create more diffuse, flat appearance▶ 3rd floor luminaire exhibits substitute globe▶ Circulation downlights retrofitted w/non-dim CFLs▶ Modern fluorescent tasklights<ul style="list-style-type: none">▷ T2 linear lamps, non-dim, locally switched	<ul style="list-style-type: none">▶ Illuminances satisfactory for typical legislative functions<ul style="list-style-type: none">▷ brightnesses flat and uninspiring; upper area dingy▶ Downlight and accent strategy arguable<ul style="list-style-type: none">▷ obvious and distracting modern intrusion▶ Tasklights create reflected glare<ul style="list-style-type: none">▷ polished stone desk top is unforgiving

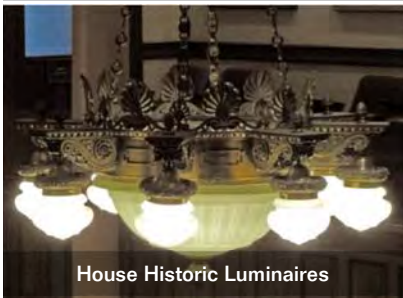
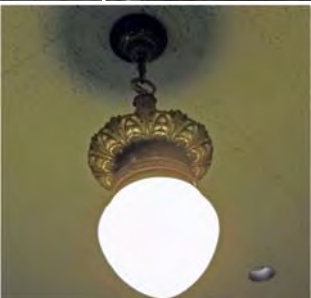
House Historic Luminaires	<ul style="list-style-type: none">▶ Medium screwbase sockets▶ Diffuse light▶ Not dimmable	<ul style="list-style-type: none">▶ Historic equipment appears to date to 1918<ul style="list-style-type: none">▷ quality opal glass diffusers<ul style="list-style-type: none">some diffuser breakage and replacements (e.g., ahistoric diffuser in right middle image)▷ cast or spun heavy gauge bronze and brass<ul style="list-style-type: none">some components bent or out of plumb (e.g., left front cast arm in image at left)▷ finishes appear stable and original▷ most extant luminaires in very good condition▶ Chamber chandeliers difficult to access	<ul style="list-style-type: none">▶ Significant historic lighting in public areas<ul style="list-style-type: none">▷ original chandeliers/period detailing intact▷ original pendants/period detailing intact▷ original wall brackets/period detailing intact▷ many appear to be in or near original locations▷ some suspensions have been modified▷ illuminances satisfactory▷ brightnesses flat and uninspiring▶ Some possible gas-pipe remnants▶ Maintenance and preservation are apparent priorities

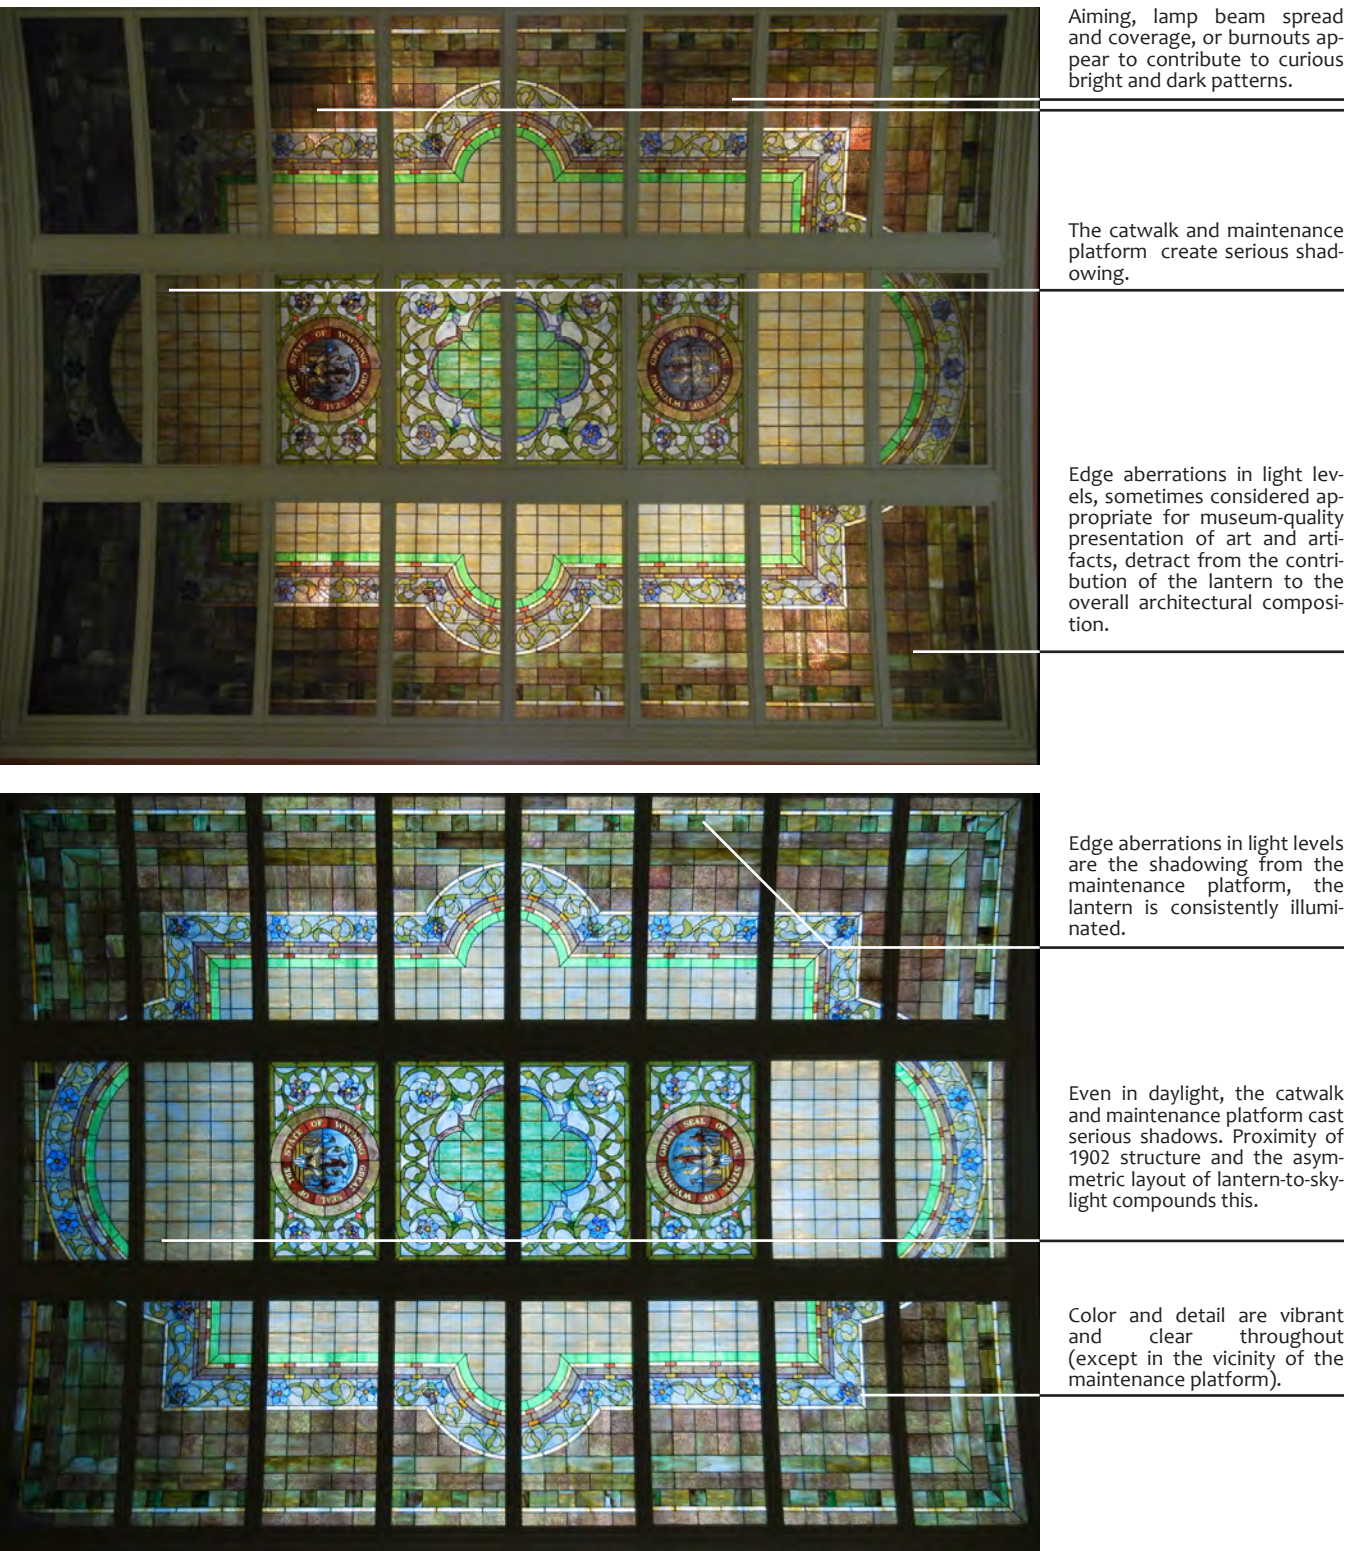
Figure 0.21. Senate Chamber Lantern – Nighttime Electric Accent Lighting (top) and Daytime Daylighting (bottom)
The historic stained glass lantern is electrically lighted for nighttime effect as a museum-like presentation. Little functional light is available from this approach. Daylighting of the historic stained glass lantern provides some basic-to-moderate functional light depending on season, time-of-day, and sky conditions. During the day, the lantern is more fully illuminated thus contributing to the Chamber’s historic architectural character. Day or night, shadowing is acute near the catwalk and the maintenance platform (“parked” at east end).

A recently-installed system of opal “greenhouse” protective diffusing panels just above the backside of the stained glass lantern acts as dust covers and accommodates periodic cleaning from a movable catwalk-like platform while reducing risk of damage to the stained glass. Similar to the situation in the House, the protective covering above the stained glass may diffuse daylight too well. This combined with the skylight transmission properties, the stained glass transmission properties, and the unfinished nature of the interstitial attic, modulates daylight too aggressively. At night, a series of ceramic metal halide PAR-lamp trackheads on tracks mounted just below the skylight backlight the lantern, but, little functional light is provided. *Figure 0.21* illustrates night and daytime lighting conditions of the Senate lantern. The movable catwalk mechanism can only be parked in such a way that creates significant shadowing on the lantern.

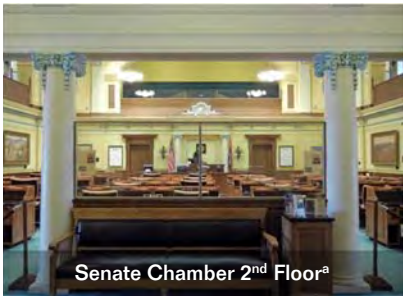
Senate Chamber 2 nd Floor ^a	<ul style="list-style-type: none">▶ 7 to 16 fc on circulation floor▶ Chamber illuminances<ul style="list-style-type: none">▷ daylighting only (representative)<ul style="list-style-type: none">• 4 to 8 fc @desks, 3 p.m. cloudy▷ electric ambient lighting only (representative)<ul style="list-style-type: none">• 33 to 46 fc @desks, max ambient scene• 55 to 85 fc @dais w/13 fc vertical▷ electric task lighting only (representative)<ul style="list-style-type: none">• 50 fc @desks (presumed same as House)	<ul style="list-style-type: none">▶ Historic incandescent decorative luminaires<ul style="list-style-type: none">▷ retrofitted with non-dim CFL lamps▷ very good condition for age (ca. 1918)▷ CFLs create more diffuse, flat appearance▶ Circulation downlights retrofitted w/non-dim CFLs▶ Modern quartz halogen downlights and accents<ul style="list-style-type: none">▷ 400W T4 minican lamps; 100W PAR38 lamps▷ dimmable▶ Modern fluorescent tasklights<ul style="list-style-type: none">▷ T2 linear lamps, non-dim, locally switched	<ul style="list-style-type: none">▶ Illuminances satisfactory for typical legislative functions<ul style="list-style-type: none">▷ brightnesses somewhat better than those in House▶ Downlight and accent strategy arguable<ul style="list-style-type: none">▷ obvious and distracting modern intrusion▶ Tasklights create reflected glare<ul style="list-style-type: none">▷ polished stone desk top is unforgiving▶ Lantern/skylight supplemental electric light strategy arguable<ul style="list-style-type: none">▷ provides aesthetic glow w/o functional light to chamber▶ Preset controls provide some functional range<ul style="list-style-type: none">▷ existing "Interim" scene excludes downlights

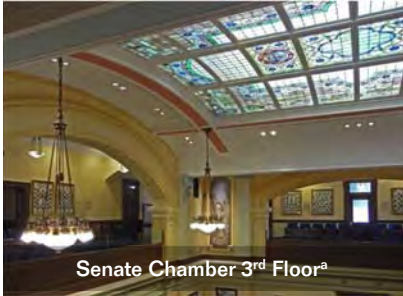
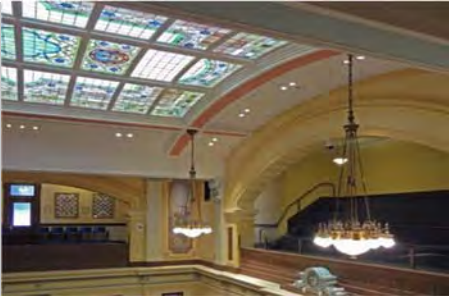
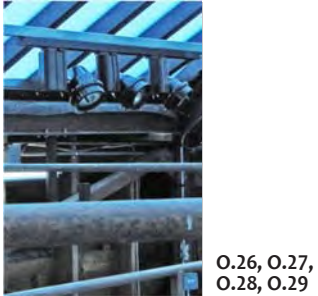
Senate Chamber 3 rd Floor ^a	<ul style="list-style-type: none">▶ 5 to 13 fc on circulation floor<ul style="list-style-type: none">▷ daylight estimated to contribute 1 to 2 fc▶ 4 to 11 fc on gallery areas<ul style="list-style-type: none">▷ daylight estimated to contribute 1 to 2 fc	<ul style="list-style-type: none">▶ Historic incandescent decorative luminaires<ul style="list-style-type: none">▷ retrofitted with non-dim CFL lamps▷ very good condition for age (ca. 1918)▷ CFLs create more diffuse, flat appearance▶ Circulation downlights retrofitted w/non-dim CFLs	<ul style="list-style-type: none">▶ Illuminances satisfactory<ul style="list-style-type: none">▷ brightnesses appear greater than those in House (perhaps due to lantern make-up, skylight configuration, livelier gallery areas/architecture, better highlighting of mural panels)▶ Downlight strategy arguable<ul style="list-style-type: none">▷ obvious and distracting modern intrusion▶ Glazing and polycarbonate selections might yield $\tau^b < 0.05$<ul style="list-style-type: none">▷ with stained glass total τ^b might be < 0.007

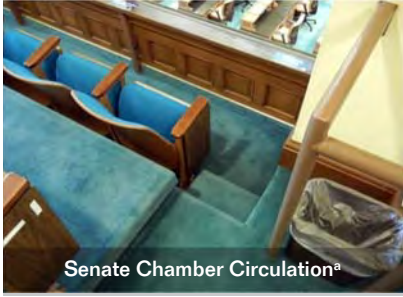
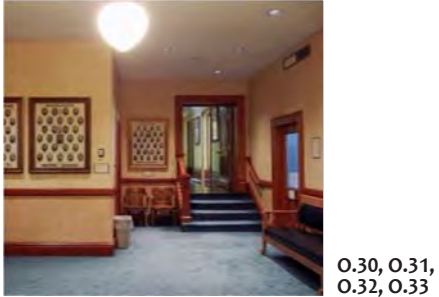
Senate Chamber Circulation ^a	<ul style="list-style-type: none">▶ See notes above on illuminances in circulation▶ 2 to 15 fc on stair treads	<ul style="list-style-type: none">▶ Historic incandescent decorative luminaires<ul style="list-style-type: none">▷ retrofitted with non-dim CFL lamps▷ very good condition for age (ca. 1918)▷ CFLs create more diffuse, flat appearance▶ Circulation downlights retrofitted w/non-dim CFLs	<ul style="list-style-type: none">▶ Illuminances satisfactory for typical legislative functions▶ Downlight and accent strategy arguable<ul style="list-style-type: none">▷ obvious and distracting modern intrusion▶ Senate lobby has sterile appearance<ul style="list-style-type: none">▷ table lights and artworks improve House Lobby

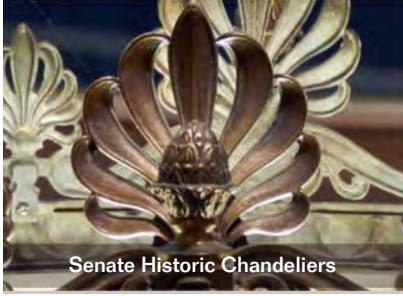
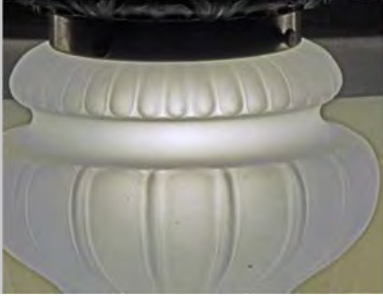
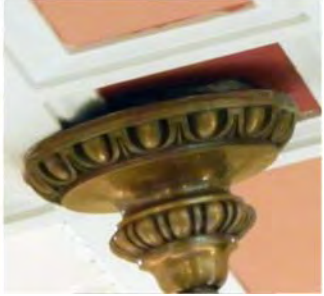
Senate Historic Chandeliers	<ul style="list-style-type: none">▶ Medium screwbase sockets▶ Diffuse light▶ Not dimmable	<ul style="list-style-type: none">▶ Equipment appears to date to 1918<ul style="list-style-type: none">▷ quality opal glass diffusers▷ some diffuser breakage and replacements▷ cast or spun heavy gauge bronze and brass▷ some components bent or out of plumb▷ finishes appear stable and original▷ extant luminaires in very good condition▶ 4 CFLs in central bowl; 1 CFL in each small globe▶ Chandeliers difficult to access	<ul style="list-style-type: none">▶ Significant historic lighting in public areas<ul style="list-style-type: none">▷ original chandeliers/period detailing intact▷ many appear to be in or near original locations▷ illuminances satisfactory▷ brightnesses flat and uninspiring▶ Maintenance and preservation are apparent priorities

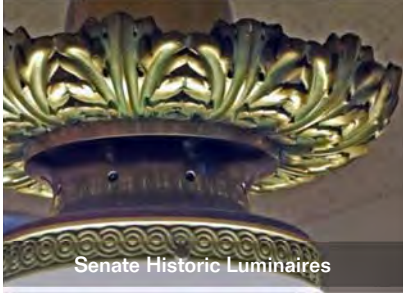
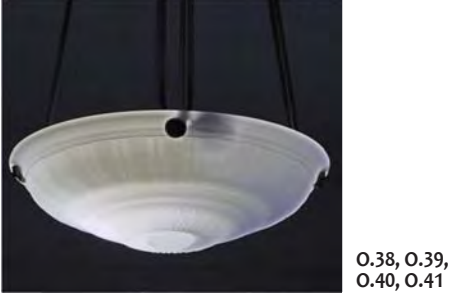
Senate Historic Luminaires	<ul style="list-style-type: none">▶ Medium screwbase sockets▶ Diffuse light▶ Not dimmable	<ul style="list-style-type: none">▶ Equipment appears to date to 1918<ul style="list-style-type: none">▷ quality opal glass diffusers▷ some diffuser breakage and replacements (e.g., ahistoric diffuser in 3rd floor lobby)▷ cast or spun heavy gauge bronze and brass▷ some components bent or out of plumb▷ finishes appear stable and original<ul style="list-style-type: none">• OEM^c "Bronze (Green Relief)" still evident▷ most luminaires in very good condition	<ul style="list-style-type: none">▶ Significant historic lighting in public areas<ul style="list-style-type: none">▷ original chamber chandeliers/period detailing intact▷ original pendants/period detailing intact▷ original chamber wall brackets/period detailing intact▷ many appear to be in or near original locations▷ some suspensions have been modified▷ illuminances satisfactory▷ brightnesses flat and uninspiring▶ Maintenance and preservation are apparent priorities

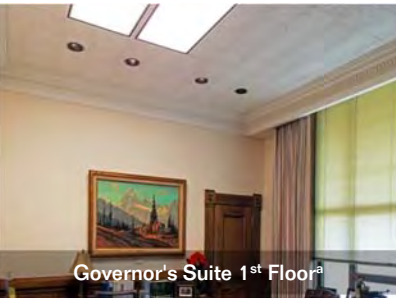
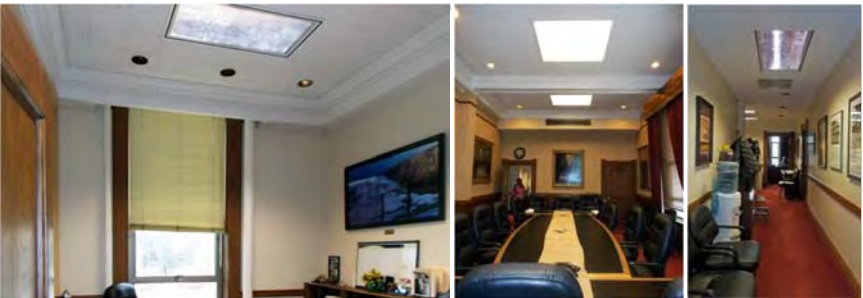
Governor's Suite 1 st Floor ^a	<ul style="list-style-type: none">▶ Typical illuminances (in all rooms but 100, 132)<ul style="list-style-type: none">▷ daylighting only (representative) window treatment deployed (as found)<ul style="list-style-type: none">• 2 to 10 fc @desks, early p.m. partly cloudy▷ electric ambient lighting only (representative)<ul style="list-style-type: none">• 30 to 55 fc @desks, all lights energized▶ Typical electric ambient illuminances in 100, 132<ul style="list-style-type: none">• 75 to 85 fc @desks	<ul style="list-style-type: none">▶ Historic incandescent decorative luminaires<ul style="list-style-type: none">▷ several remain - see below▶ 1970s recessed fluorescent luminaires<ul style="list-style-type: none">▷ 2 ft by 4 ft<ul style="list-style-type: none">• lensed multi-lamp versions• paracube louvered multi-lamp versions▷ 4 ft by 4 ft<ul style="list-style-type: none">• lensed multi-lamp versions▶ 1970s recessed downlights in select areas<ul style="list-style-type: none">▷ most retrofitted with non-dim CFL lamps	<ul style="list-style-type: none">▶ Illuminances satisfactory for typical administrative functions<ul style="list-style-type: none">▷ brightnesses uninspiring; color-of-light unflattering▶ Fluorescent luminaires are visually/physically overwhelming<ul style="list-style-type: none">▷ visually disconnected from historic context▷ lensed versions are glary▷ paracube louvered versions create cave impressions▶ Downlights are obvious and distracting modern intrusion<ul style="list-style-type: none">▷ unable to compete with 2x4 and 4x4 fluorescents

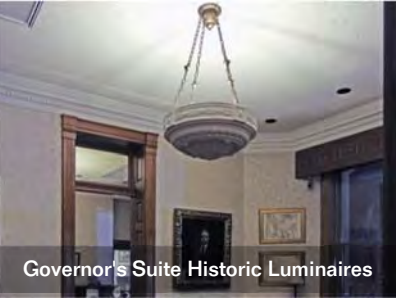
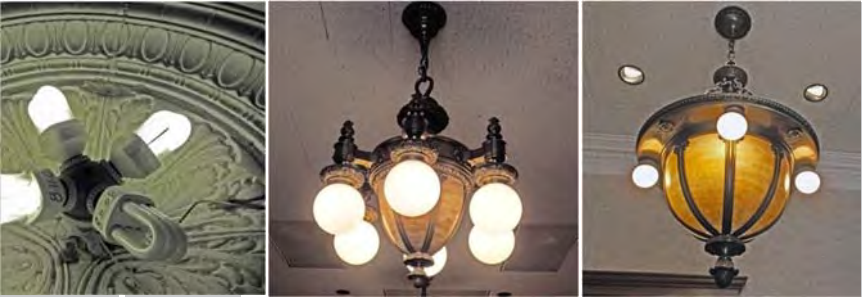
Governor's Suite Historic Luminaires	<ul style="list-style-type: none">▶ Medium screwbase sockets▶ Diffuse light▶ Not dimmable	<ul style="list-style-type: none">▶ Equipment appears to date to 1918<ul style="list-style-type: none">▷ quality art glass diffusers▷ cast or spun heavy gage bronze and brass▷ stamped or formed heavy gauge▷ finishes appear stable and original▷ most extant luminaires in very good condition	<ul style="list-style-type: none">▶ Several historic luminaires (of unknown origin w/in capitol)<ul style="list-style-type: none">▷ apparently original chandeliers/period detailing intact (left middle luminaire can be attributed to Beardslee 1916 BOM)▷ apparently original pendants/period detailing intact▷ original locations within capitol cannot be confirmed▷ overall suspensions likely have been modified▶ Maintenance and preservation are apparent priorities

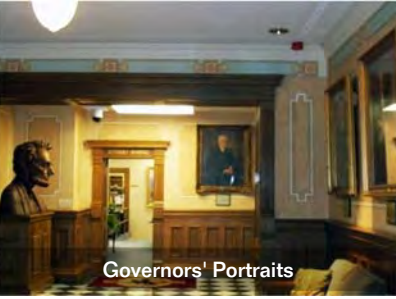
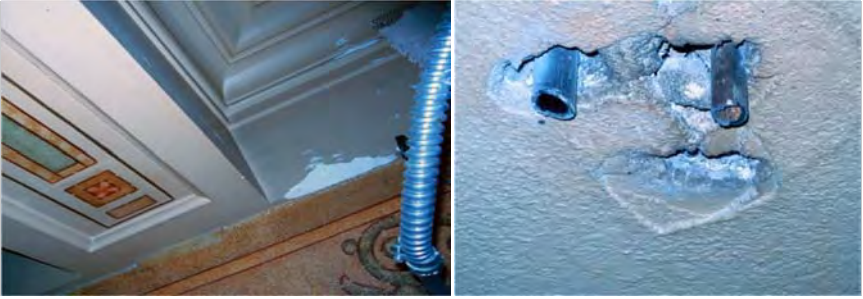
Governors' Portraits	<ul style="list-style-type: none">▶ No illuminance measurements made	<ul style="list-style-type: none">▶ Fluorescent lensed surface mount<ul style="list-style-type: none">▷ 1970s-era lighting▷ at entries to Attorney General's and Governor's▶ Historic articulated glass pendants with CFLs▶ Recessed adjustable accents in vicinity of portraits<ul style="list-style-type: none">▷ 1970s-era black Alzak reflectors▷ Rated for 300W PAR56 lamps<ul style="list-style-type: none">• de-lamped to 200W PAR56• very short life• too intense for sensitive artwork	<ul style="list-style-type: none">▶ Illuminances satisfactory for circulation▶ Fluorescent surface-mount and accent strategy arguable<ul style="list-style-type: none">▷ obvious and distracting modern intrusions▷ intense accents accelerate sensitive artwork degradation▶ Potential historic decorative painting scheme uncovered<ul style="list-style-type: none">▷ dropped ceiling may hide decorative paint and gas pipe (see images to right; far right pipe in far right image appears to be black iron gas pipe)

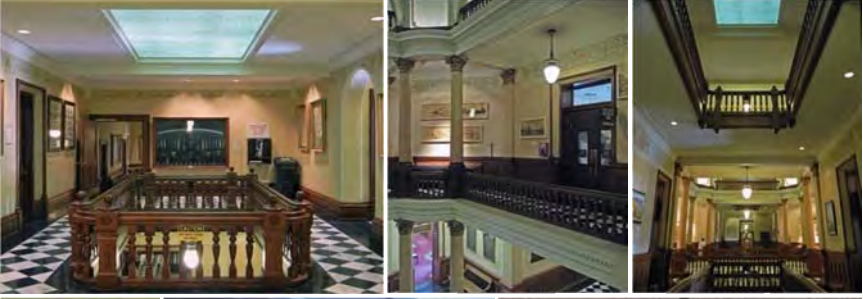
Rotunda and Circulation	<ul style="list-style-type: none">▶ 1st floor illuminances (electric light only)<ul style="list-style-type: none">▷ 8 to 9 fc on rotunda floor▷ 29 to 40 fc on desks▷ 2 to 3 fc on north and south vestibule floors▷ 8 to 20 fc general circulation▷ 11 fc at east elevator threshold▶ 2nd floor illuminances (electric light only)<ul style="list-style-type: none">▷ 3 to 4 fc on general circulation▷ 50 to 140 fc on artworks <p>continued below</p>	<ul style="list-style-type: none">▶ Historic incandescent decorative luminaires<ul style="list-style-type: none">▷ retrofitted with non-dim CFL lamps▷ very good condition for age (ca. 1918)▷ CFLs create more diffuse, flat appearance▷ some globes are broken or modern substitutes▶ Fluorescent lensed recessed 2x4 and 4x4 units▶ 1970s recessed downlights in select areas<ul style="list-style-type: none">▷ most retrofitted with non-dim CFL lamps▶ Track monopoint accents in vicinity of artworks<ul style="list-style-type: none">▷ too intense for sensitive artworks	<ul style="list-style-type: none">▶ Illuminances satisfactory for circulation<ul style="list-style-type: none">▷ brightnesses uninspiring; color-of-light unflattering▶ Fluorescent 2x4s and 4x4s and accent strategy arguable<ul style="list-style-type: none">▷ obvious and distracting modern intrusions▷ intense accents accelerate sensitive artwork degradation▶ Faux skylights/laylights at 3rd floor over each stair well<ul style="list-style-type: none">▷ 1970s or 1980s mercury or metal halide backlighting

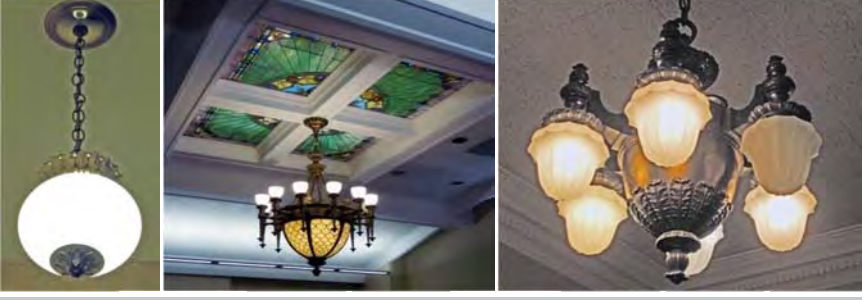
Other Historic Luminaires	<p>Rotunda and Circulation (continued)</p> <ul style="list-style-type: none">▶ 3rd floor illuminances (electric light only)<ul style="list-style-type: none">▷ 7 to 41 fc on general circulation▶ North Service Stairs illuminances (electric light only)<ul style="list-style-type: none">▷ 0.7 to 3 fc on general circulation <p>Other Historic Luminaires</p> <ul style="list-style-type: none">▶ Medium screwbase sockets▶ Diffuse light▶ Not dimmable	<ul style="list-style-type: none">▶ Equipment appears to date to 1918<ul style="list-style-type: none">▷ quality opal glass diffusers▷ some diffuser breakage and replacements▷ cast or spun heavy gauge bronze and brass▷ some components bent or out of plumb▷ finishes appear stable and original▷ most luminaires in very good condition	<ul style="list-style-type: none">▶ Significant historic lighting in public areas<ul style="list-style-type: none">▷ original chandeliers/period detailing intact▷ original pendants/period detailing intact▷ many appear to be in or near original locations▷ some overall suspensions have been modified▷ illuminances satisfactory▷ brightnesses flat and uninspiring▶ Maintenance and preservation are apparent priorities

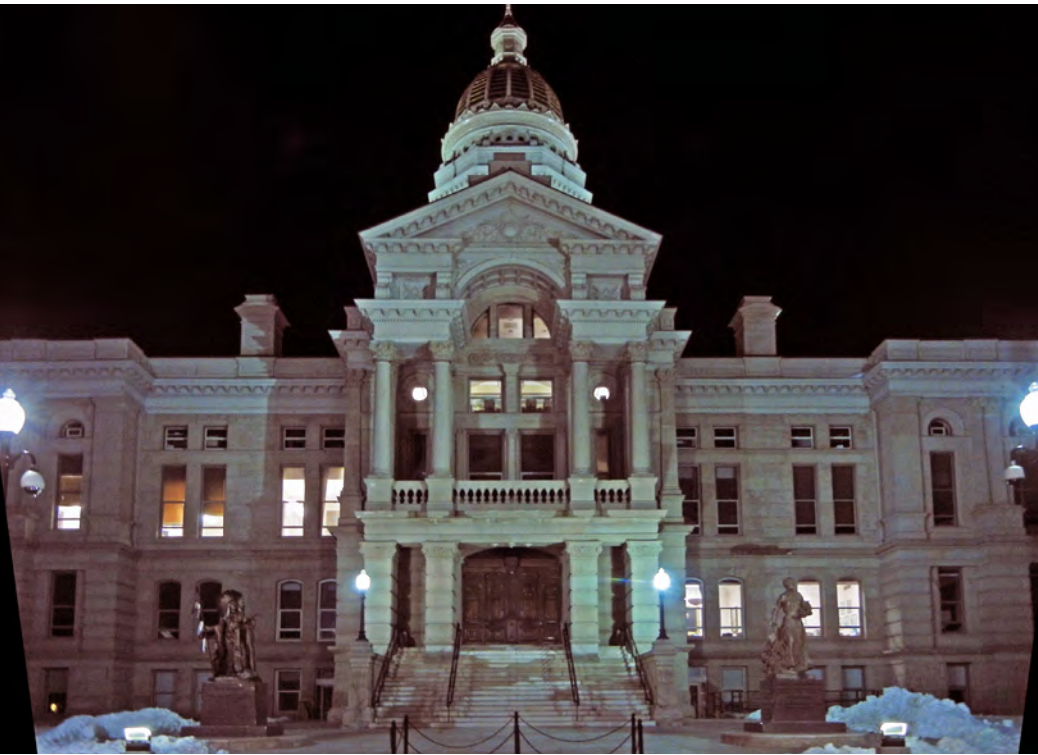
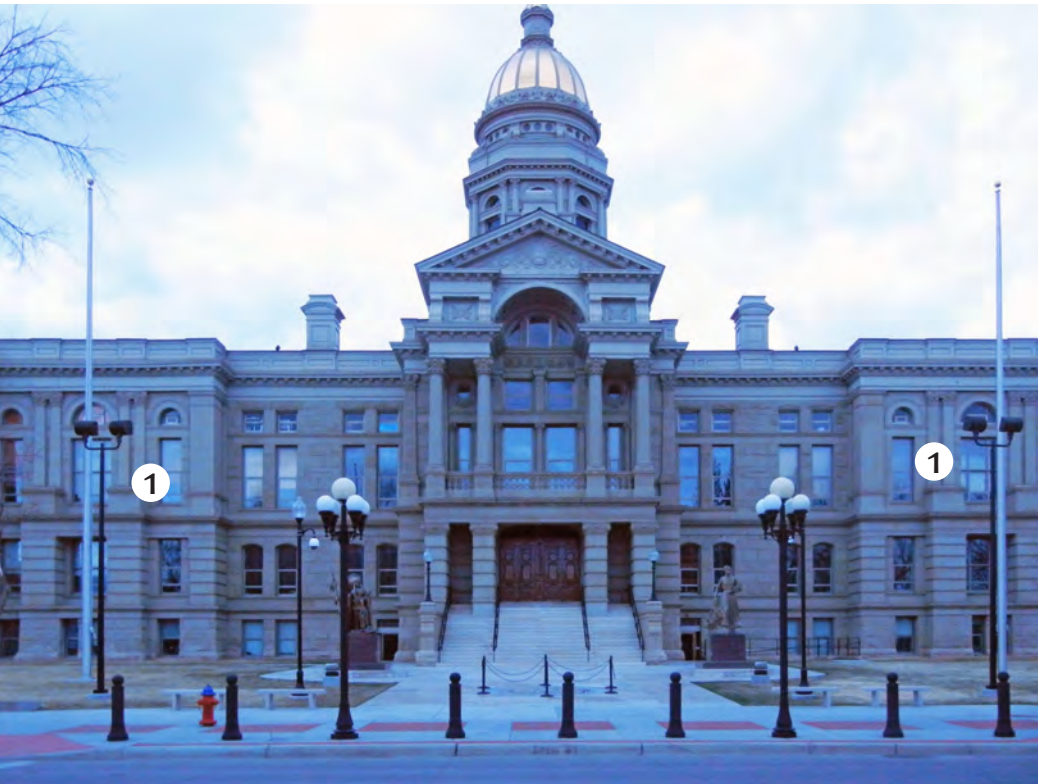
Figure O.62. Facade Lighting

The statues of Esther Hobart Morris and Chief Washakie are softly illuminated. Their bronze-toned finish combined with the bluish color of the clear metal halide causes these sculptures to recede into darkness. The statues Spirit of Wyoming at the west lawn and the Bison on the east lawn appear to be illuminated with clear metal halide. The replica of the Liberty Bell at Carey and Capitol and the Spanish American War memorial at Central and Capitol do not appear to be illuminated at night. A “W” logo at the northwest corner defined by 25th Street is illuminated. A calf sculpture on the southwest lawn honoring former Governor Hansen is not illuminated. The state flag and the US flag do not appear to be flown at night and are not illuminated.

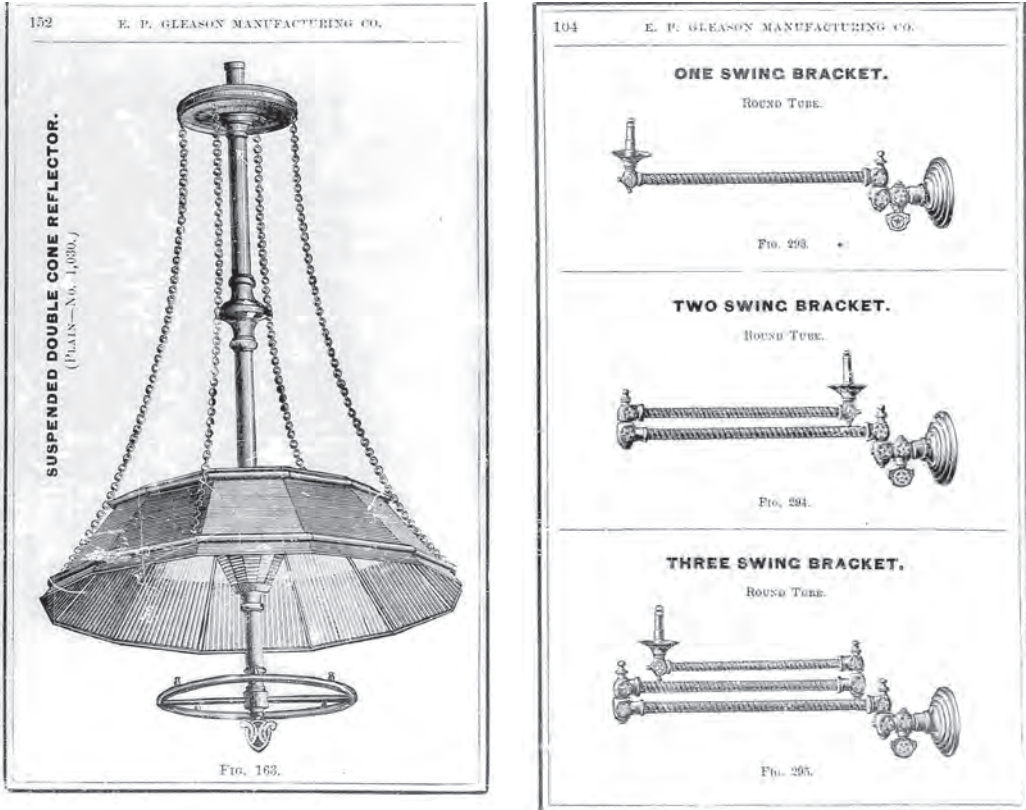
Figure O.63. Phase 1 -1888 Gas Lighting

Double cone gas reflectors are referenced in the Phase 1 specifications and bid schedules. An example from E.P. Gleason’s 1887 catalog is shown here (left). The versions in the Wyoming Capitol were “5 feet 6 inches in diameter, containing 30 burners each, with shut-off at convenient points of access.” These must have been quite bright. In the same Gleason catalog, wall brackets were available in various arrays (right). The top most variety is similar in scale and decoration to the bracket on a plaque in Room 117 (see [Figure O.64](#) below).

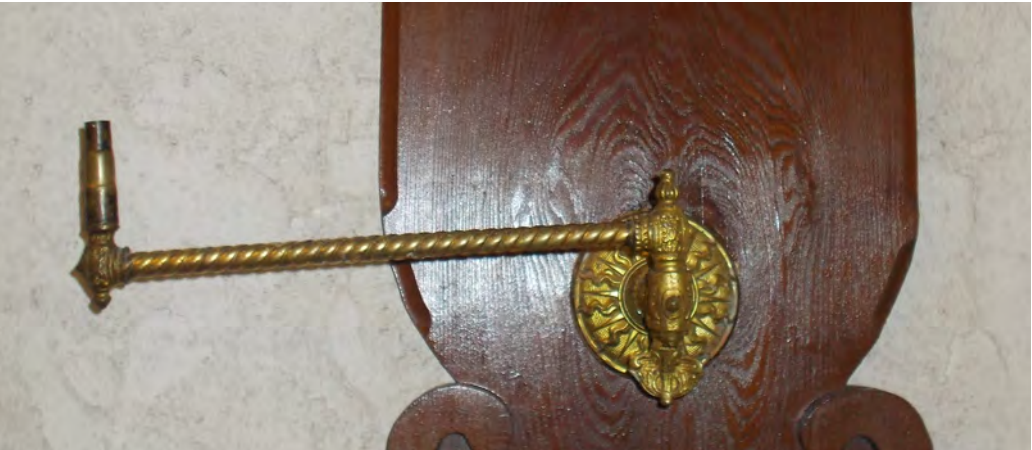
Figure O.64. Wall Bracket Plaque in Room 117

A plaque exhibiting a gas wall bracket can be found in Room 117. Perhaps this is a remnant from Phase 1.

A plaque bearing a gas wall bracket hangs in the Auditor’s Suite along the north wall of the office in proximity to the rotunda (Room 117). This is an interesting curiosity [[See Figure O.64](#)]. Perhaps this is remnant from the original building’s gas lighting system. [See O.02.02 Historical Lighting Conditions | Phase 1 - 1888](#).

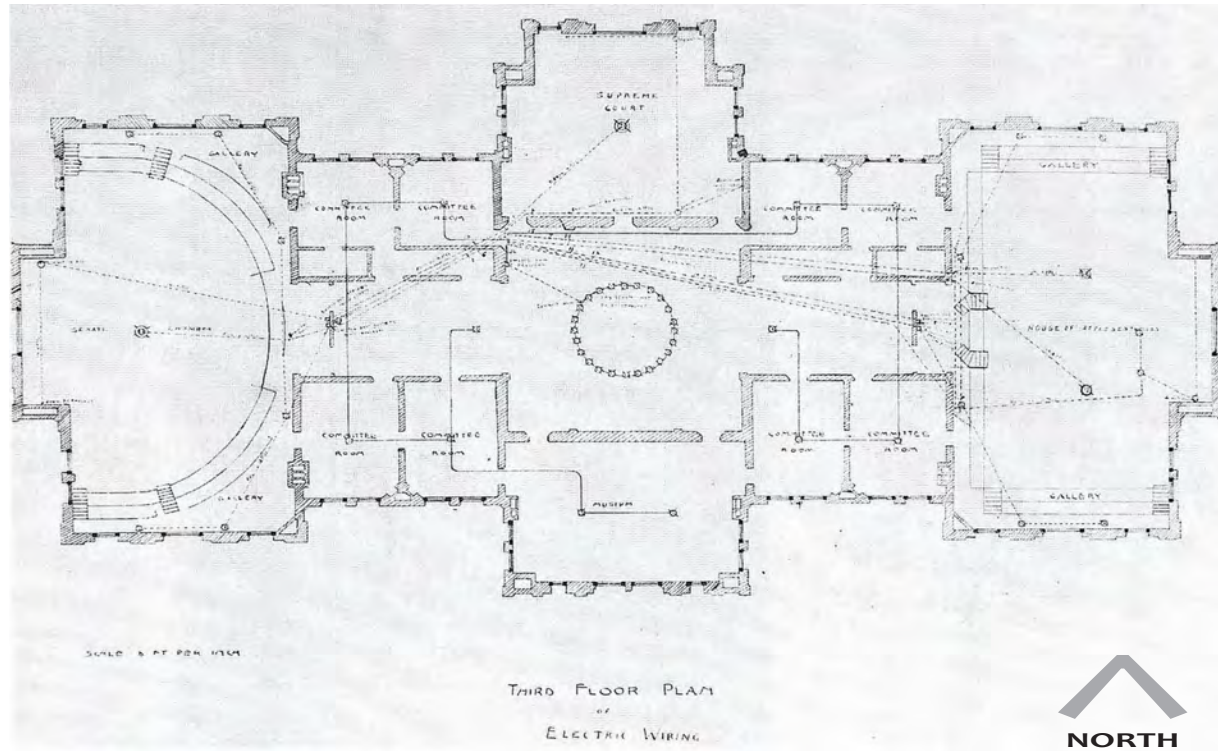
Figure O.65. ca. 1889 Electric Wiring (Lighting) Plan

Lighting is clearly indicated on this plan, believed to be ca. 1889, and is apparently a combination gas and electric plan. The Supreme Court luminaire symbol shows “30” presumably corresponding to the number of burners cited in the 1886 specifications. The Senate is fitted with a 12-burner luminaire and the House with two 12-burner luminaires (corresponding to the number of gas burners shown in the combination gas/electric fixtures seen in Figure O.66). This plan may not have been completely implemented until 1896 or so or may not have even been drawn until that time – this is an undated drawing.

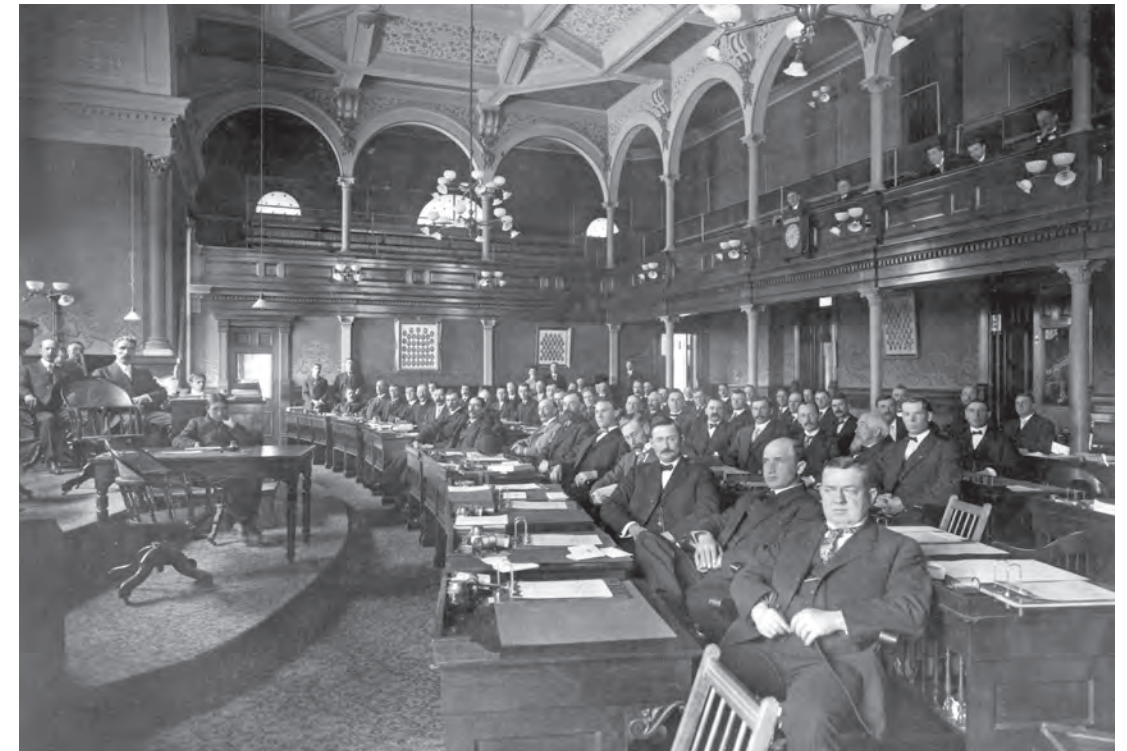
Figure O.66. Late 19th/Early 20th Century View of House of Representatives

The lighting equipment shown in this undated photograph are consistent with the plans and commission reports of the 1890 to 1896 time frame. The combination wall brackets and chandeliers are fitted with the number of gas burners cited on plans. Wall brackets appear to match those in Figure O.67 dated 1902. Chandeliers are multi-burner versions of the pendant fixture shown in Figure O.69 and O.70. This was a common means of increasing/decreasing light output and fixture scale while using a standard kit of parts.

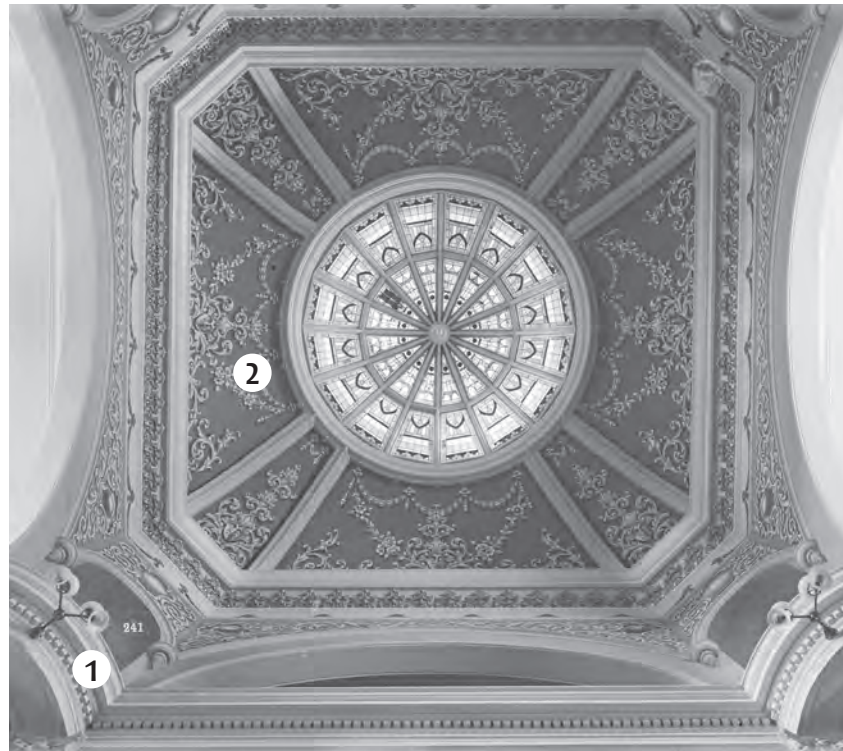
Figure O.67. 1902 View of Rotunda Dome

Combination wall brackets are shown on the rotunda 2nd floor fascia detailing (①). These are similar to versions seen in Figures O.66 and complement the pendants shown in Figures O.69 and O.70. Electric lamps ring the perimeter of the dome (②) more clear in the close-up shown in Figure O.68).

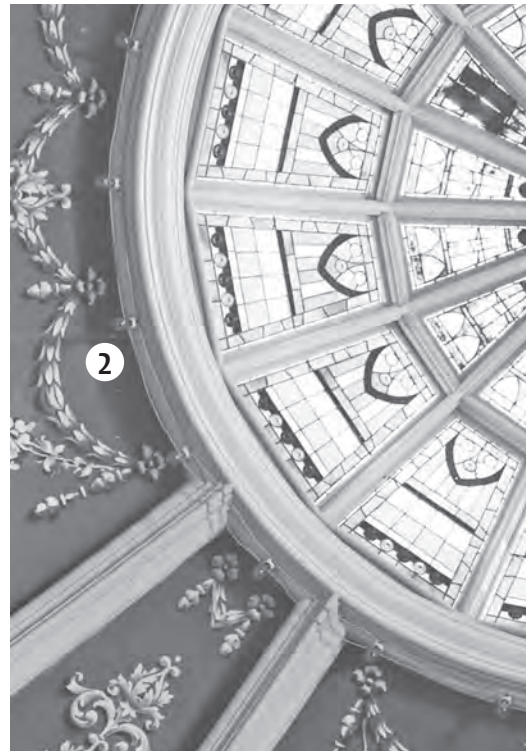
Figure O.68. 1902 Electric Lamps

A common application for the then-new, more universal and utilitarian source, incandescent lamps, architectural detailing was outlined with lamps (②) consistently placed.

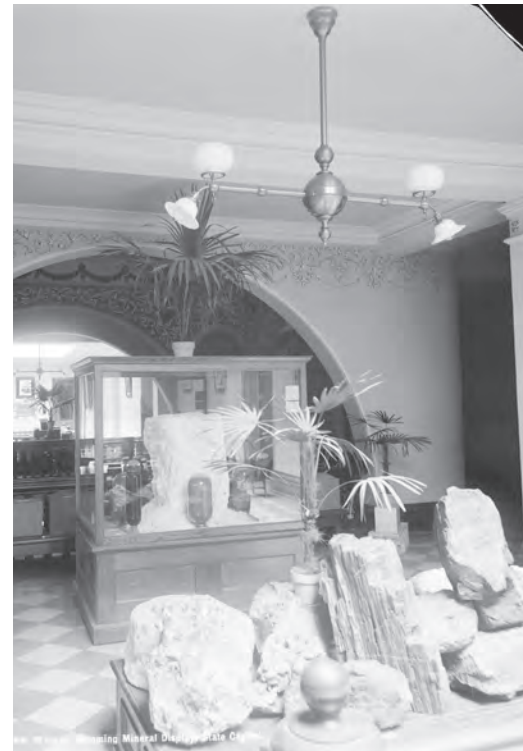
Figure O.69. 1902 Mineral Display on 3rd Floor

This combination luminaire (and another visible through the arch to the west side of the rotunda), likely served as the “standard” fixture for circulation and most work spaces.

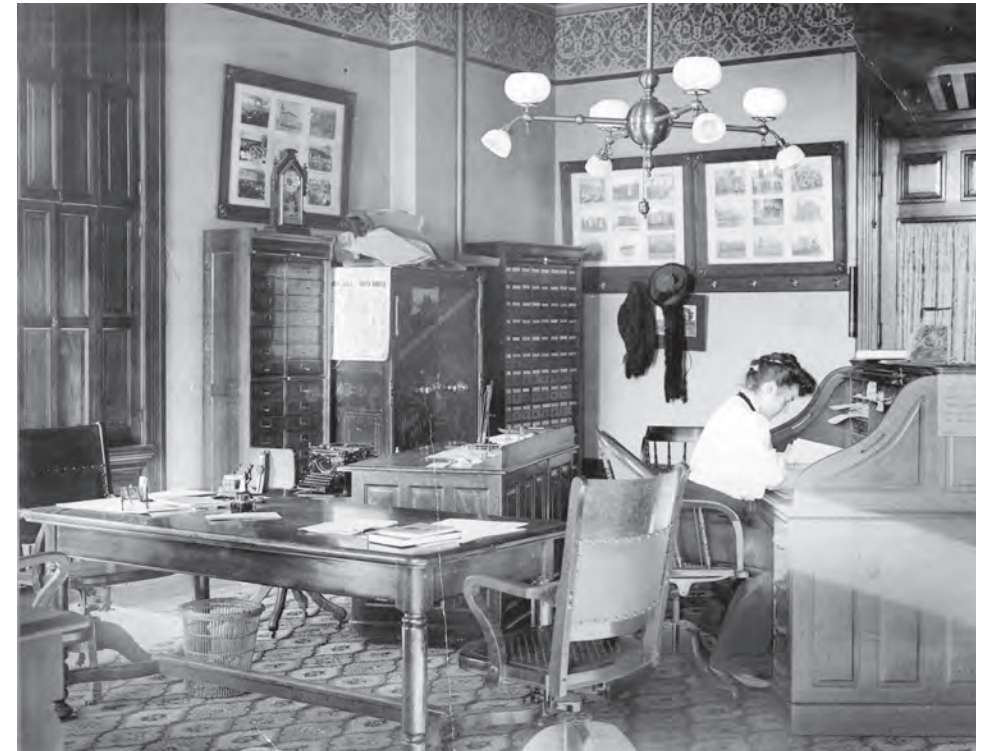
Figure O.70. 1907 Margaret Knight, Deputy State Superintendent of Schools

This combination luminaire, a 4-arm version of the example shown in Figure O.69, in an office setting suggests the universal application of a standard approach to lighting throughout much of the capitol after Phase 2 completion. The dangle hanging from the central cluster body is a switch, presumably for the electric lights.
