WYOMING STATE CAPITOL REHABILITATION & RESTORATION

LEVEL I /LEVEL II ARCHITECTURAL LIGHTING REPORT

24 FEBRUARY 2014

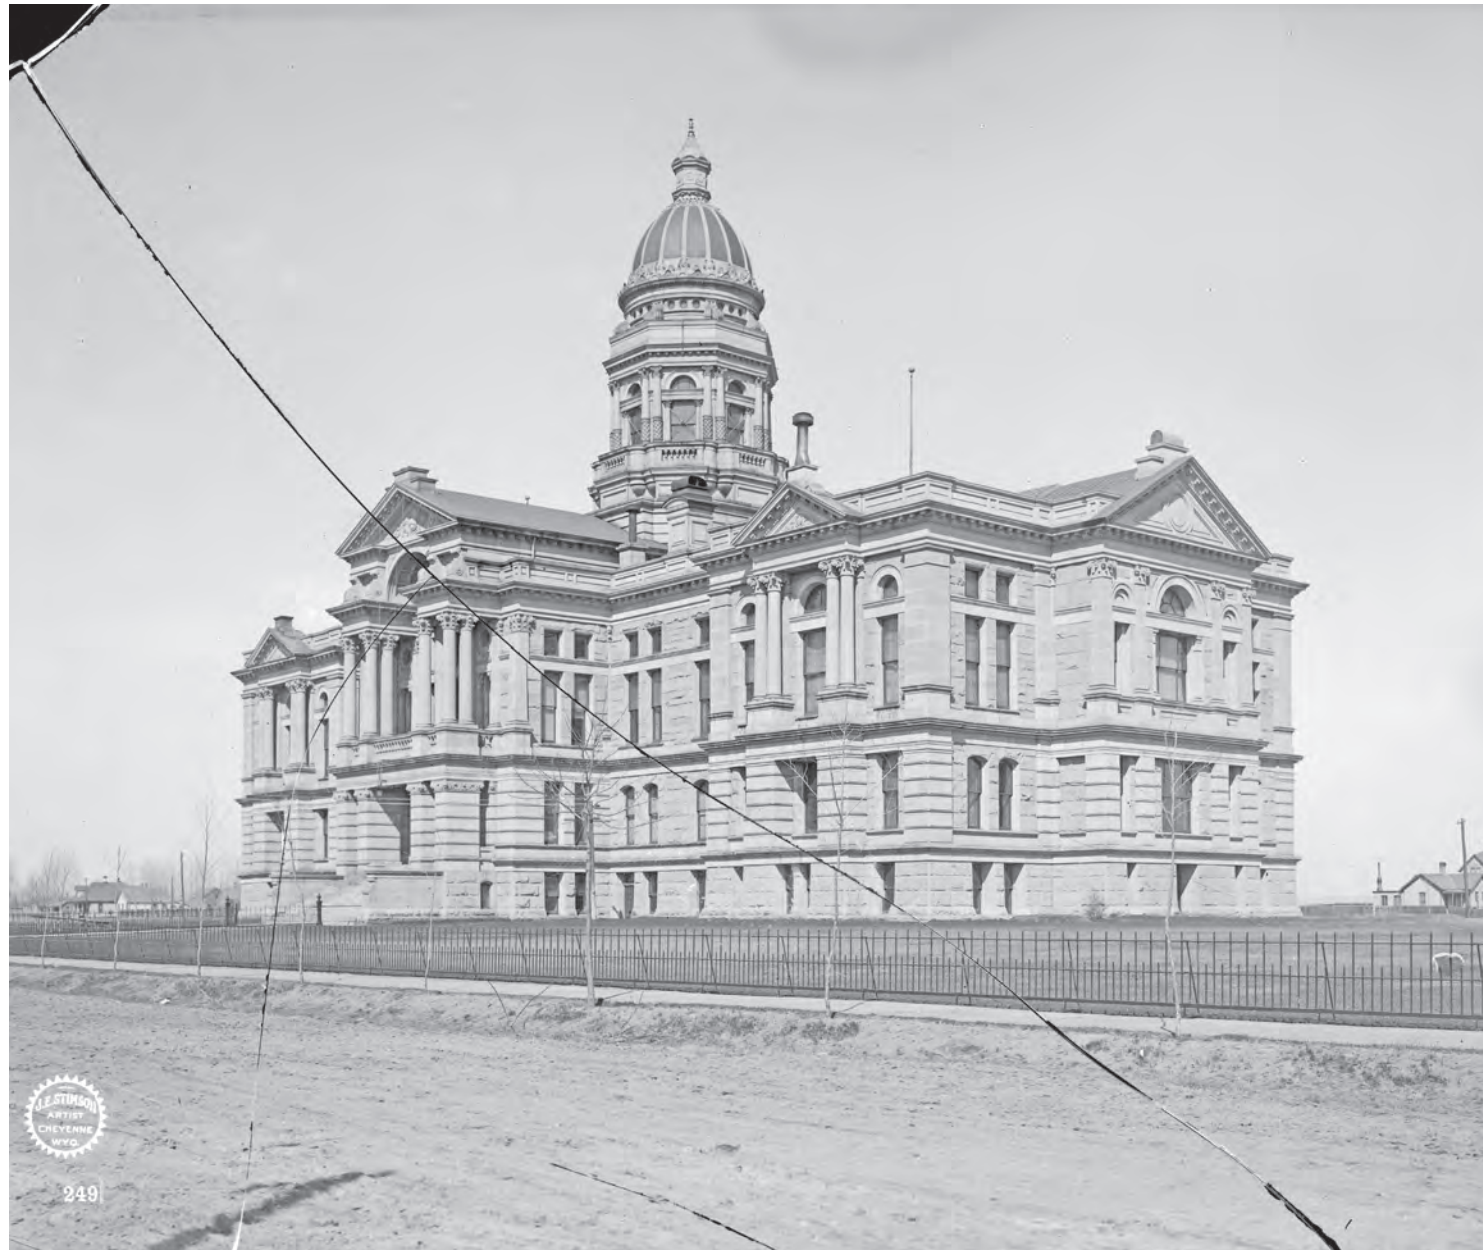
Figure O.71. 1902 Electrification and Exterior Lighting

The capitol building as it appeared twelve years after completion of Phase 2. Electric wiring and even an arc lamp are shown in this photograph. Figure O.72 more clearly delineates the electrical wiring to the building and the arc lamp at the south entrance. Contrary to original plans and ongoing commission report directives, electric wiring was apparently not placed in conduit below grade for some time. This made for an unsightly, if not unsafe, installation.

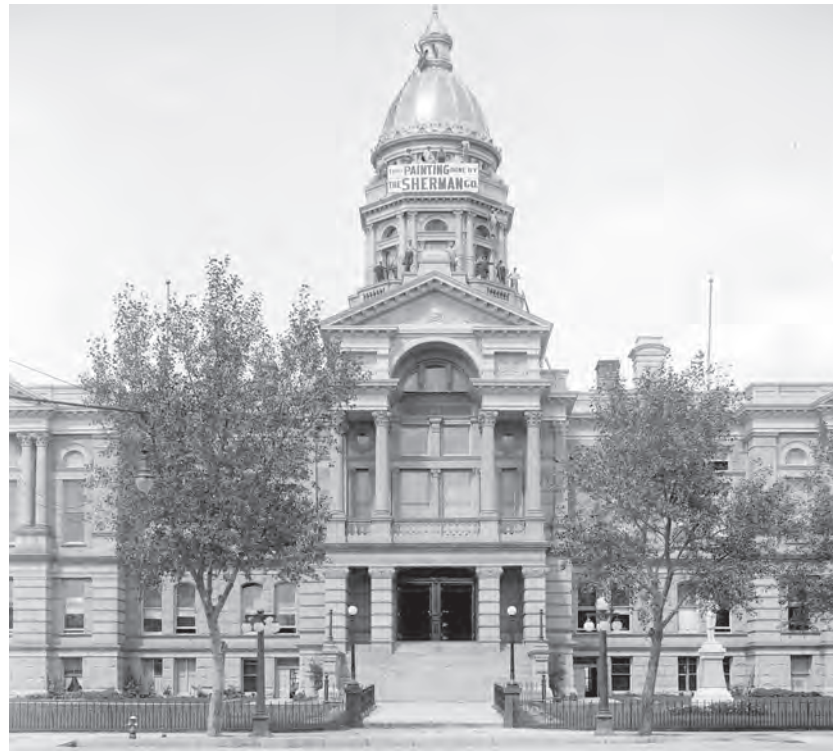
Figure O.73. ca. 1915-1916 South Entrance

In 1914, The Capitol Building Commission reported installation of “cluster lights” on the north side of the capitol. This view of the south entrance believed ca. 1915-1916 shows cluster lights. Cluster lights in this form are seen in catalogs as early as 1903. Figure O.74 is a close-up view of the south entrance illustrating three different postlights in use at that time.

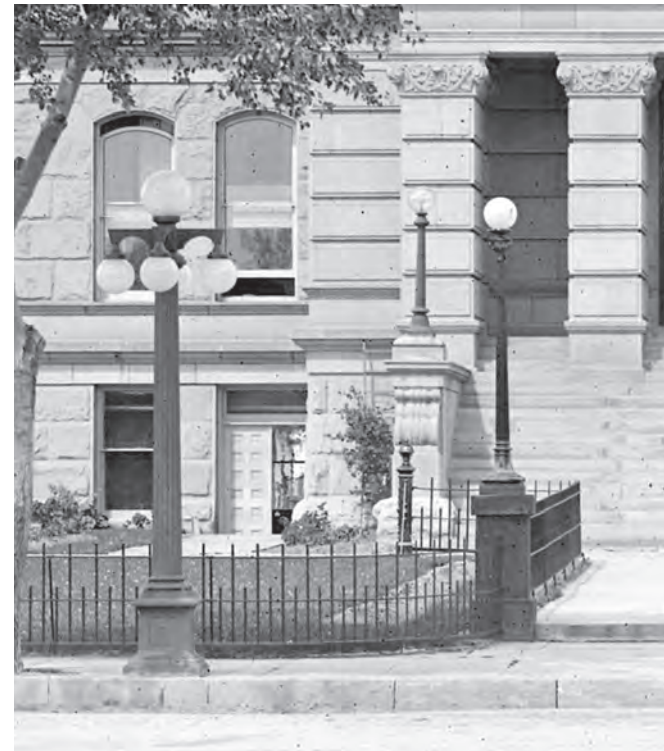
Figure O.74. ca. 1915-1916 South Entrance

The curb line drop-off area was illuminated with cluster postlights using opal globes and, likely, incandescent filament lamps. This appears to be a Union Metal postlight (Figure O.75). Gate standards define the site proper. Stair standards are shown more clearly in Figure O.76.

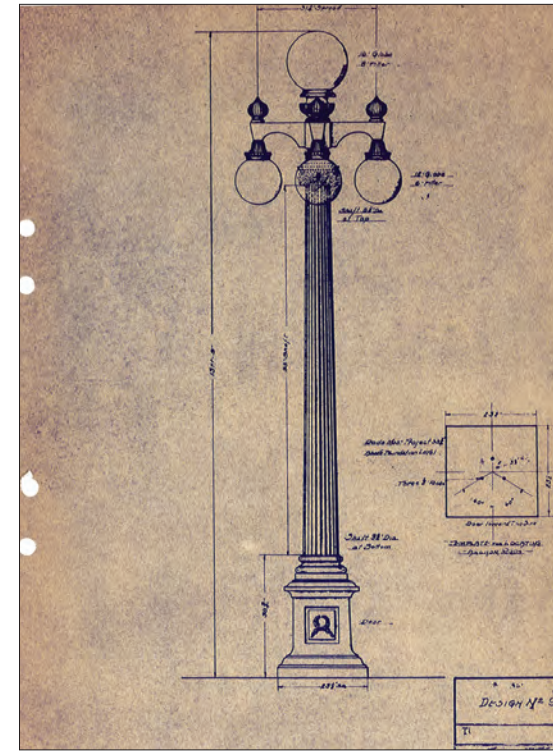
Figure O.75. ca. 1913 Union Metal Drawing

The cluster lights seen in Figures O.73 and O.74 are believed to be this model from Union Metal's archives ca. 1913. The ornaments on top of the arms were, apparently, not ordered or were removed after installation. The wreath is a Union Metal mark.

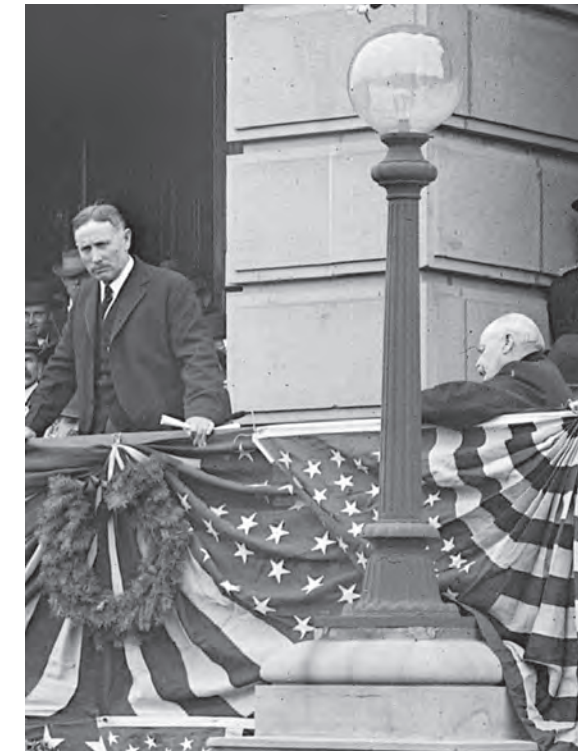
Figure O.76. 1915 Kendrick Inauguration

The light standards on the stair plinths exhibit an unusual clear glass globe, through which can be seen an incandescent filament lamp.

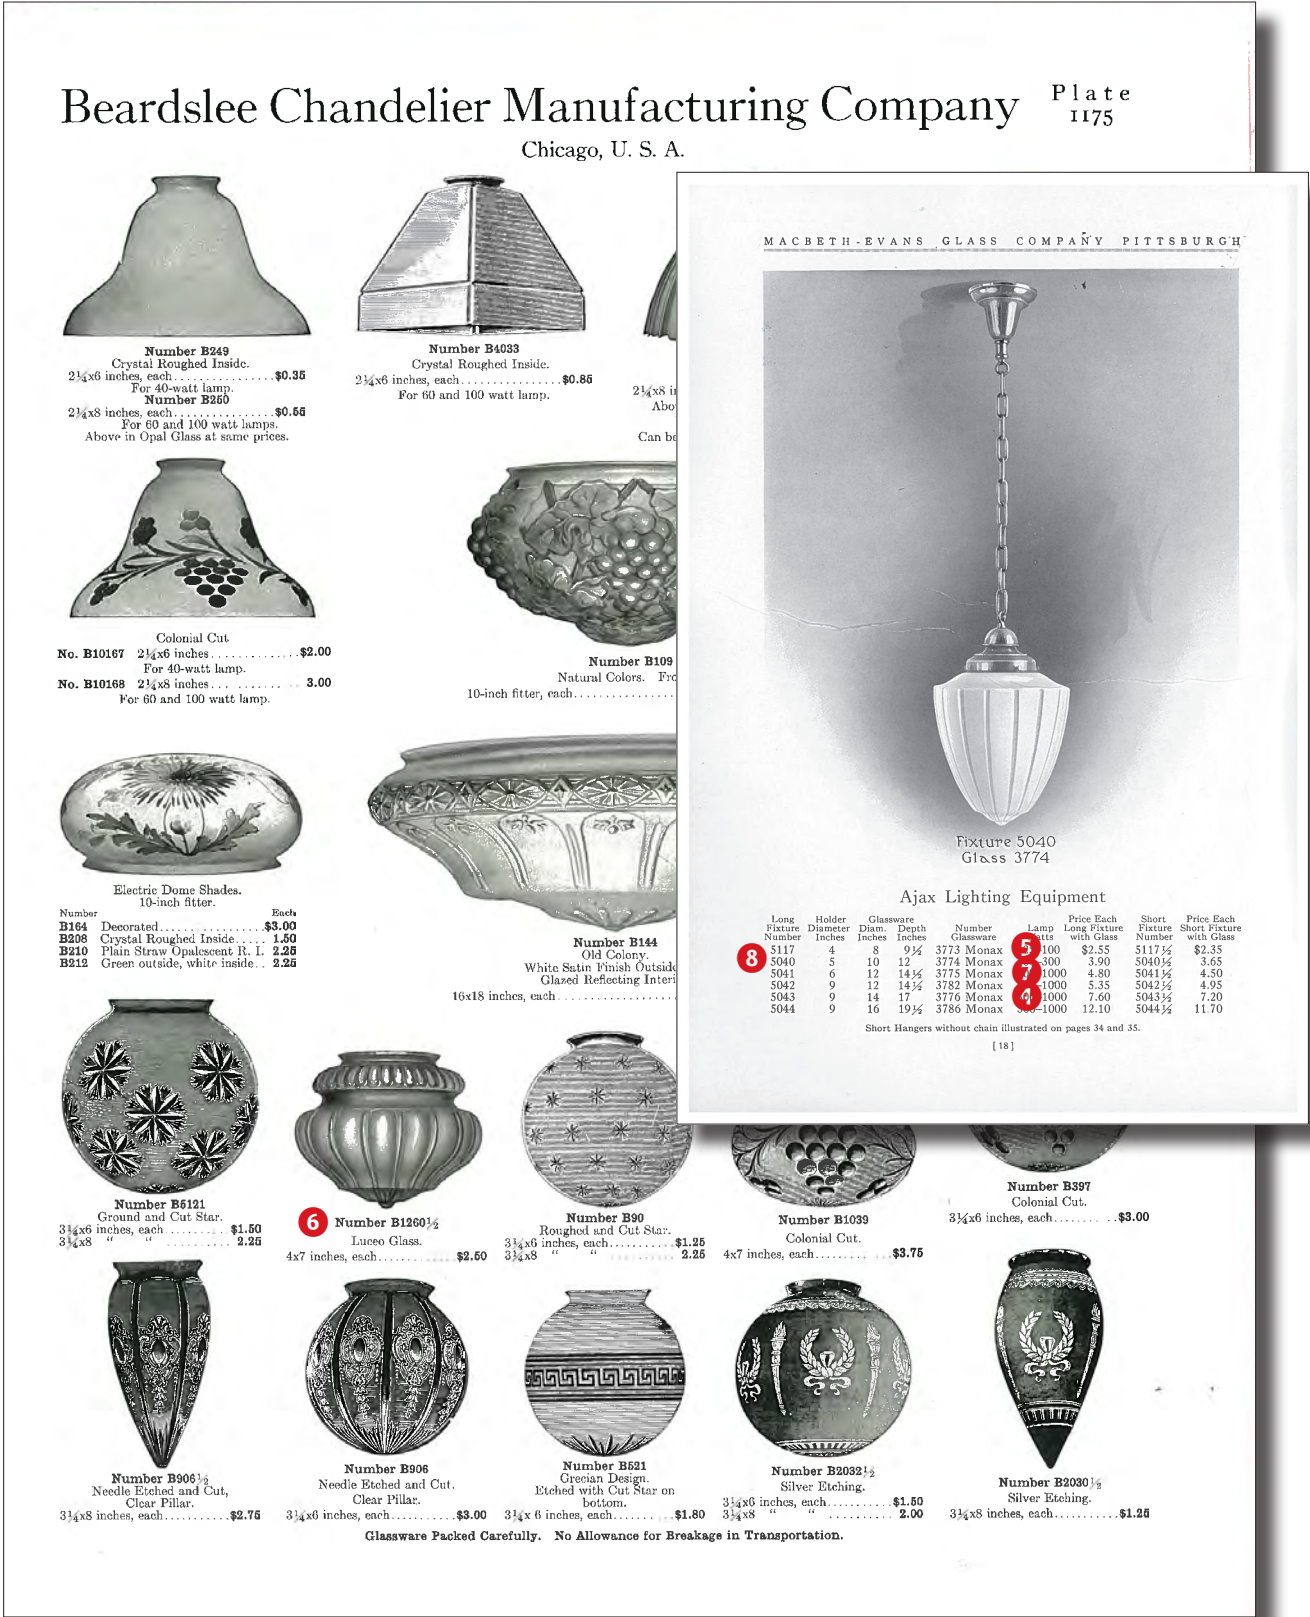
Figure O.78. 1915 Beardslee Catalog No. 22 Shade Plate 1175 and 1910 Macbeth-Evans Alba Shade Reference (inset)
The Beardslee Catalog page and the Macbeth-Evans Catalog page (inset) identifies/corroborates the shades on many extant pendants, surface mounts, chandeliers and wall brackets (see Table O.6).

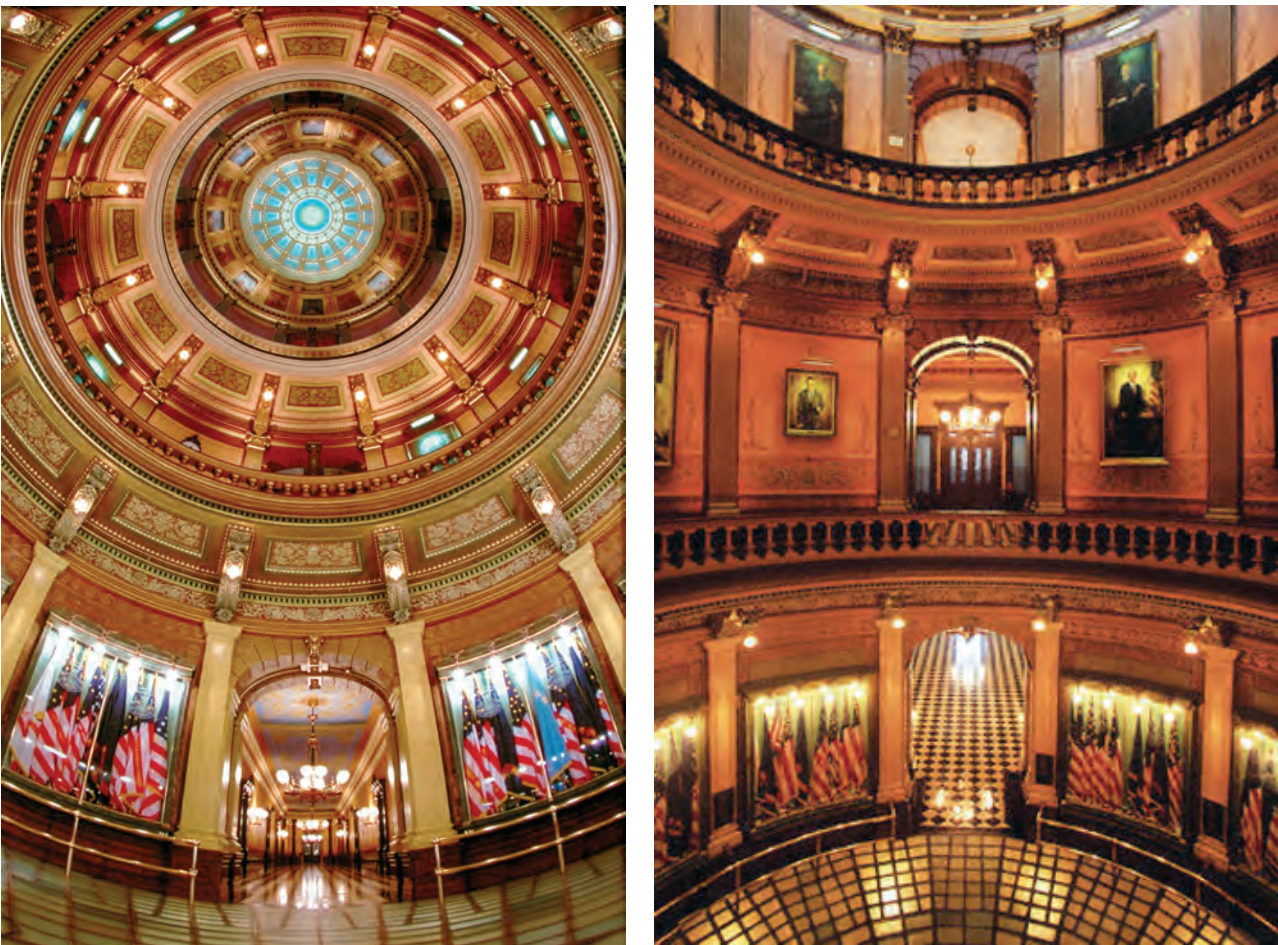
Figure O.79. 1879 Michigan Capitol Flag Displays and Governors' Portraits

The image on the left is a fish-eye view of the rotunda with the displays of replica flags. Historic flags are kept in dark storage. The image on the right is a more conventional view of the rotunda with better depiction of the UV-filtered picture lights used to illuminate portraits in a historically-sympathetic manner (commercially-available picture lights can be found in the literature at the turn of the 20th century). Picture lights have the benefit of always fixing the light onto the same location on the artwork without relying on re-aiming (or misaiming) by maintenance or curatorial personnel, as readily happens with adjustable art accent lights.

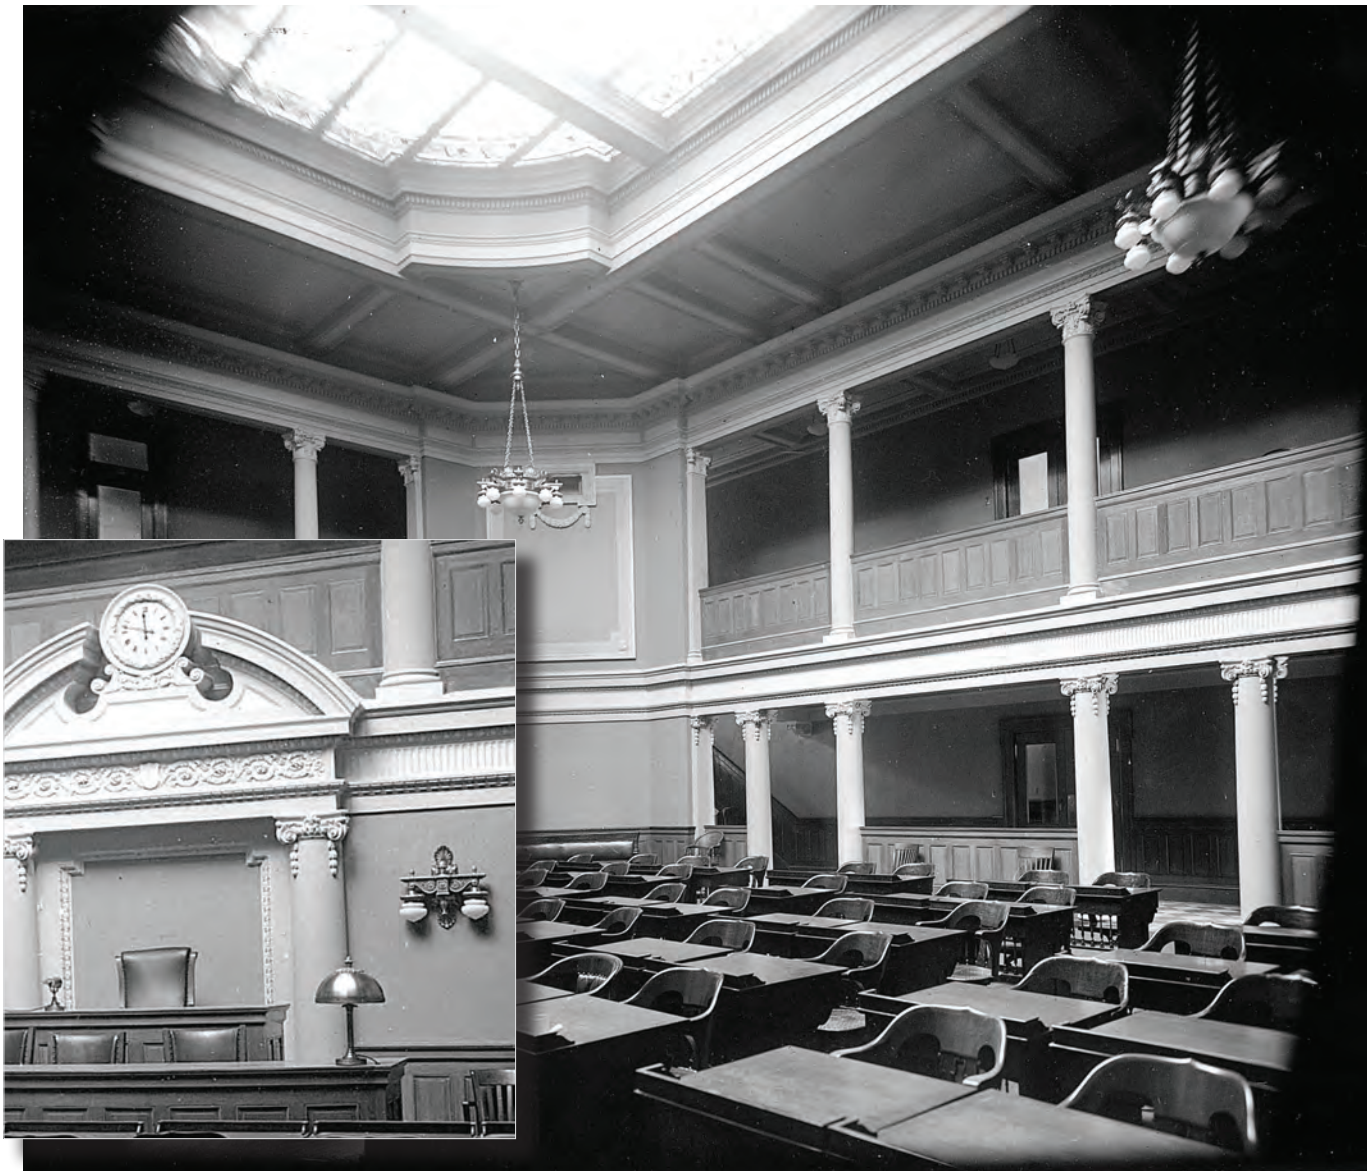
Figure O.82. ca. 1918 House Chamber | Basis for Recommended Lighting Work

The salient components of lighting work recommended to achieve an overall functional, aesthetic, and historically-sympathetic restoration for the House Chamber are based on Phase 3/1918 and outlined in the accompanying text on House Chamber.

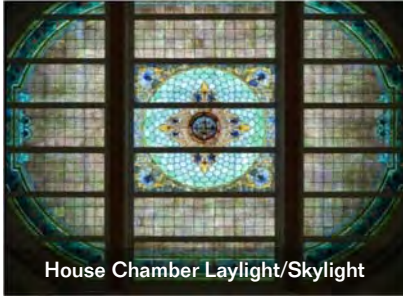
House Chamber Laylight/Skylight	<ul style="list-style-type: none">▶ Restore laylight lantern for more functional electric light and daylight<ul style="list-style-type: none">▷ Redesign upper-most skylight glazing to higher transmittance▷ Redesign lantern protective layer to near-clear higher transmittance▷ Redesign maintenance access to eliminate shadowing▶ Introduce automated shading system<ul style="list-style-type: none">▷ Control daylight glare and night spill light▶ Introduce tunable LED floodlights at perimeter of interstitial space<ul style="list-style-type: none">▷ Contribute functional light to chamber for night sessions▷ Photocell control to respond to daylighting▷ Replay dynamics and whiteness of daylighting at night for sessions

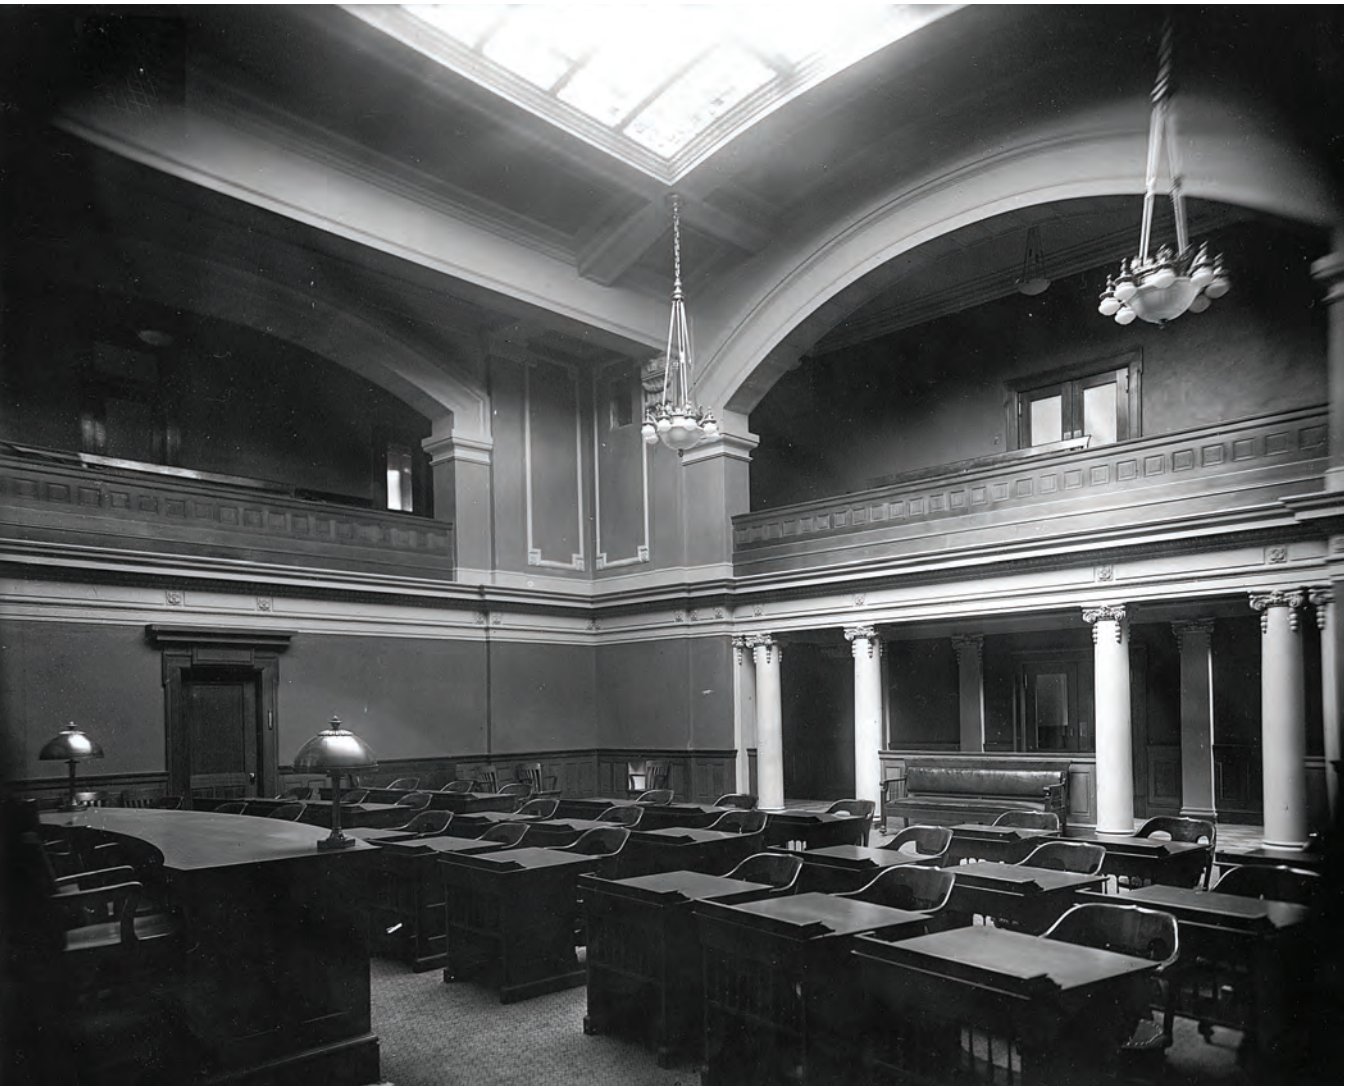
Figure O.96. ca. 1918 Senate Chamber | Basis for Recommended Lighting Work
The salient components of lighting work recommended to achieve an overall functional, aesthetic, and historically-sympathetic restoration for the Senate Chamber are based on Phase 3/1918 and outlined in the accompanying text on Senate Chamber.

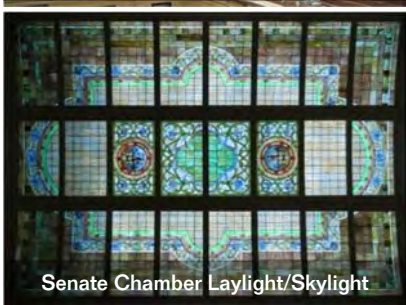
Senate Chamber Laylight/Skylight	<ul style="list-style-type: none">▶ Restore laylight lantern for more functional electric light and daylight<ul style="list-style-type: none">▷ Redesign upper-most skylight glazing to higher transmittance▷ Redesign lantern protective layer to near-clear higher transmittance▷ Redesign maintenance access to eliminate shadowing▶ Introduce automated shading system<ul style="list-style-type: none">▷ Control daylight glare and night spill light▶ Introduce tunable LED floodlights at perimeter of interstitial space<ul style="list-style-type: none">▷ Contribute functional light to chamber for night sessions▷ Photocell control to respond to daylighting▷ Replay dynamics and whiteness of daylighting at night for sessions					O.107.

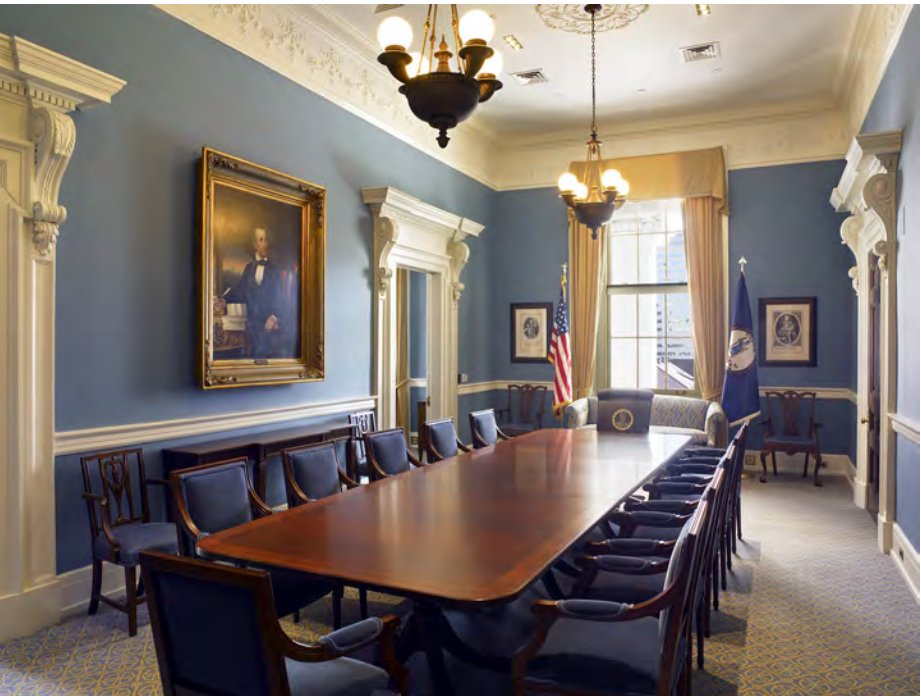
Figure O.128. Ceremonial Conference Room | Discreet Accent Lighting

The Governor's Ceremonial Conference Room at the Virginia Capitol is fitted with re-created historic luminaires from the period of significance (1906) with discreet linear accent lights for fill and focal lighting (barely visible in the top of the photo just to the left and right of the chandelier ceiling medallion).

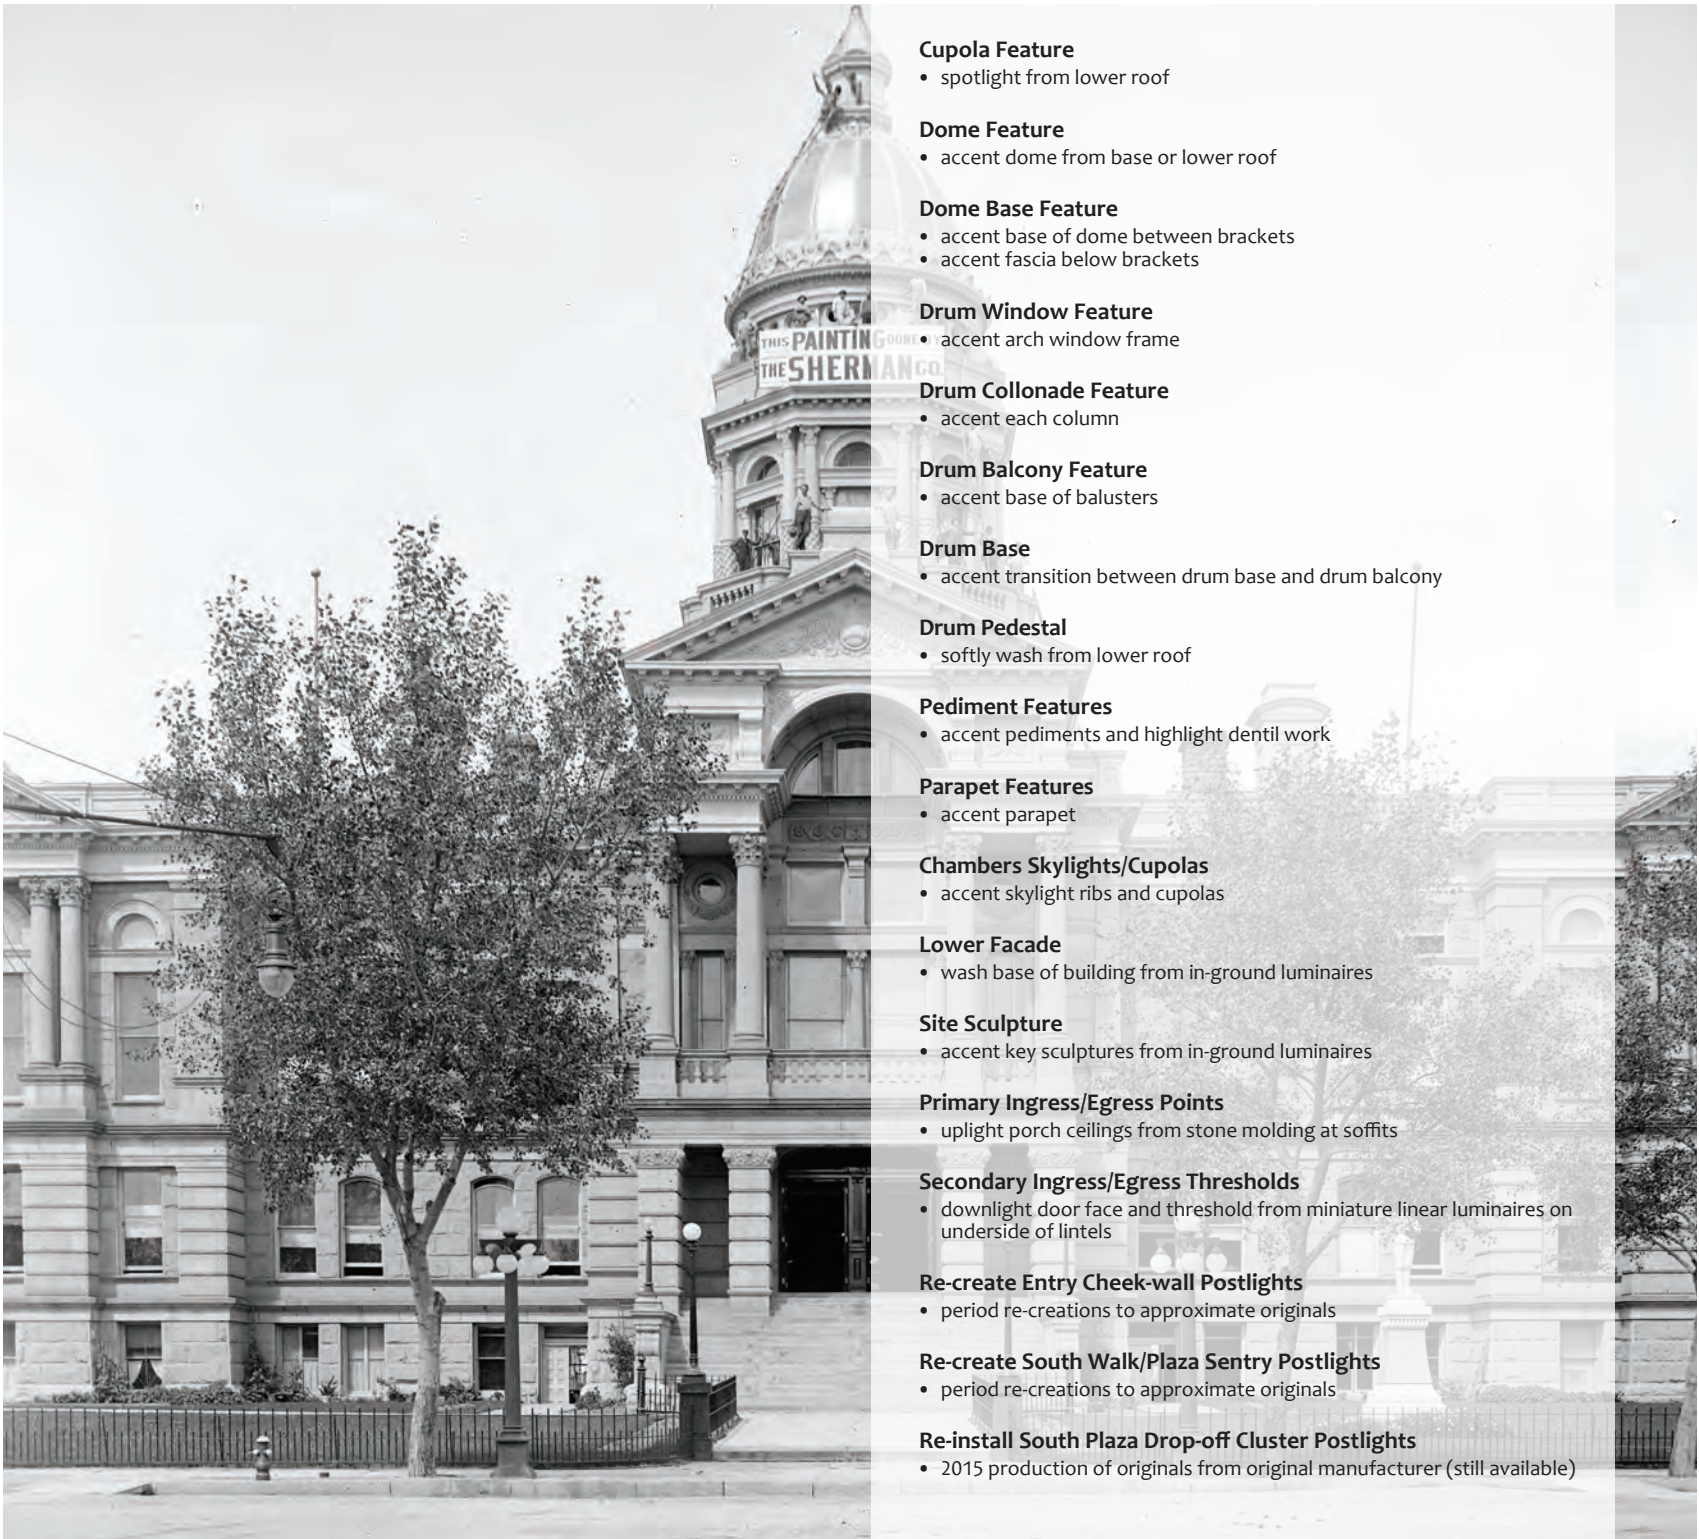
Figure O.129. ca. 1915 South Site and Facade | Outlining Recommended Lighting Work

The salient components of lighting work recommended to achieve an overall functional, aesthetic, and historically-sympathetic restoration for the site and facade are identified. The photograph illustrates historically-appropriate lighting hardware for a 1918 period of significance. None of this equipment survives. See Figures O.74 and O.76 for detailed views of post lights. Figure O.130 illustrates two preliminary facade lighting schemes based on the recommended lighting work identified above.

Based on the lighting work outlined in Figure O.129, two preliminary facade lighting studies are illustrated. The top image illustrates the effects of the integration of small very-long-life LED luminaires onto the dome proper and at the base of the roof parapet to highlight these architectural features. The top image also illustrates the effects of integrating larger very-long-life LED spot- and flood-light luminaires at key positions on the roof and ground. This results in visual articulation of much of the facade architecture at night. In the bottom image, the small LED luminaires have been removed at the dome proper and the roof parapet along with accents at the skylight structures, resulting in a more traditional lower cost facade lighting approach. In any event, these LEDs use controlled-beam optics and are dimmable to respect the dark-sky. Switching off some lighting and dimming others at a predetermined curfew and shading windows and skylights at night contribute to an improved dark-sky condition during the period of astronomical twilight. In both images, window- and skylight-shades are deployed which further reduces light spill and limits the opportunity of unwanted surveillance.
