Section 4 : Historic Analysis

WYOMING STATE CAPITOL
LEVEL I / LEVEL II STUDY

HISTORIC EVOLUTION
DOCUMENTATION

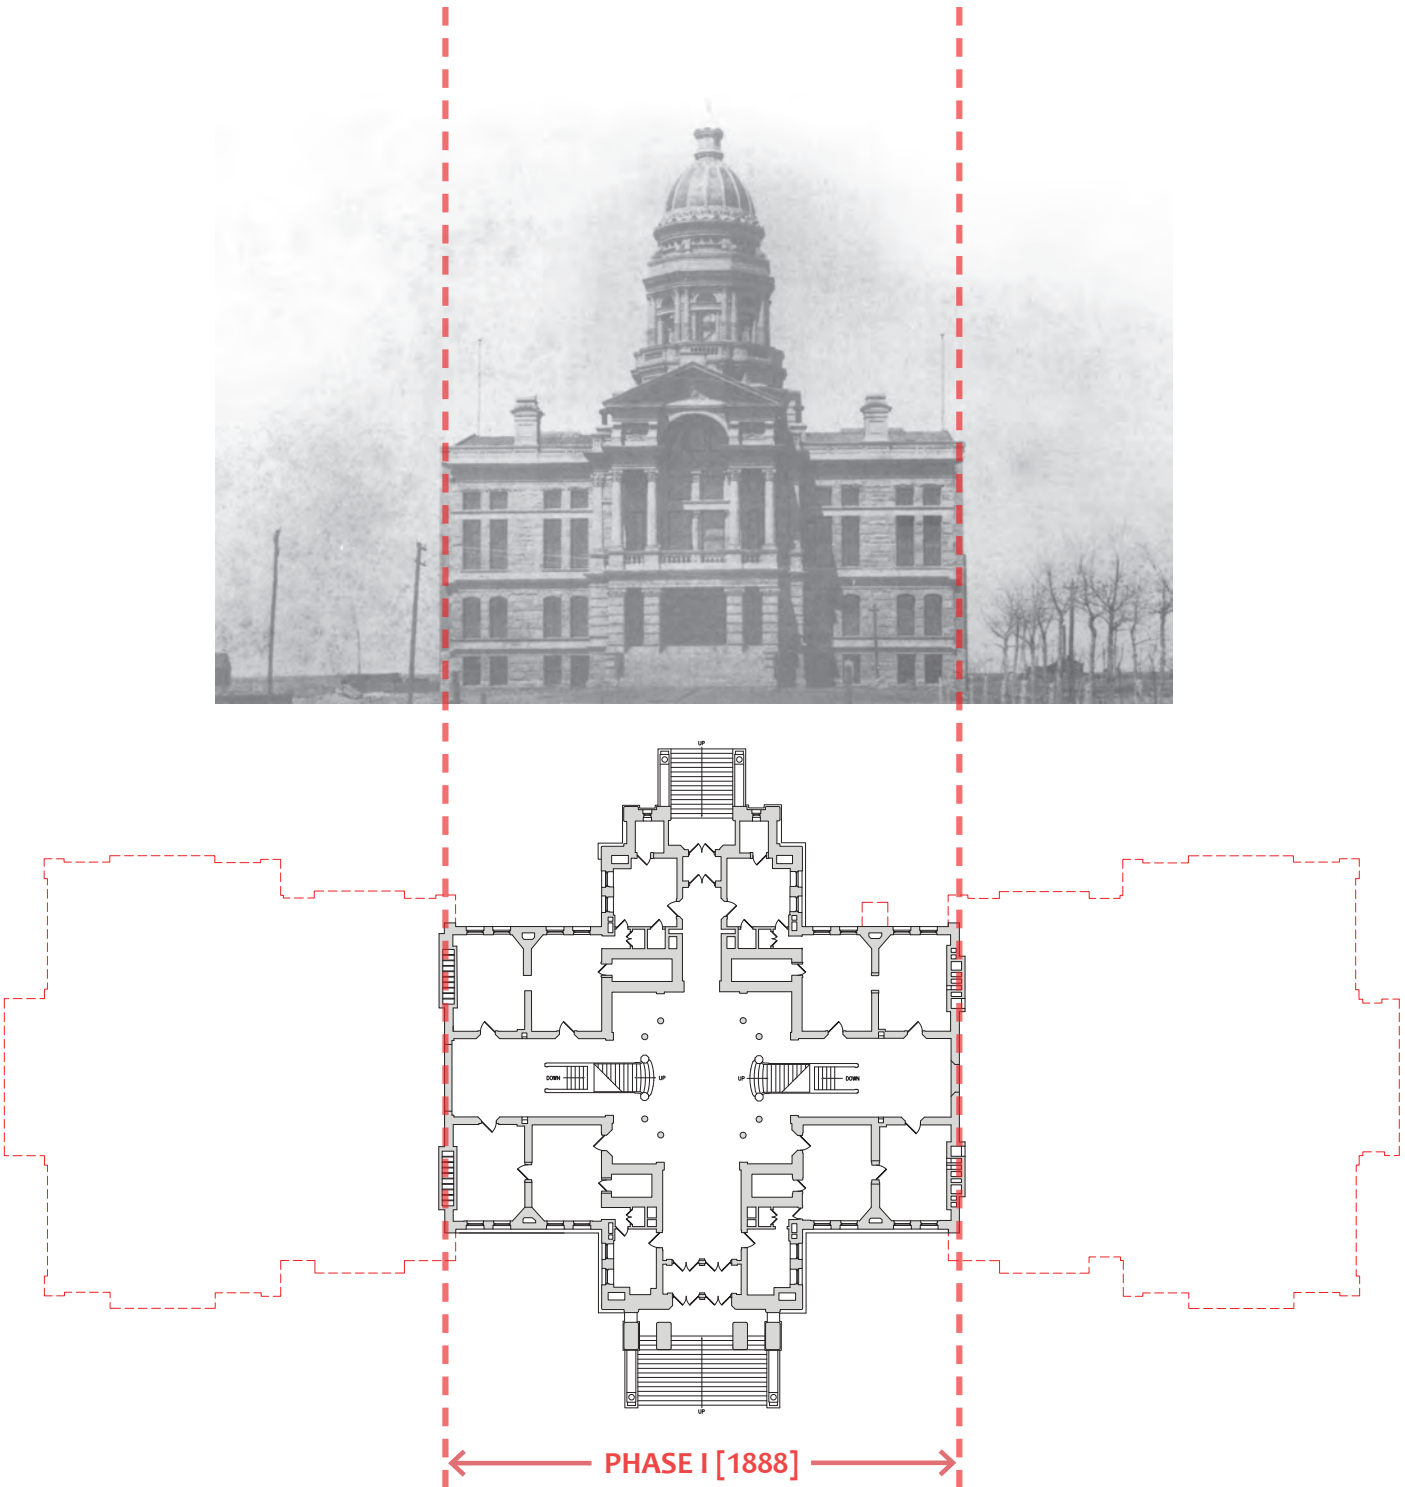
Figure 4.10: Phase I [1888] First Floor Plan & Historic Photograph of South Elevation, ca. 1888.

Originally designed by **David W. Gibbs & Company** of Toledo, Ohio, the Renaissance Revival building was intended as one building to be constructed in two successive phases. The first phase, completed in 1888 by Adam Feick & Brother of Sandusky, Ohio, was a cruciform shaped structure topped with a copper dome designed in the spirit of the U.S. Capitol dome in Washington, D.C. Openings at the east and west end walls were designed as part of the Phase I project to connect the first phase of construction with the second phase. The openings were infilled with brick in order to keep the building weathertight until the Phase II project was constructed. In the interior, these openings were slightly recessed and finished similar to the adjacent openings with wood trim and splayed plaster jambs.

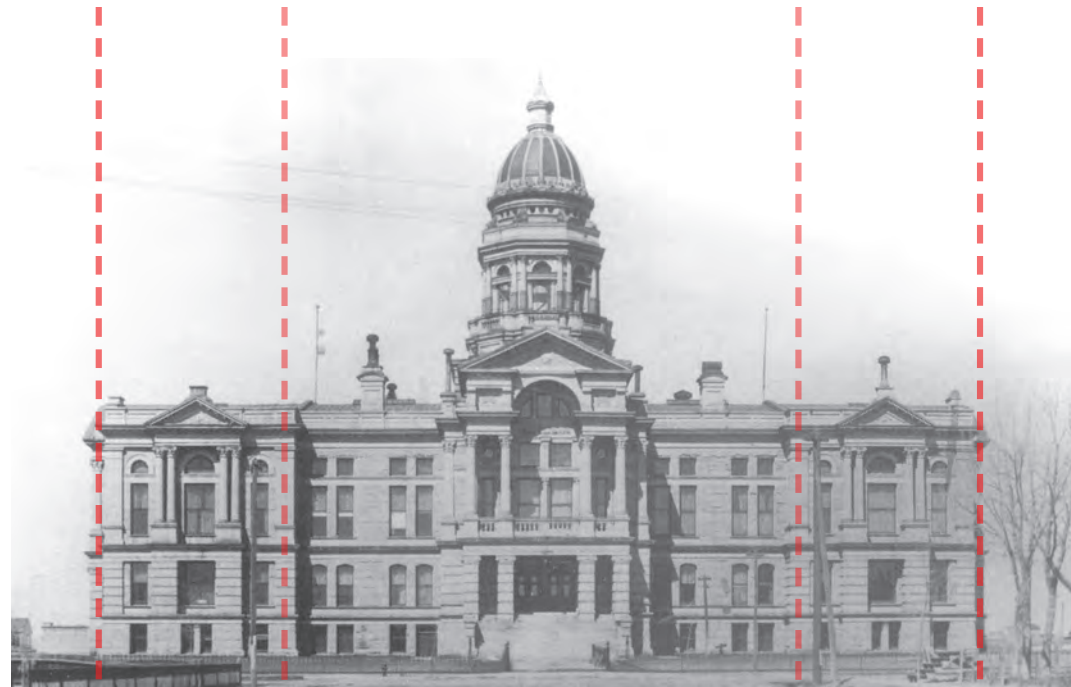
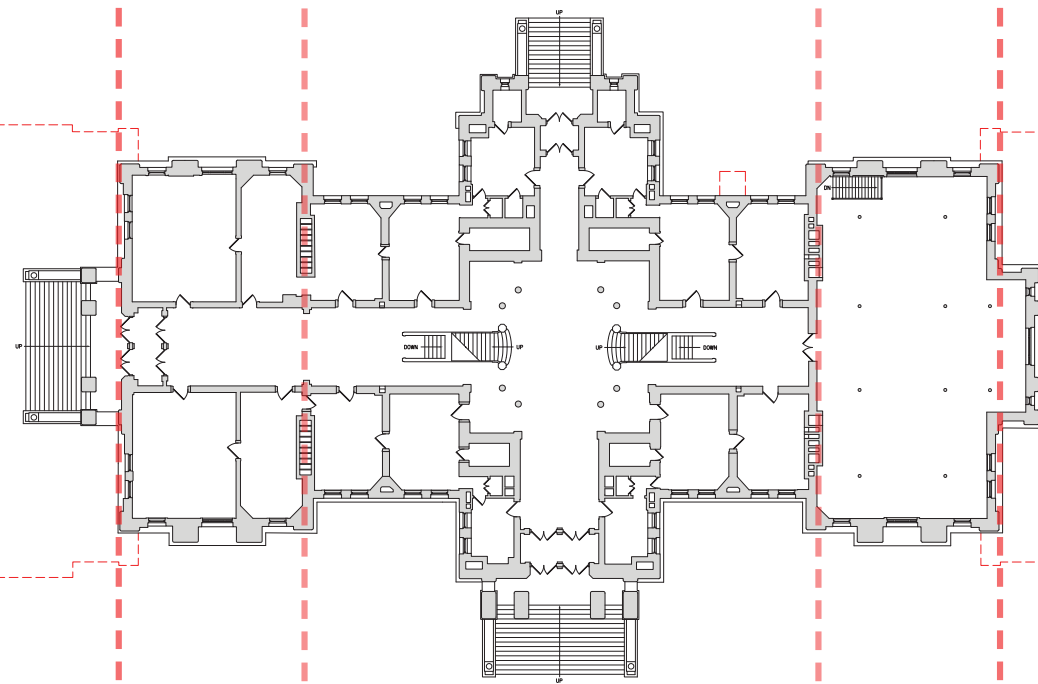
PHASE II [1890]

Figure 4.11: Phase II [1890] First Floor Plan & Historic Photograph of South Elevation, ca. 1890.

Almost immediately after the completion of the first phase in 1888, construction on the second phase commenced to add two wings at the east and west. The wings provided space for the State Library, the original House and Senate Chambers, as well as additional office space for the Capitol. Their completion coincided with Wyoming’s admittance to the Union as the 44th State three months later on July 10, 1890.

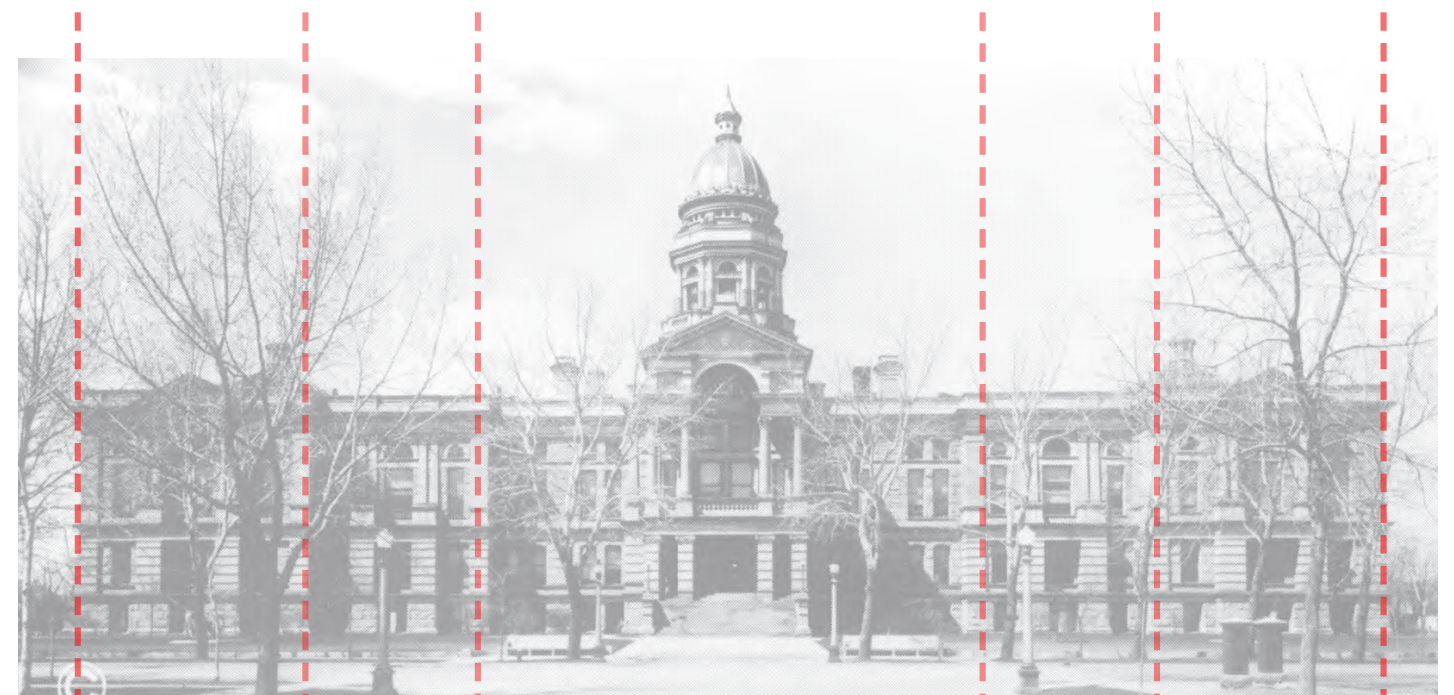
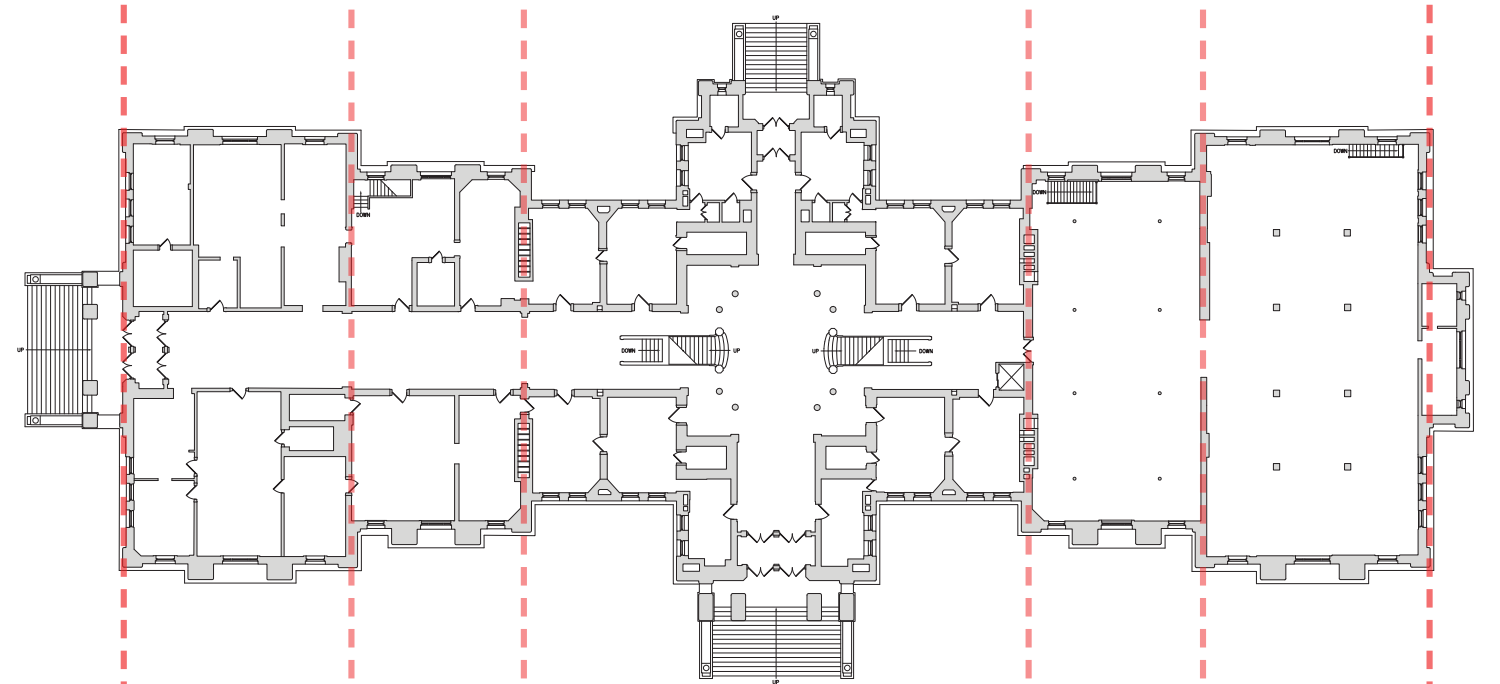
PHASE III [1917]

Figure 4.12: Phase III [1917] First Floor Plan & Historic Photograph of South Elevation, ca. 1917.

Despite the relative youth of the Capitol, the state was growing at an incredible rate and soon the structure had become overcrowded. During the first two decades of the 20th Century, due to favorable settlement laws and the burgeoning oil industry, the State of Wyoming’s population grew twice as fast as the national average. In 1915, the Thirteenth Legislature approved the design and construction of new additions to the east and west. Designed by **William DuBois** of Cheyenne and completed in 1917, the expansion provided new, larger House and Senate Chambers, as well as an increased number of committee rooms and executive office spaces. DuBois’ design attempted to retain the existing architectural features of the initial two phases designed by Gibbs; the Phase II east and west porticos were removed and facsimiles were designed proportionate to the new, larger east and west wings. The final form of the Capitol is a building that appears to be of one construction phase, as seen today.

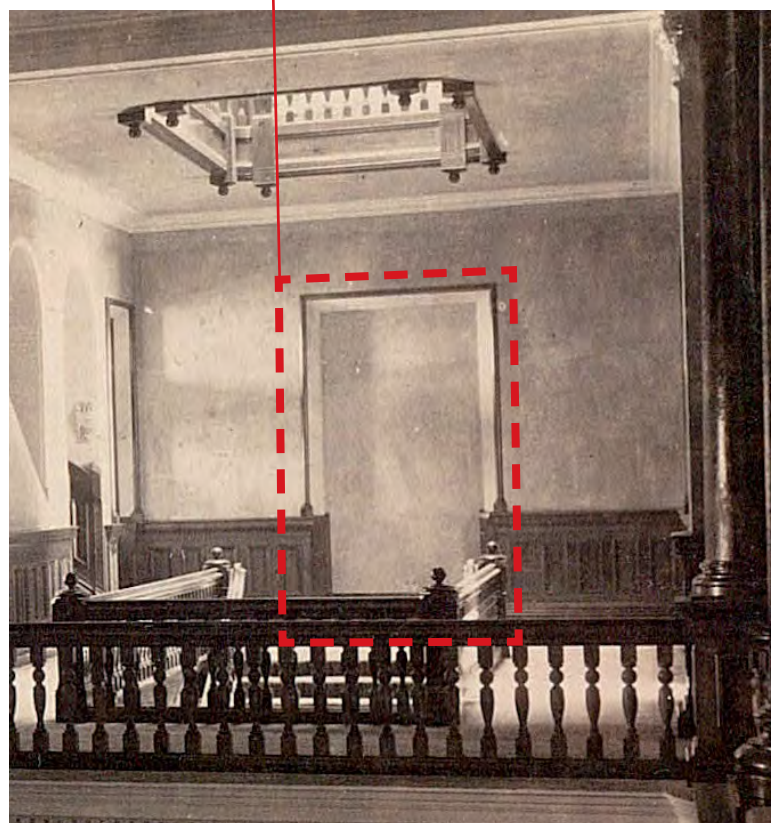
Figure 4.16: Post-Construction Photograph of Phase I Construction, Showing the Infilled and Framed Interior Openings Connecting the Phase I Wing with the Yet-To-Be Constructed Phase II Addition, ca. 1888.

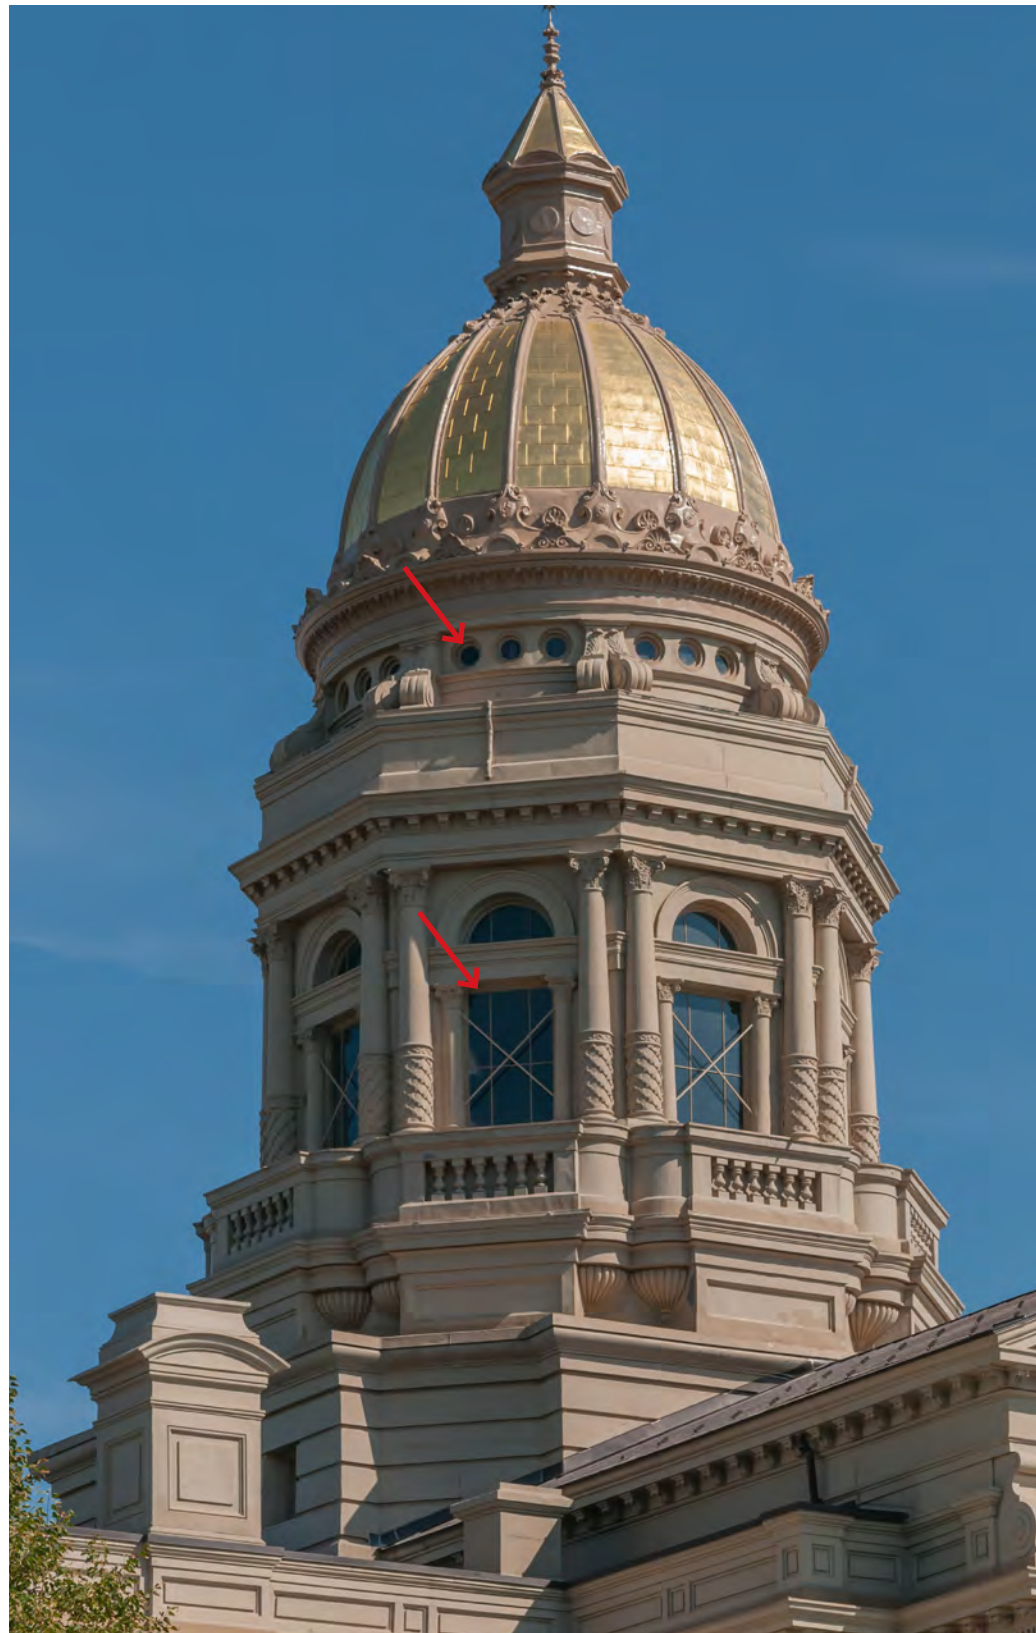
Figure 4.19: Wyoming State Capitol Dome Exterior. Note the small porthole windows and the large rectangular windows that will require finishes analysis to verify the finishes of the frames and sashes in relation to the metal.

Regarding the windows, additional analysis would be needed. Both the porthole windows at the upper area of the Dome and the large rectangular windows in the drum of the Dome, need to be analyzed for contrasting [darker] paint. This choice was made to enhance the three dimensional qualities of the Dome’s design.

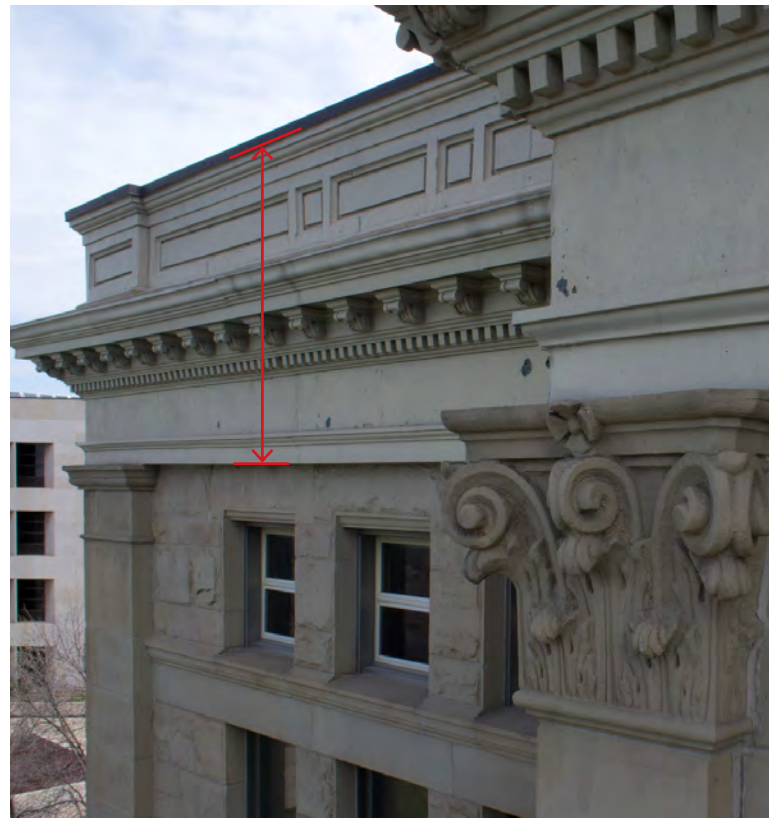
Figure 4.20: West Return of the North Portico. The building elements above the third story pilasters are galvanized metal originally sandpainted to simulate the adjacent masonry.

The **parapets** were constructed of metal – and not stone – and were finished in a similar fashion, i.e. sandstone color paint with the application of sand on the wet paint for texture.

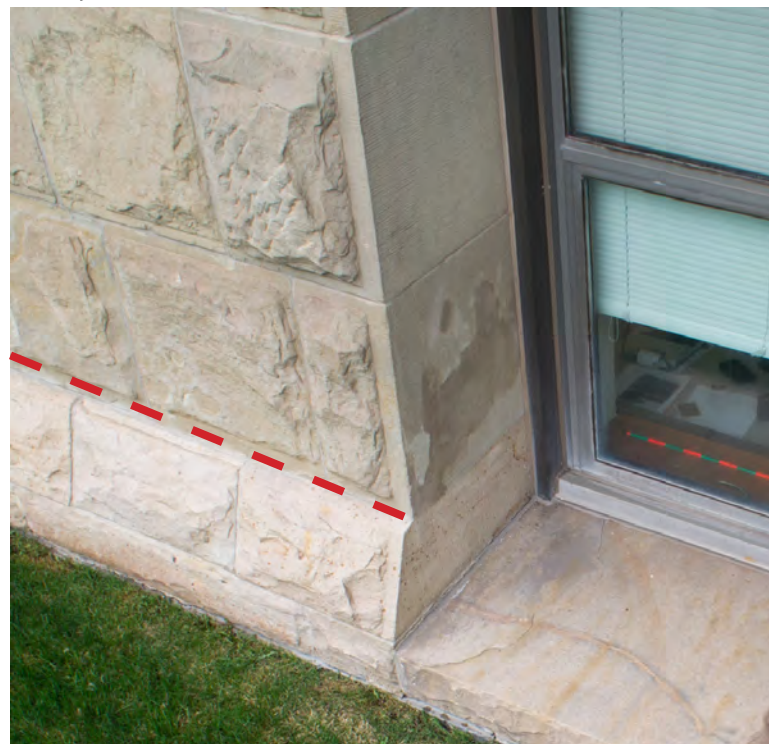
Figure 4.21: The First Two Courses of Sandstone, Below the Dashed Line are Buff/ Pink Sandstone from Fort Collins, Colorado. The remaining sandstone is quarried from Rawlins, Wyoming. Note the efflorescence at the jamb caused by the upward migration of groundwater through the stone.

- The first two [2] courses of stone at the base of the building are an iron-containing buff/pink sandstone from Fort Collins, Colorado.
- The remaining masonry walls [from the base to the parapet] are a gray sandstone quarried in Rawlins, Wyoming.

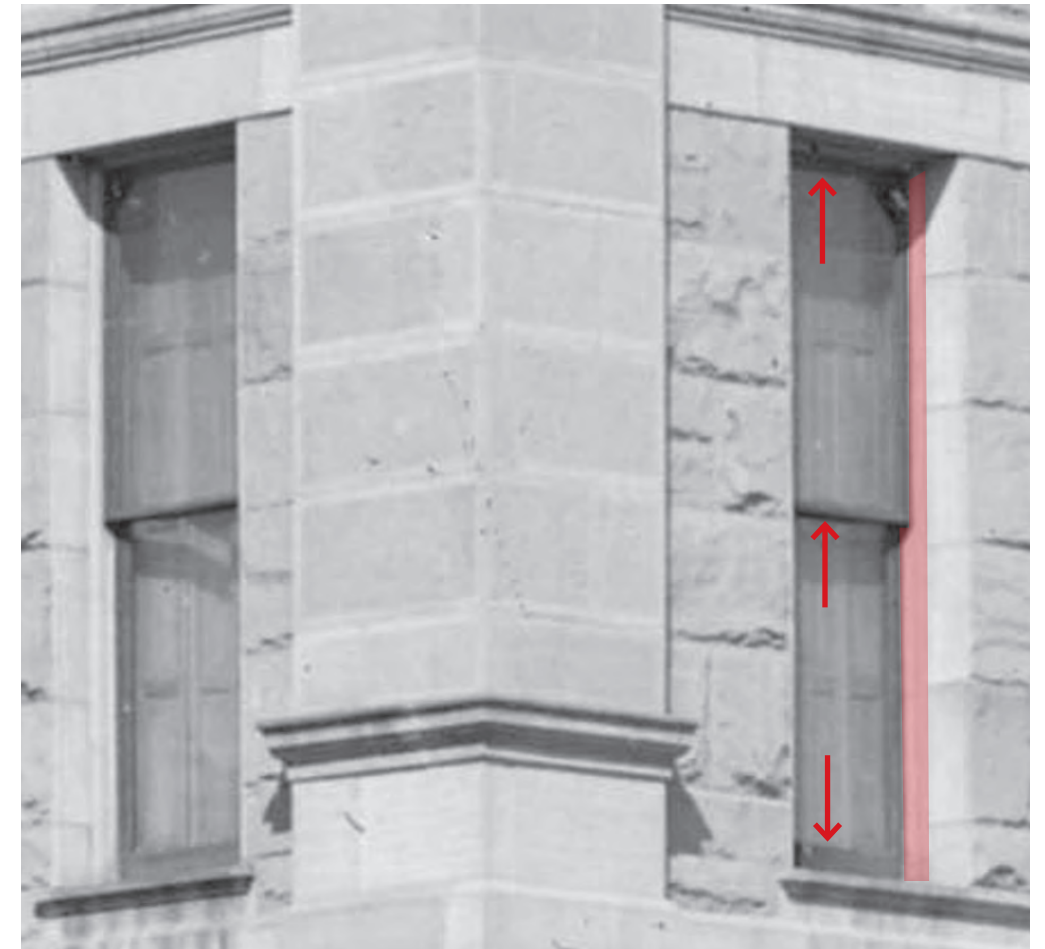
Figure 4.22: Detail of Original Wood Windows, ca. 1902. The sand colored frame is highlighted in red at right. The dark painted sash is indicated with the red arrows.

- The frames were painted in a sandstone color and sand painted, and;
- The sashes were finished in a Dark Olive or Bronze-Green paint along the exterior, and with three [3] coats of varnish along the interior.

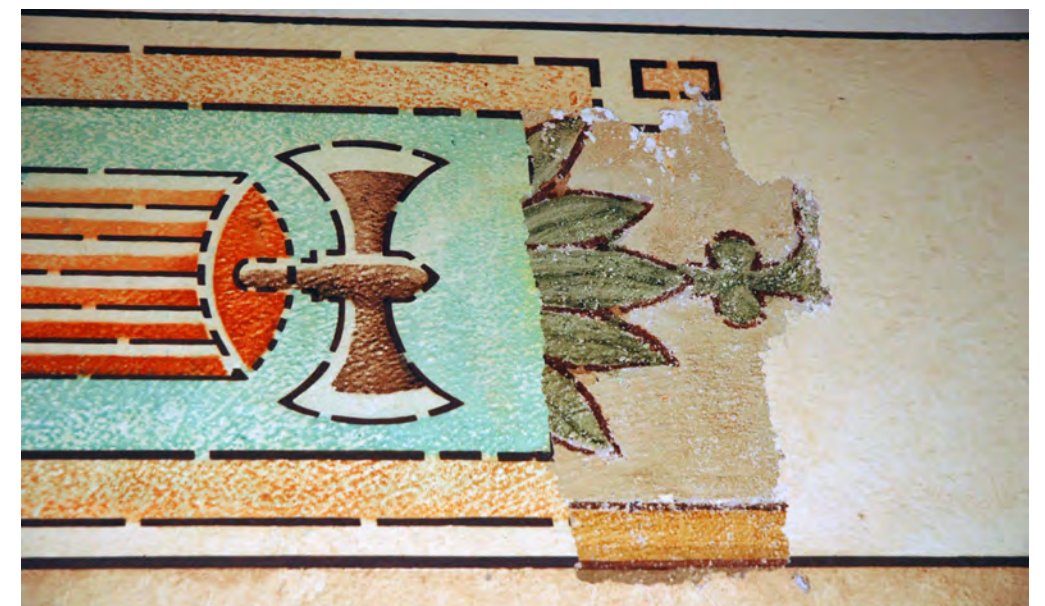
Figure 4.23: Finishes Exposure at the Third Floor Corridor. The existing decorative fascies design is seen on the left, and a historic motif at the right.

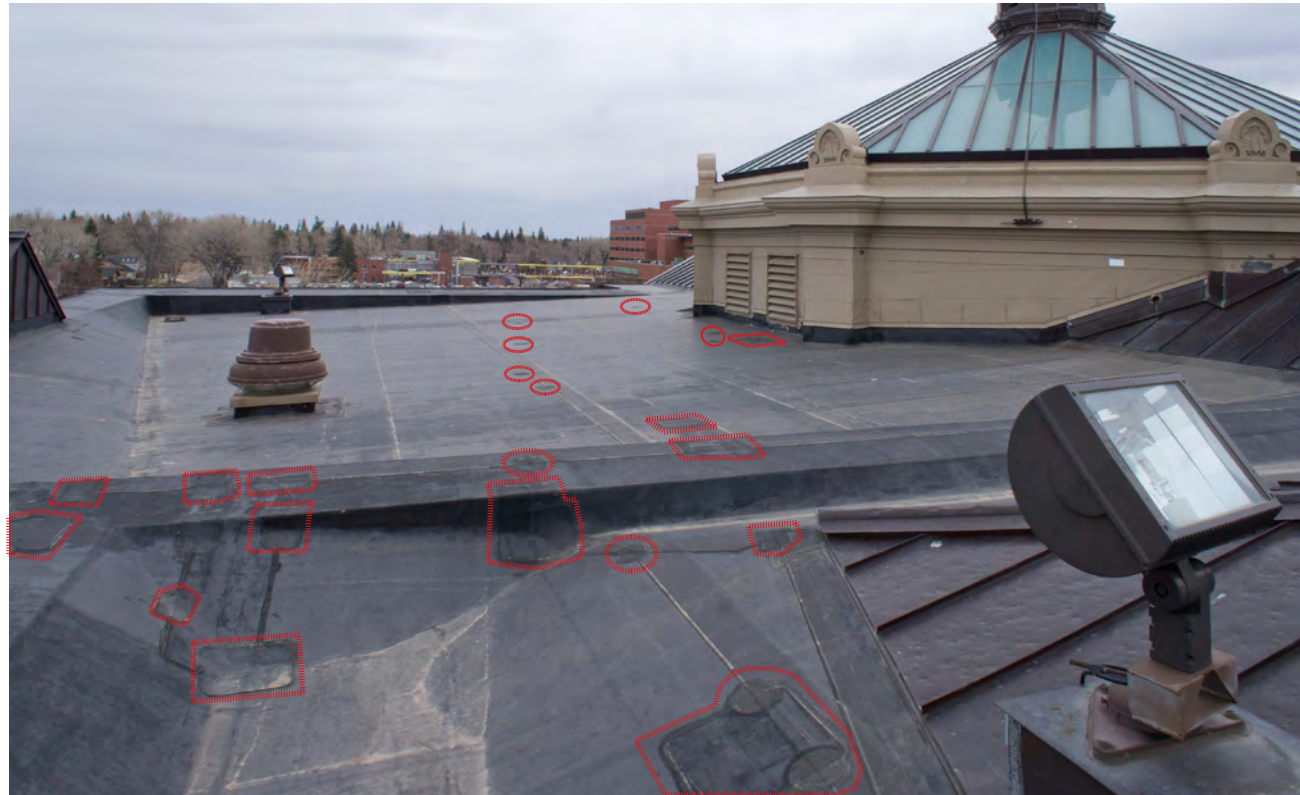
Figure 4.29: Multiple Patch Repairs to the Low-Slope EPDM Roof Membrane. Each of these patches represents a short term, “band-aid” repair installed by building maintenance since the roof was installed in 1999.

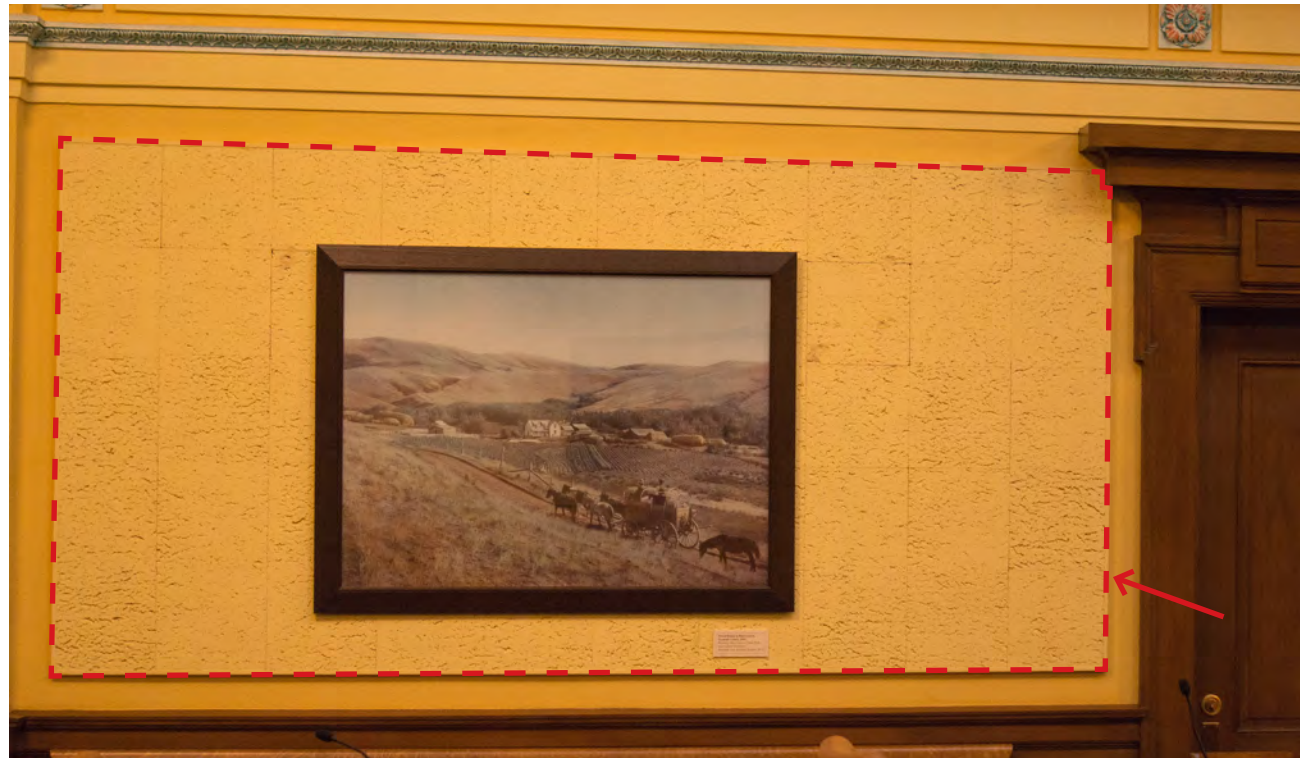
Figure 4.30: Acoustical Tile Panels Applied to the Plaster Wall Surfaces Throughout the Senate Chambers. The Installation of the Acoustical Tile Panels Dates to the 1974-1980 Interior Renovation Campaign.

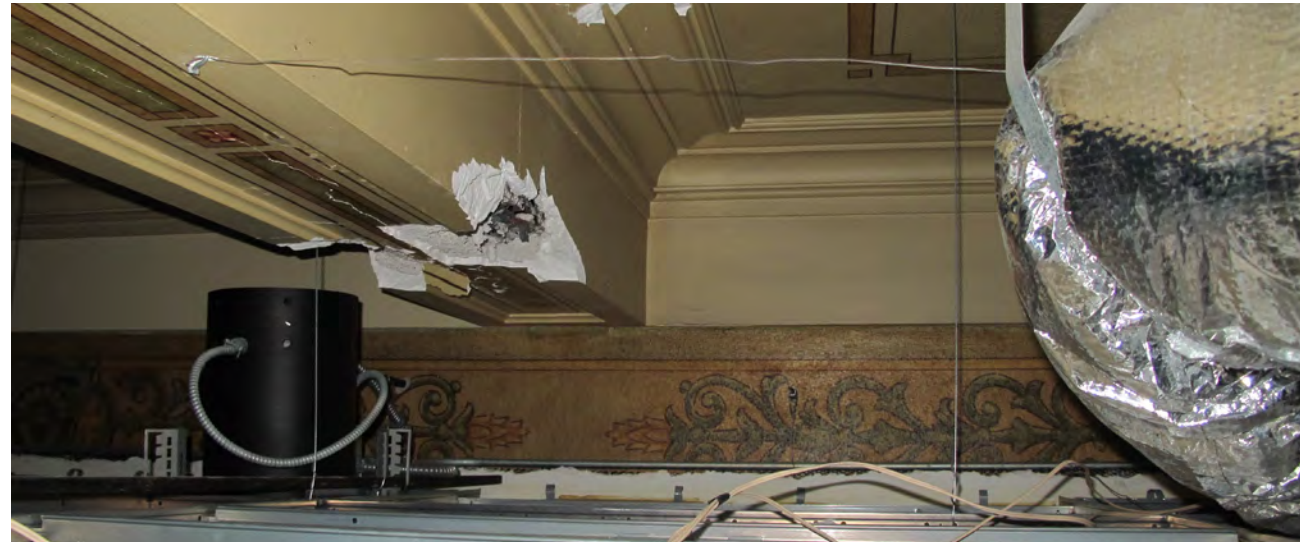
Figure 4.31: Historic Decorative Plaster and Finishes Covered Up and Damaged as a Result of the Installation of Suspended Acoustical Tile Ceilings During the 1974-1980 Interior Renovations. The plasterwork and finishes can be recaptured and restored as part of the rehabilitation and restoration.

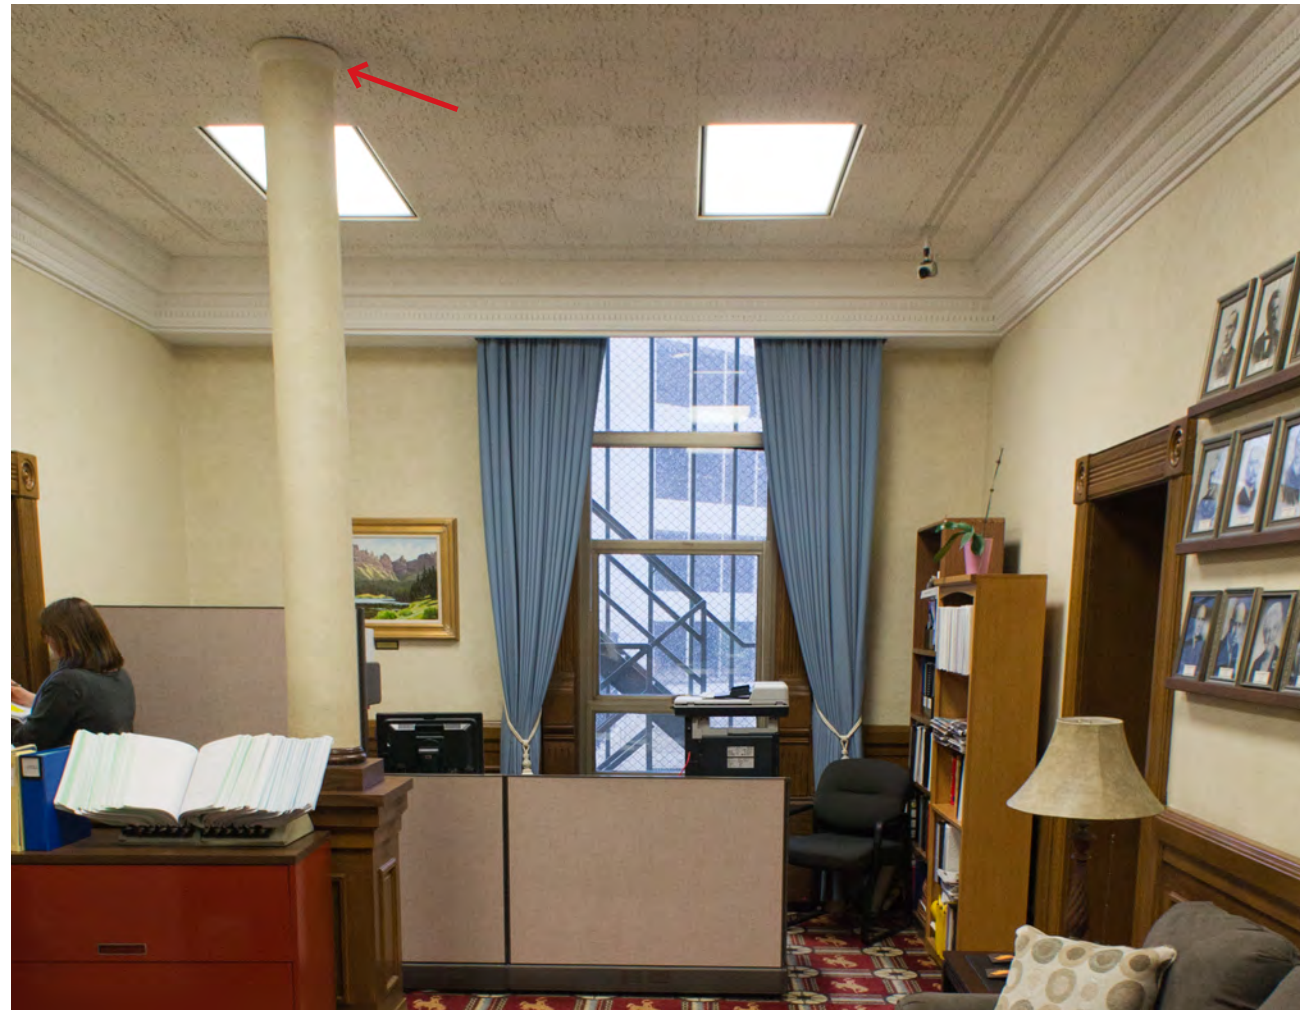
Figure 4.32: Original Phase II [1890] Cast Iron Column Capital Hidden From View By the Suspended Acoustical Tile Ceiling. This is an important condition, as significant historic fabric is covered by the suspended ceiling, including decorative finishes and trim.

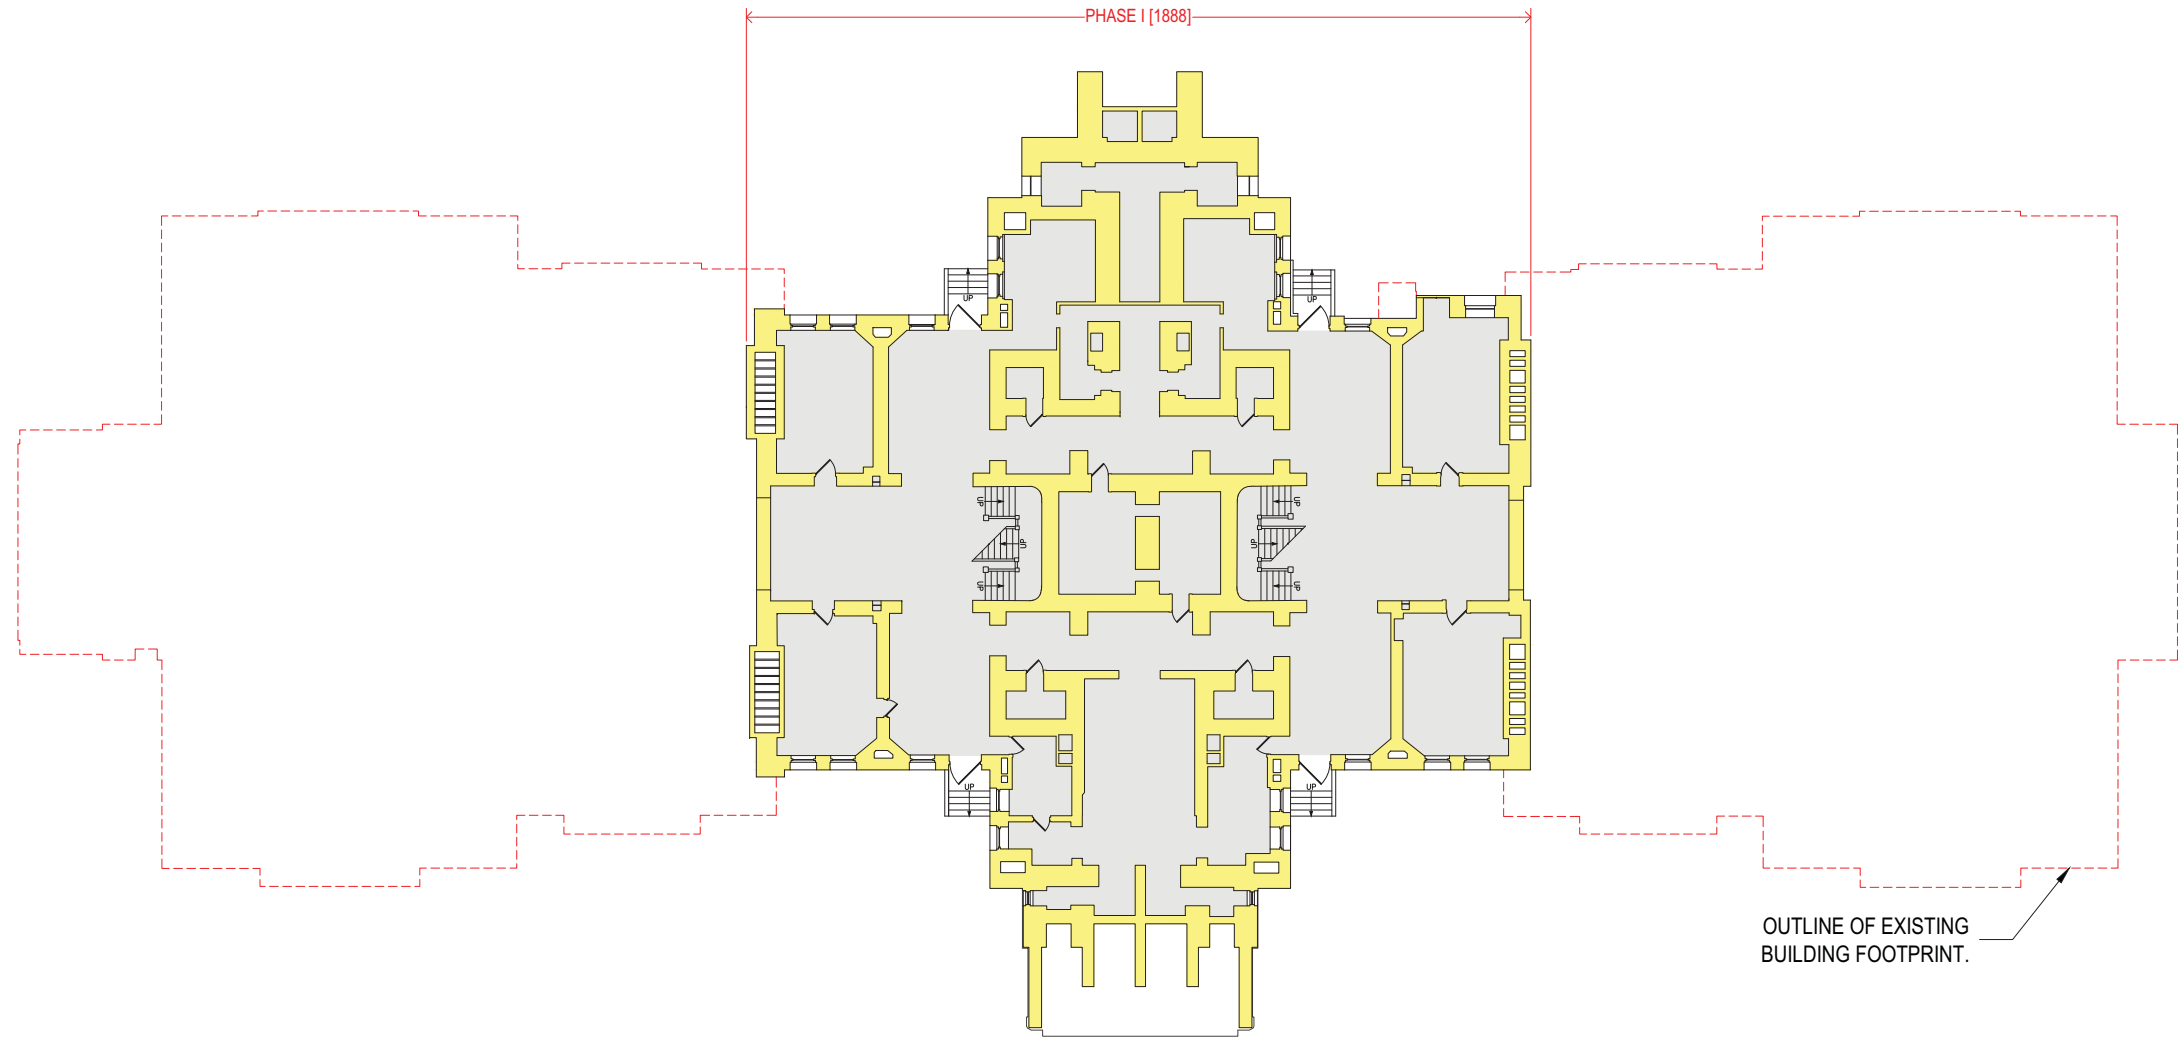
1 BASEMENT LEVEL PLAN
HE-101 3/32" = 1'-0"

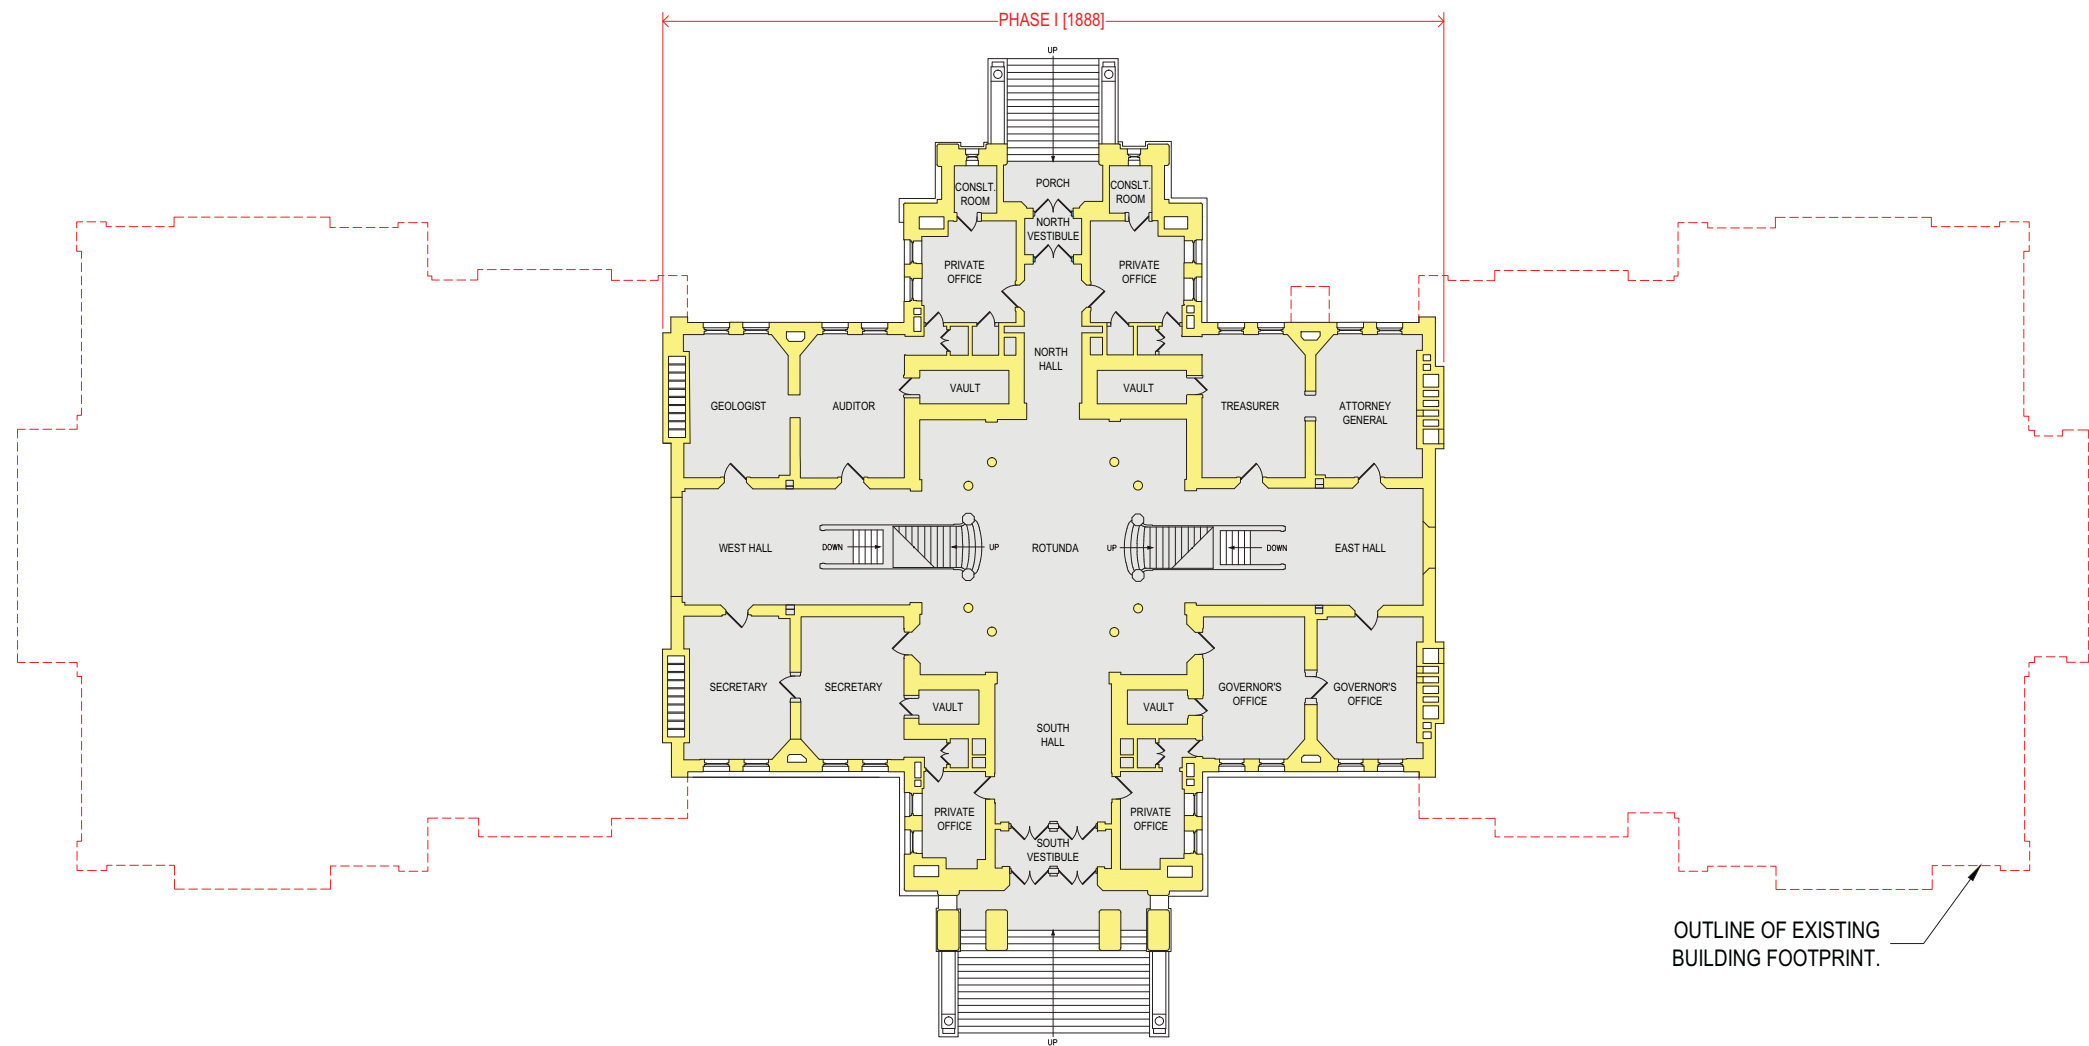
DRAWING NUMBER
HE-102

OUTLINE OF EXISTING
BUILDING FOOTPRINT.

1 FIRST FLOOR LEVEL PLAN
HE-102 3/32" = 1'-0"
