Appendix M : Life Safety and Fire Protection Assessment

WYOMING STATE CAPITOL REHABILITATION & RESTORATION

LEVEL I /LEVEL II LIFE SAFETY AND FIRE PROTECTION ASSESSMENT

24 FEBRUARY 2014

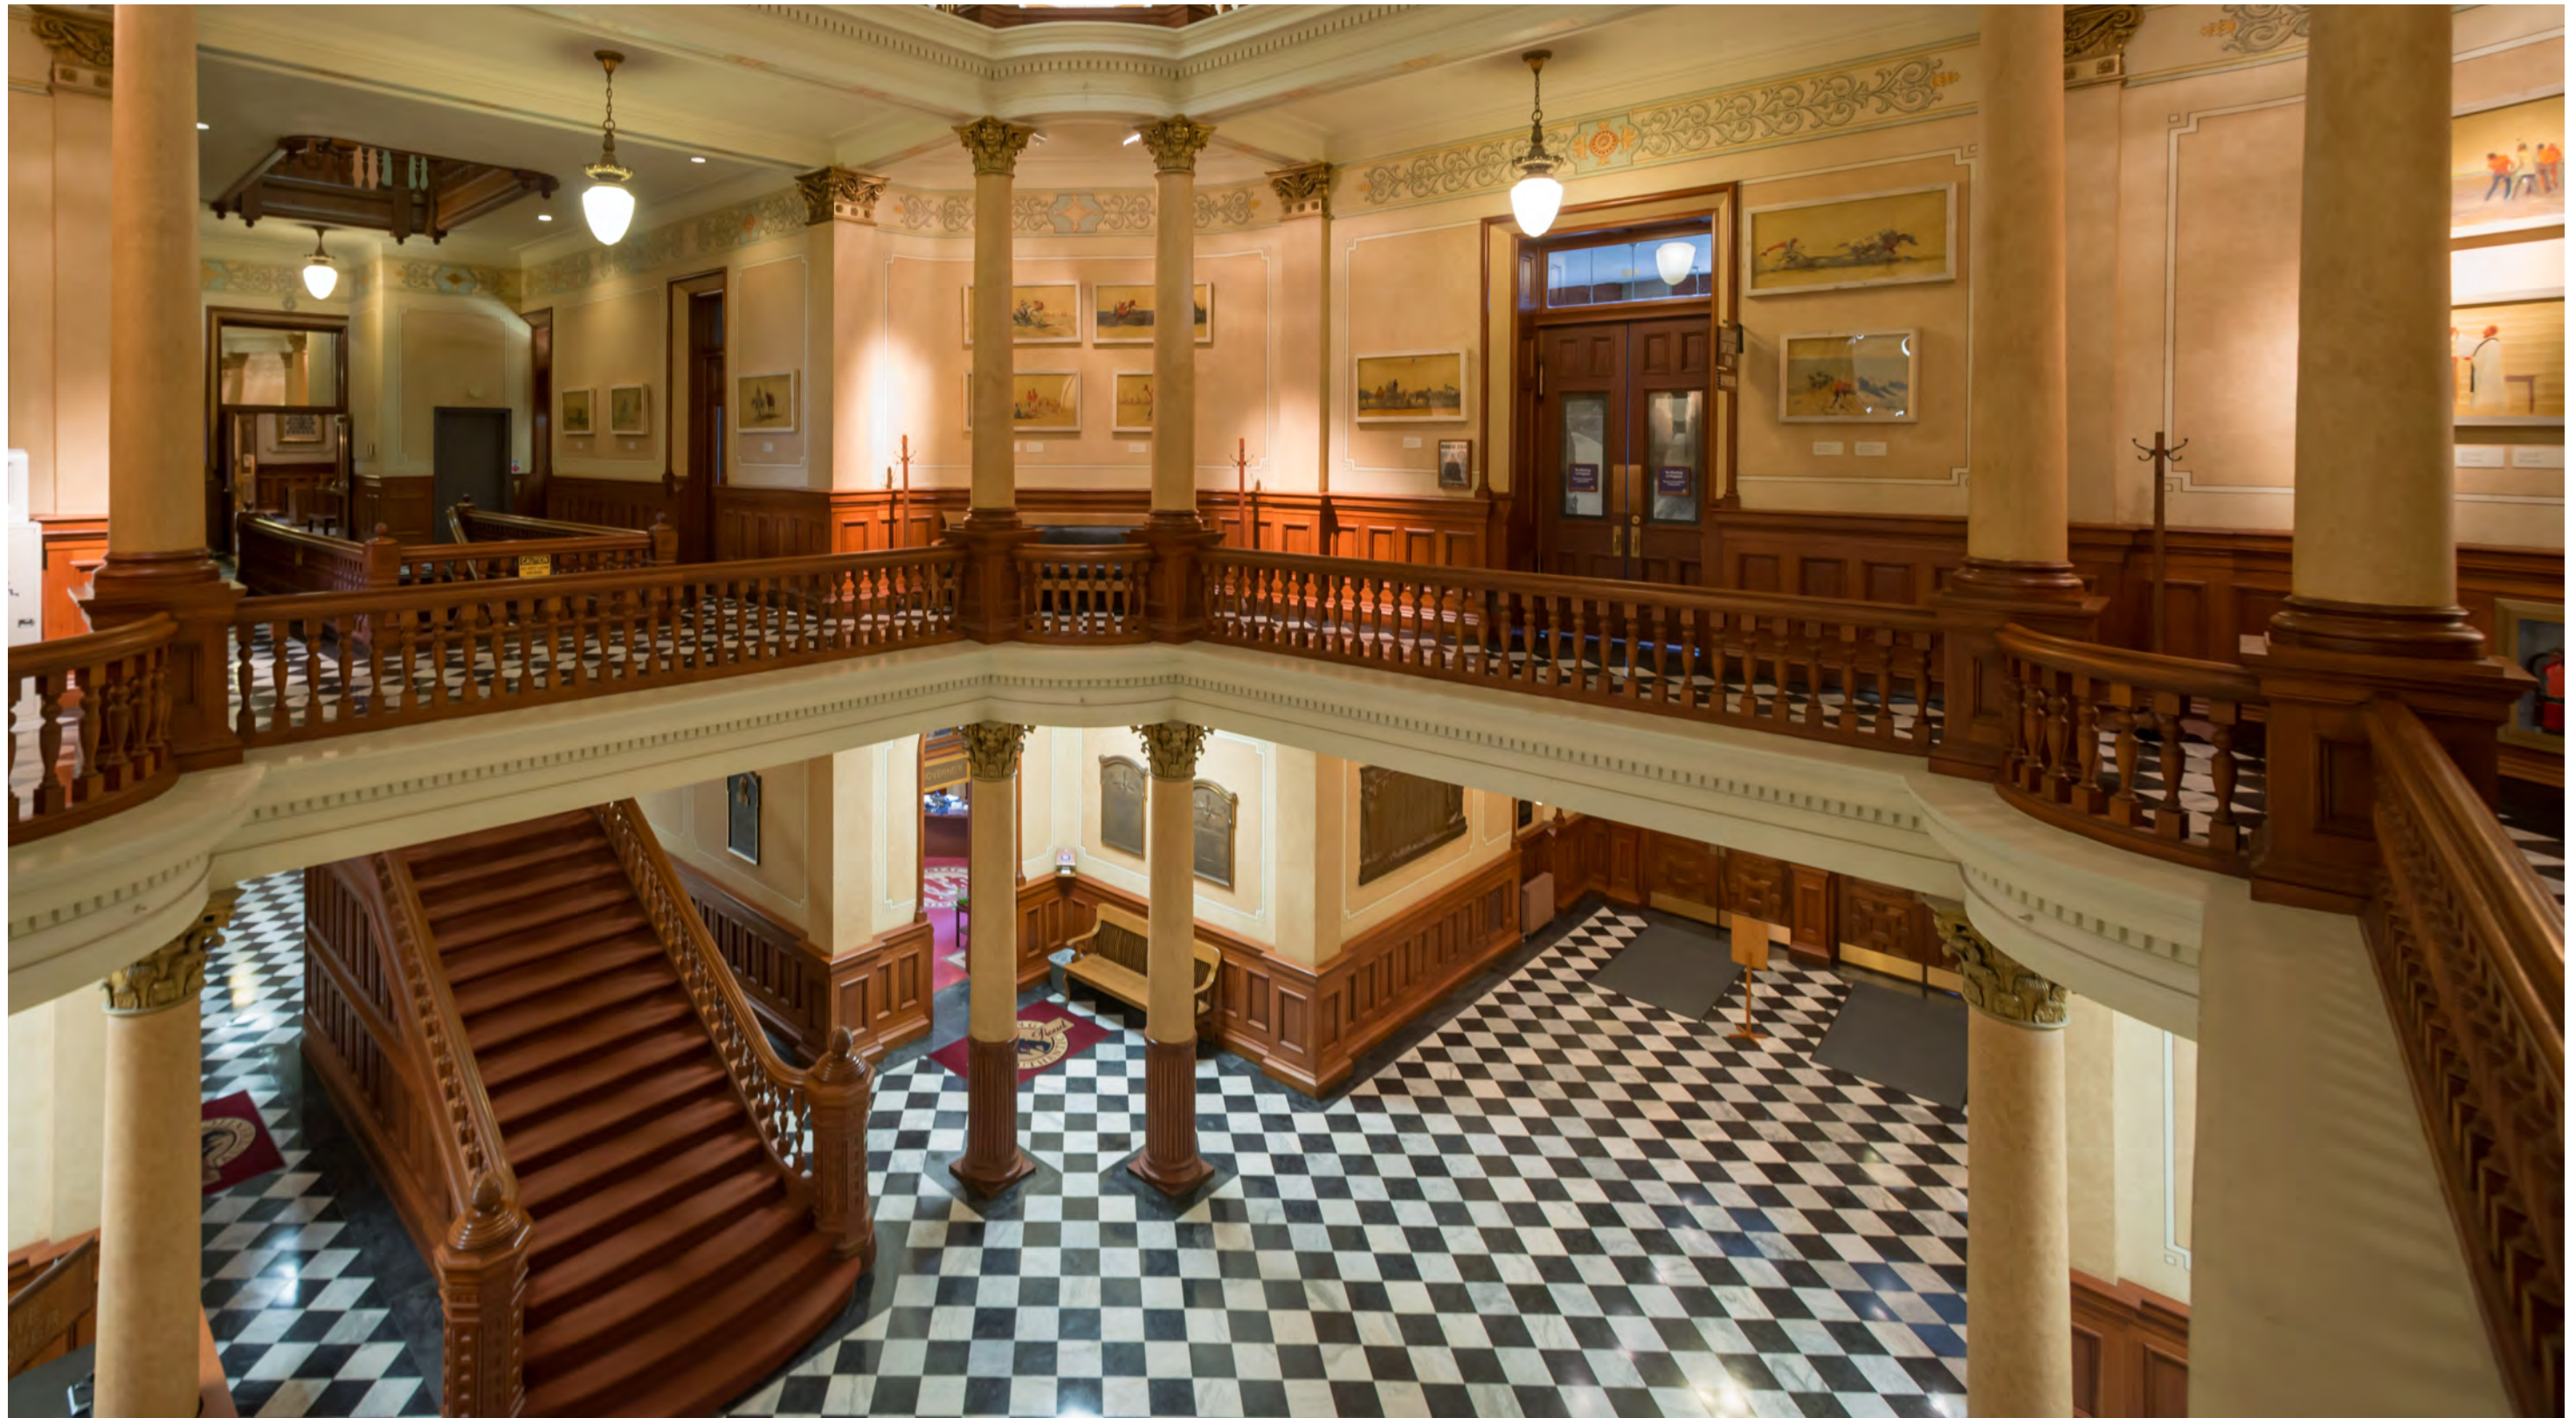
Figure 2-12. Second Floor Rotunda.

- d. Historic railings in the Rotunda and the monumental stairs are well below the code required heights, constituting a life safety risk. Similar conditions exist in the Chambers.
