Section 5: Site & Building Assessment

As part of the **Level I / Level II Study** for the Wyoming State Capitol, members of the **HDR/PDP/Plan1 Design Team** performed a comprehensive visual assessment of the exterior and interior of the Capitol Building and Site. Multiple site visits were made by the Design Team from March, 2013 through October, 2013 to conduct an intensive assessment of the building interior and exterior, including the existing building systems. With the assistance of members of the **State of Wyoming Department of Administration and Information Division of Construction Management [AICM]** and the Capitol facilities team, up-close visual access to the building was conducted using 125’ and 80’ high portable lifts and ladders. In addition, visual assessment of the Dome exterior and interior was performed using industrial rope access techniques. Interior assessments and building surveys were also conducted during this period.

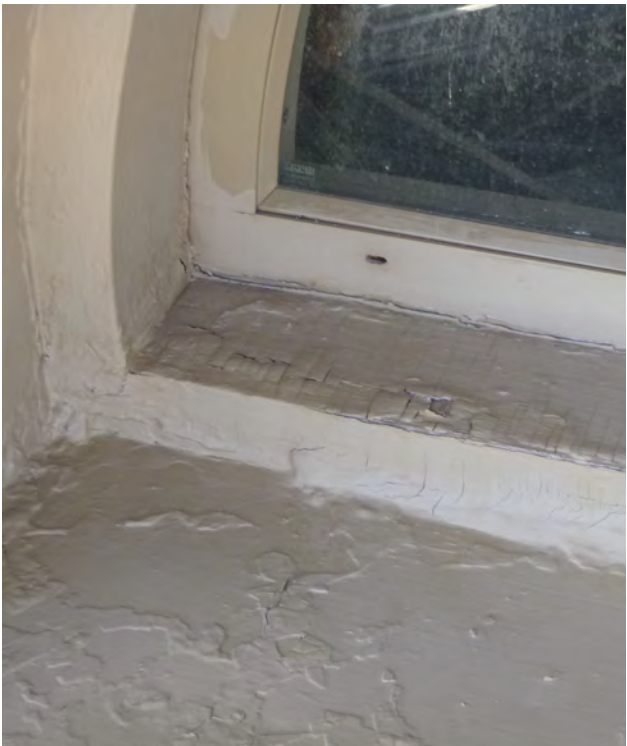
- The inoperable semi-circular windows at the colonnade and the inoperable round windows at the drum attic have wood frames and sash. These windows are in fair condition, with minor weathering of the wood and failed paint coatings. [Figure 5.2.11]

Figure 5.2.11: Coating Failure Adjacent to Window Frame and Sill.

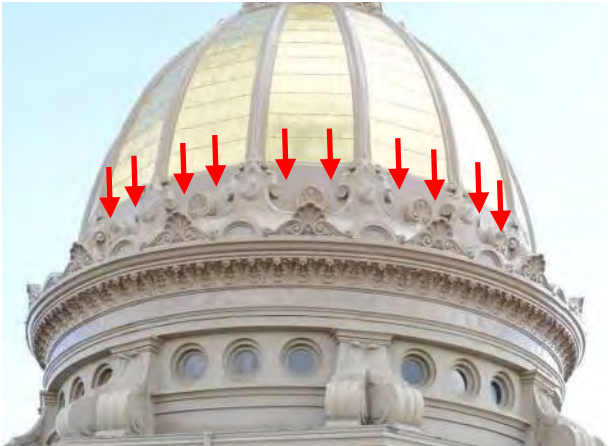
Figure 5.2.12: Diagram Illustrating the Observed Open Seam Locations at the Ornamental Metal Along the Base of the Dome Exterior.

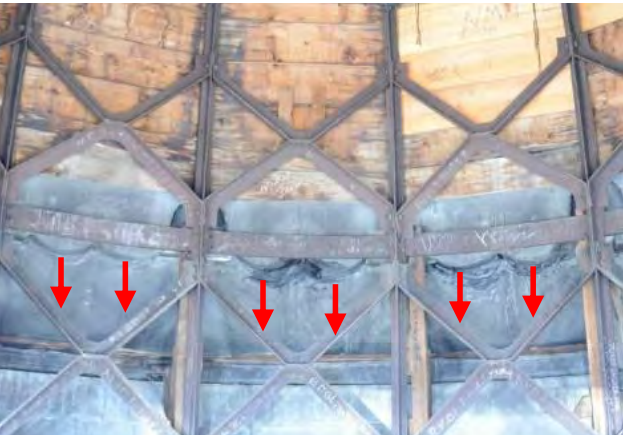
Figure 5.2.13: Diagram Illustrating the Corresponding Interior Locations of the Observed Open Seam Locations at the Ornamental Metal Along the Base of the Dome Exterior.

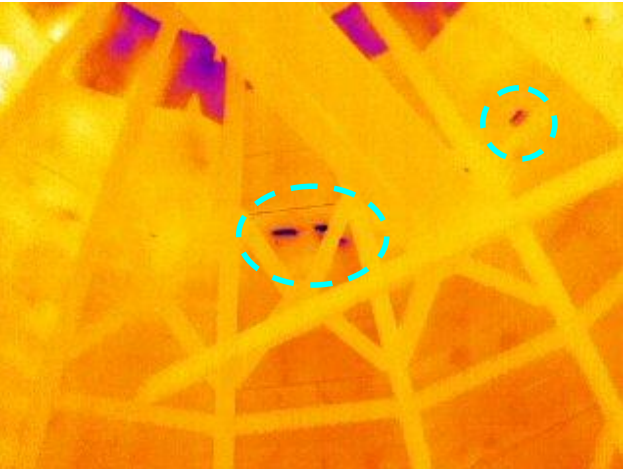
Figure 5.2.14: Thermal Image of the Interior Locations of the Observed Open Seam Locations at the Dome Exterior. The warmer [purple] locations indicate areas of heavy moisture, while the cooler [yellow] areas indicate areas of little or no moisture.

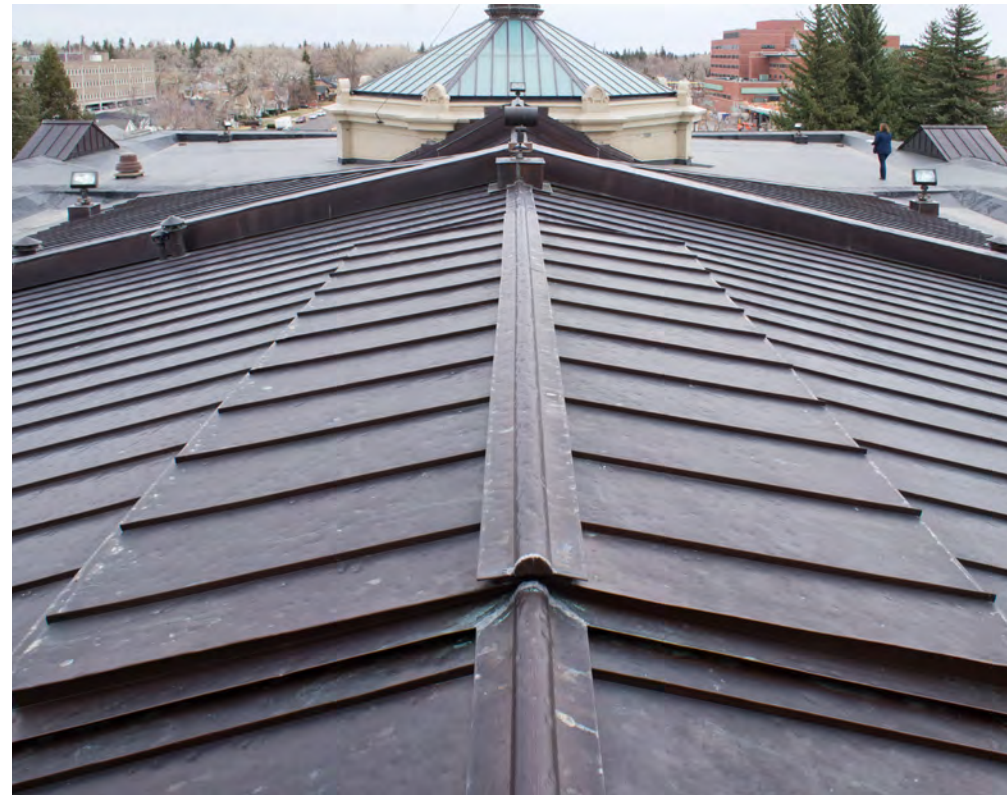
Figure 5.3.1: View of Standing Seam Metal Roof at Ridgecap.

According to the original specifications, the sloped roofing system at the Wyoming State Capitol consisted of painted standing seam tin, while the “flat roofs, including the gutter liners,” were clad with soldered flat seam tin. [Figure 5.3.1] Today, the sloped portions of the roof are clad with standing seam copper and the flat sections of the roof are covered with rubber or EPDM (ethylene propylene diene monomer (M-class) rubber). [Figure 5.3.3]

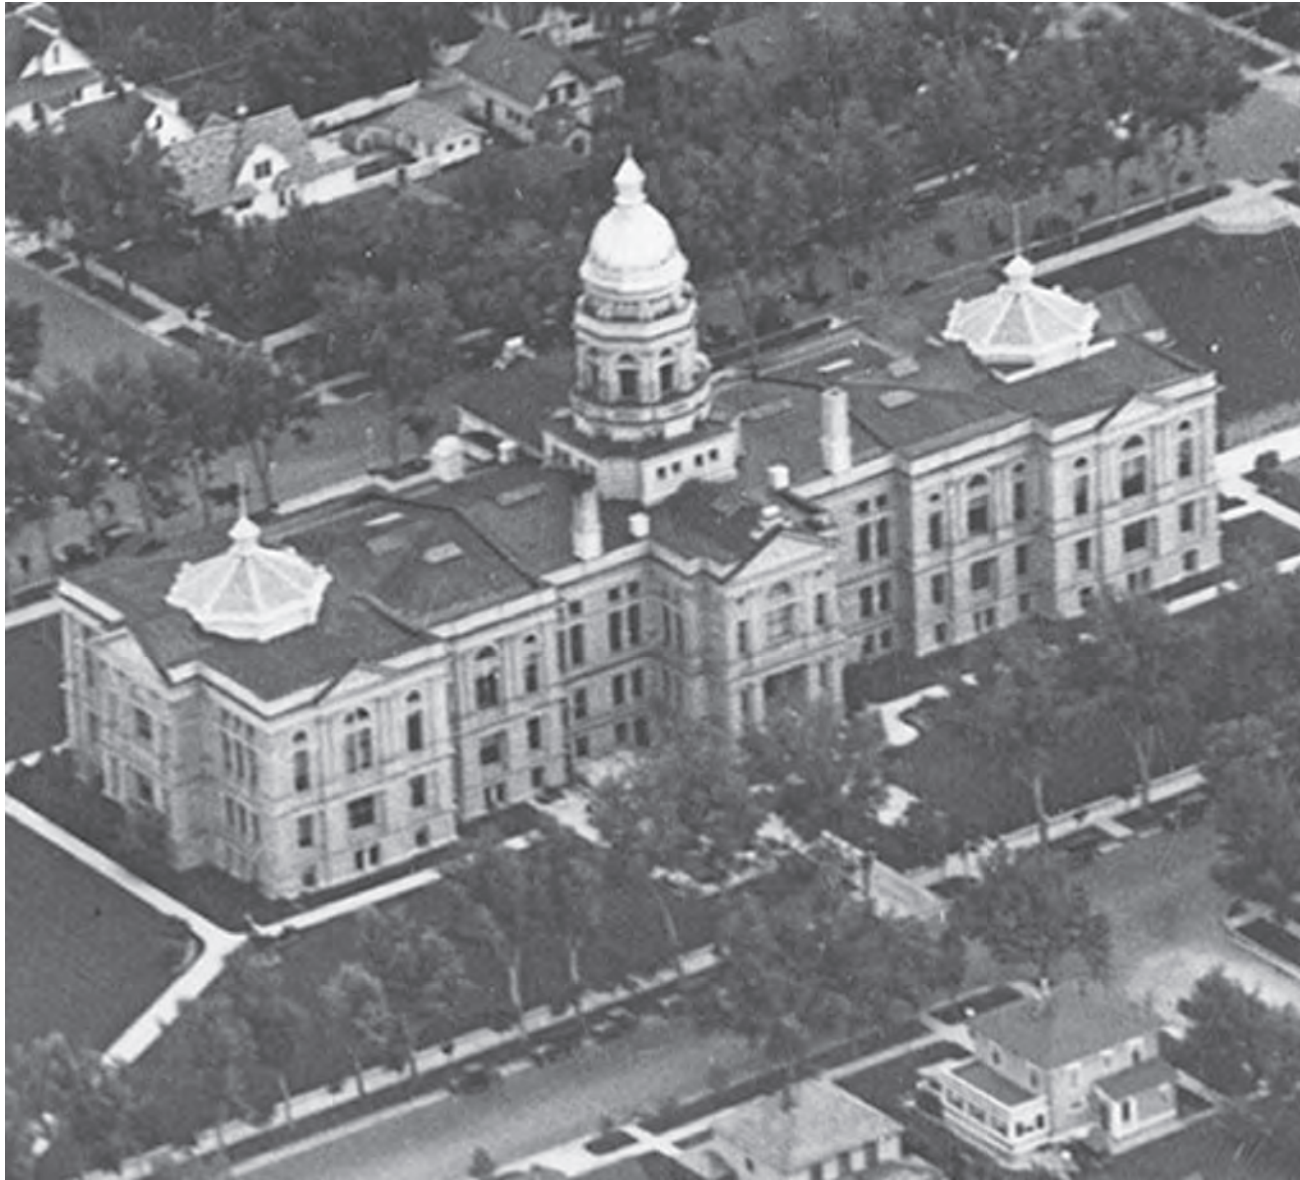
Figure 5.3.4: Wyoming State Capitol Buiding, Aerial View of Roof and North Elevation, looking Southwest, ca. 1930.

The existing EPDM roof has numerous patches, and the maintenance staff states that they patch the roof on an annual basis. [Figures 5.3.4, 5.3.5 and 5.3.6] The EPDM roof is nearing the end of its useful life and will require replacement in the near-term.

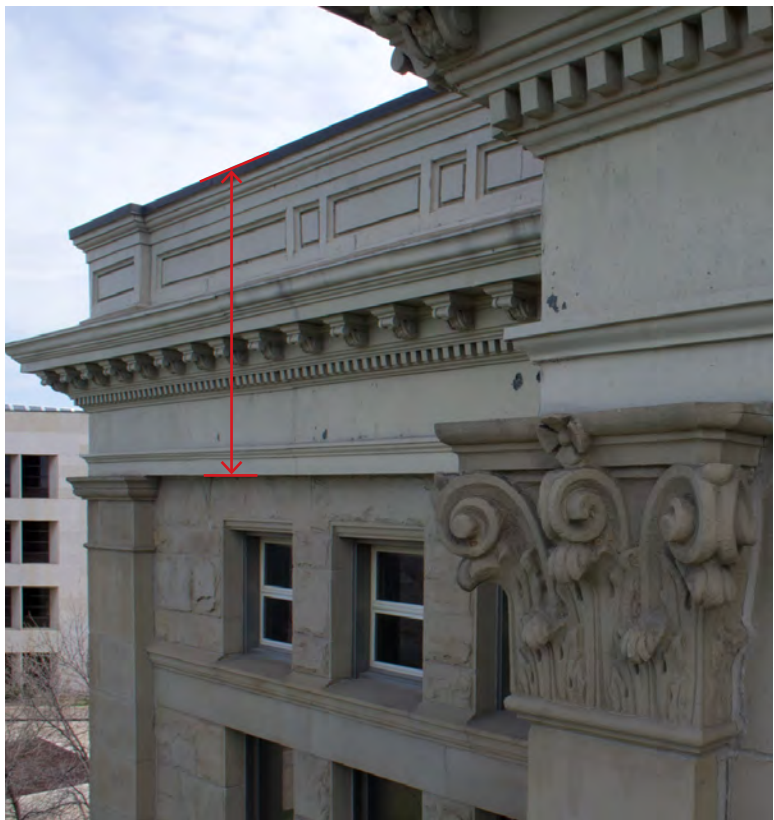
Figure 5.4.3: West Side of North Portico Looking South. The building elements above the third story pilasters are galvanized metal.

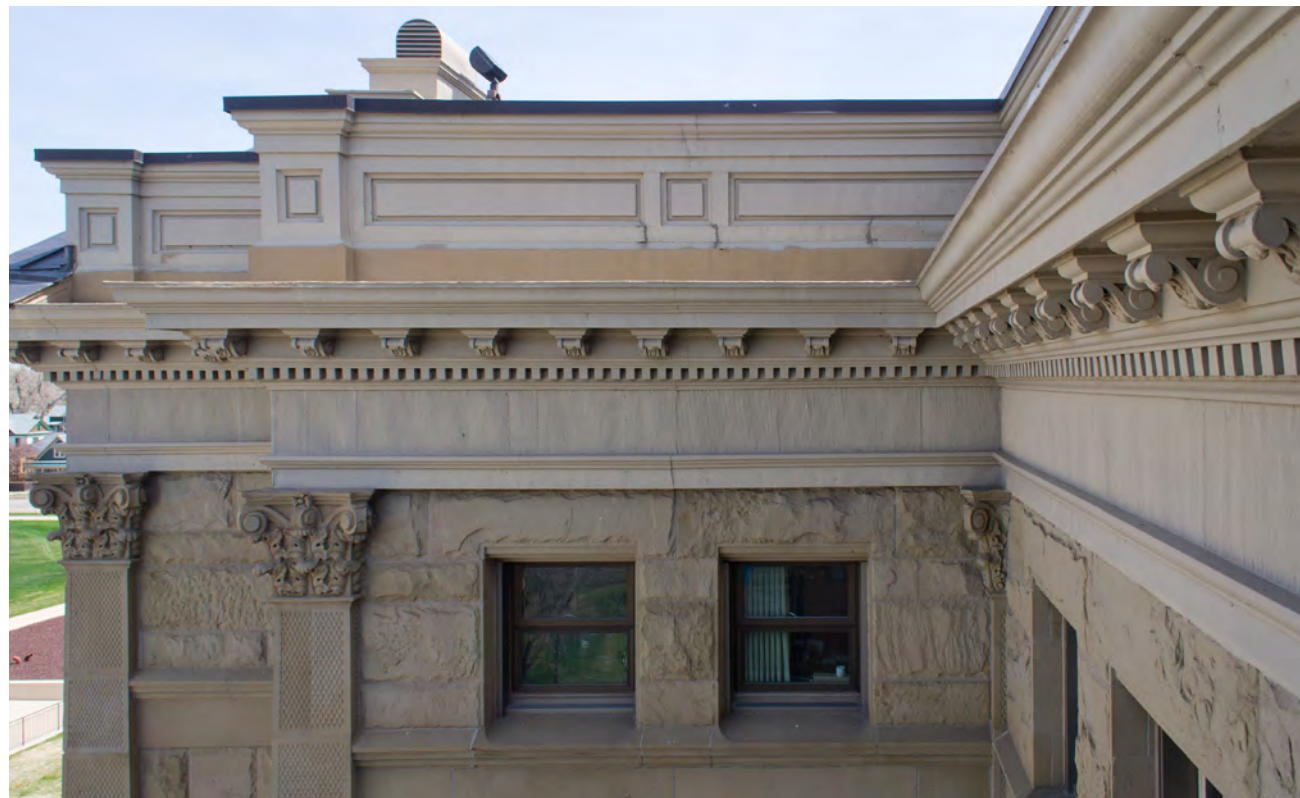
Figure 5.4.4: Galvanized Metal Entablature, Cornice, and Parapet Walls at the North Elevation.

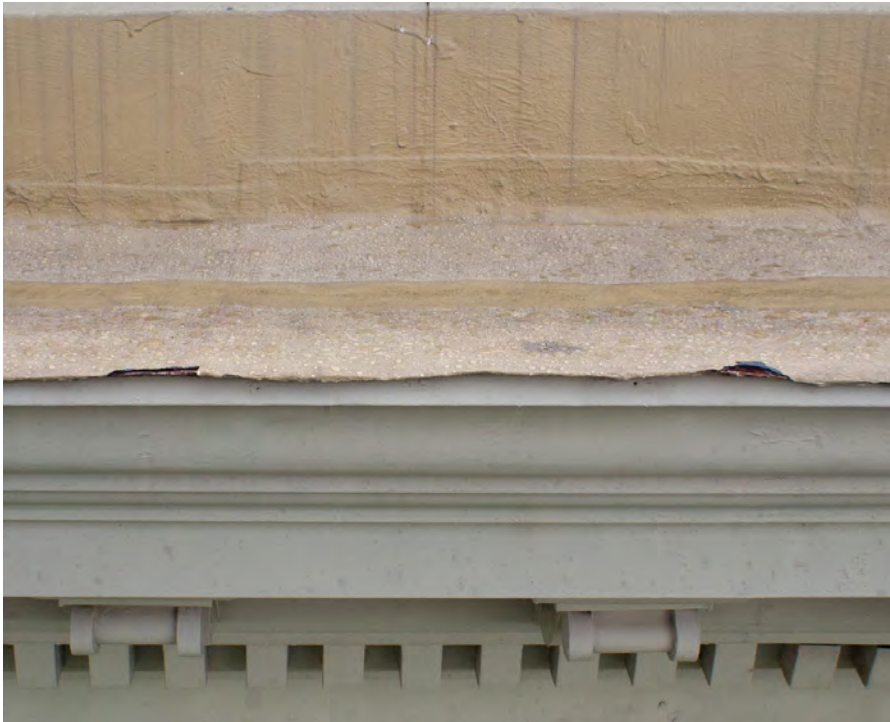
It appears that a cold-fluid applied membrane has been applied to the cornice. At some locations the membrane does not appear to be fully adhered to the cornice, particularly at the edges. Standing water was also noted at the cornice following rain events. [Figures 5.4.8, 5.4.9, and 5.4.14].

Figure 5.4.9: Detail of Areas Where the Cold-Fluid Applied Membrane Is Not Fully Altered to the Cornice.

- Remove all metal panels for the full length of the decorative parapet to repair and repoint the masonry back-up wall. Masonry back-up material may require repairs.

- All surfaces are to be stripped to bare metal, and all rust is to be removed.
- All metal surfaces are to be sound and deemed acceptable to the coatings manufacturer prior to any surface preparation. All metal surfaces are to be properly prepared to receive new coatings. A rust-inhibitive primer is to be applied to the bare metal, and new high performance coatings are to be applied to all metal surfaces according to the manufacturer's requirements and approved by a technical representative.

- Following all repairs and refinishing of the metal, the panels are to be reinstalled and proper flashing installed to ensure a weather-tight system.
- In addition, the Design Team will further evaluate the existing drainage conditions of the roof and determine whether modifications need to be made to incorporate overflow scuppers or other drainage features.

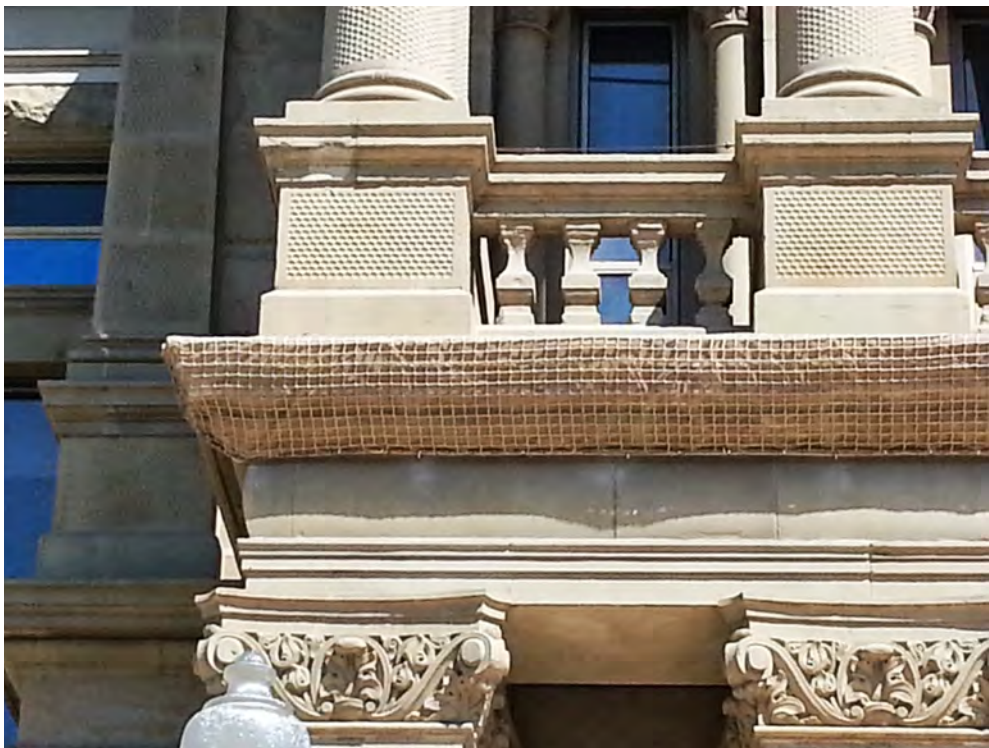
Figure 5.5.2: Close-up of the Protective Netting Installed at the Areas of Distress at the Cornice Above the South Entrance as a Result of the Design Team's Discovery.

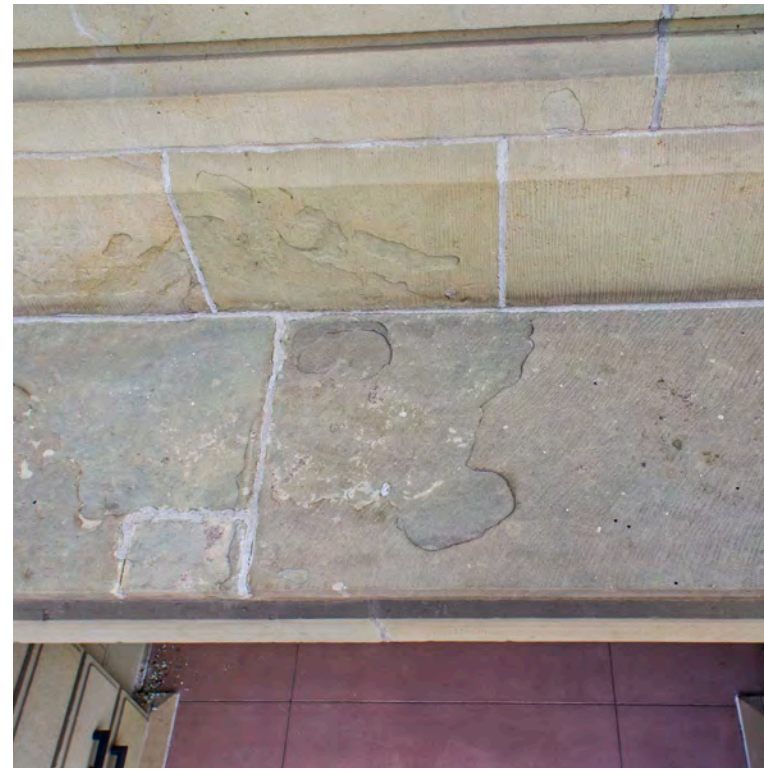
Figure 5.5.11: Typical Delamination at Top of Cornice.

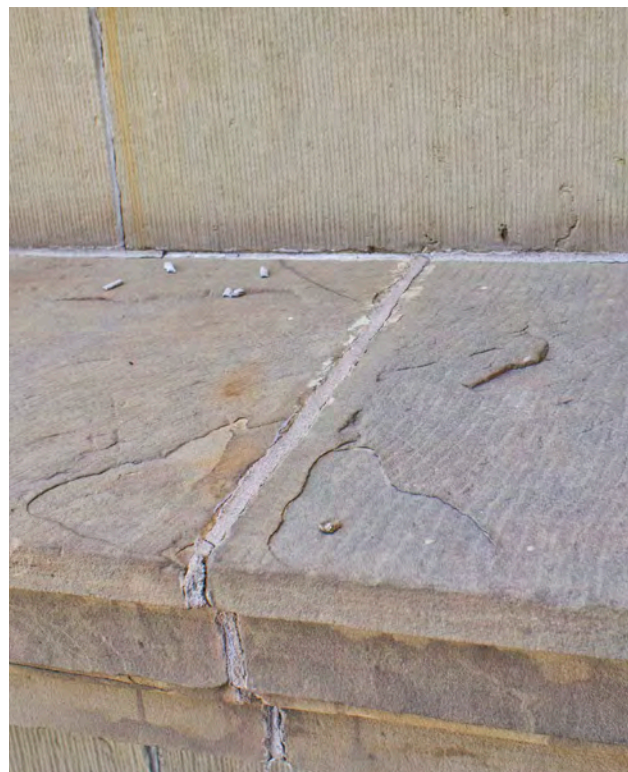
Figure 5.5.12: Typical Delamination at Top Surface at Cornice above First Floor Level.

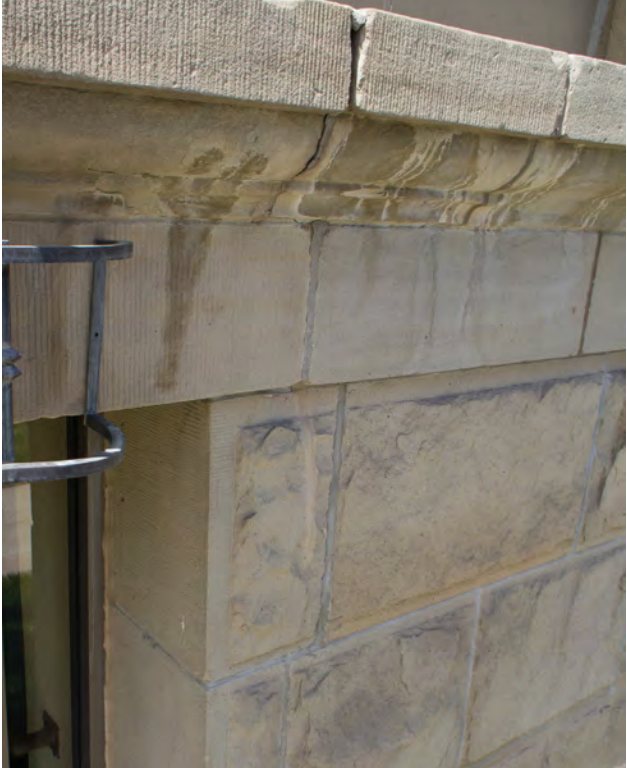
Figure 5.5.18: East Elevation Cracked Stone and Mortar Joint at the Cornice above a Cracked Stone Unit That Has Been Repaired.

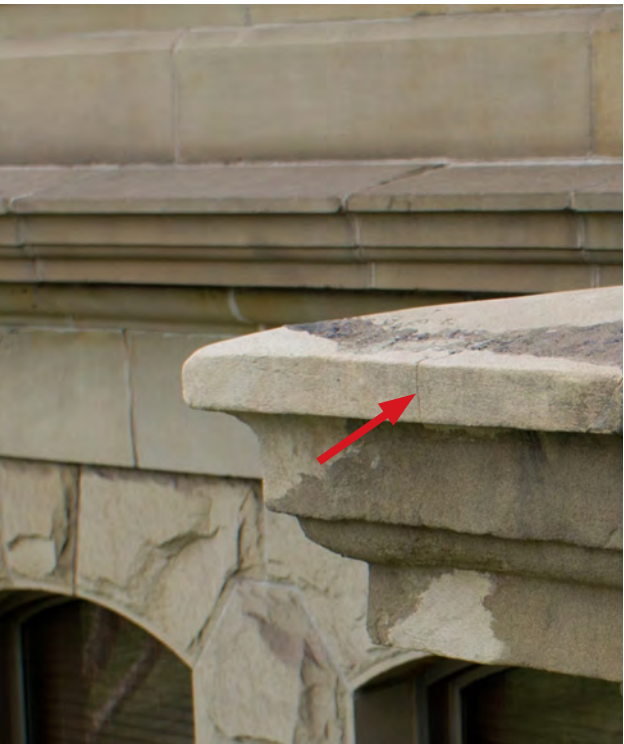
Figure 5.5.24: Cracked Patch Repair at the Corner of the Cornice on the North Elevation.

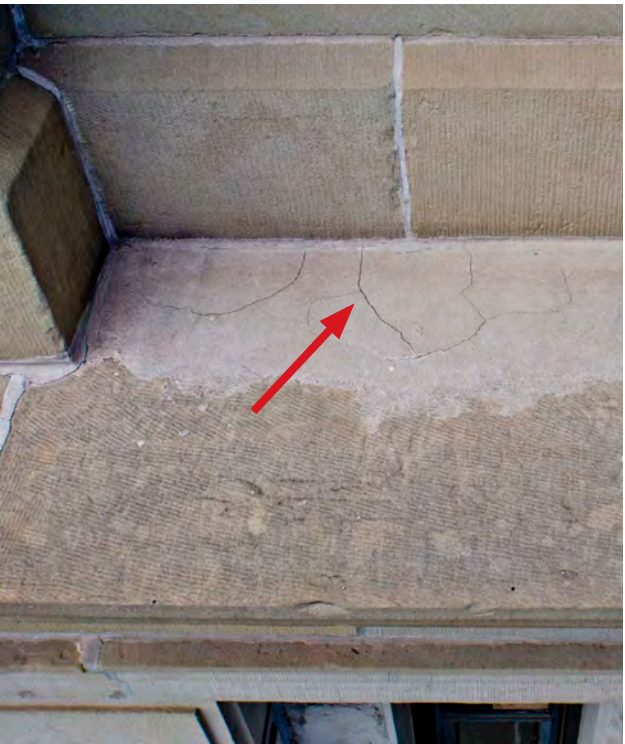
Figure 5.5.25: Cracked Patch Repair at the Cornice Below a Window at the South Elevation.

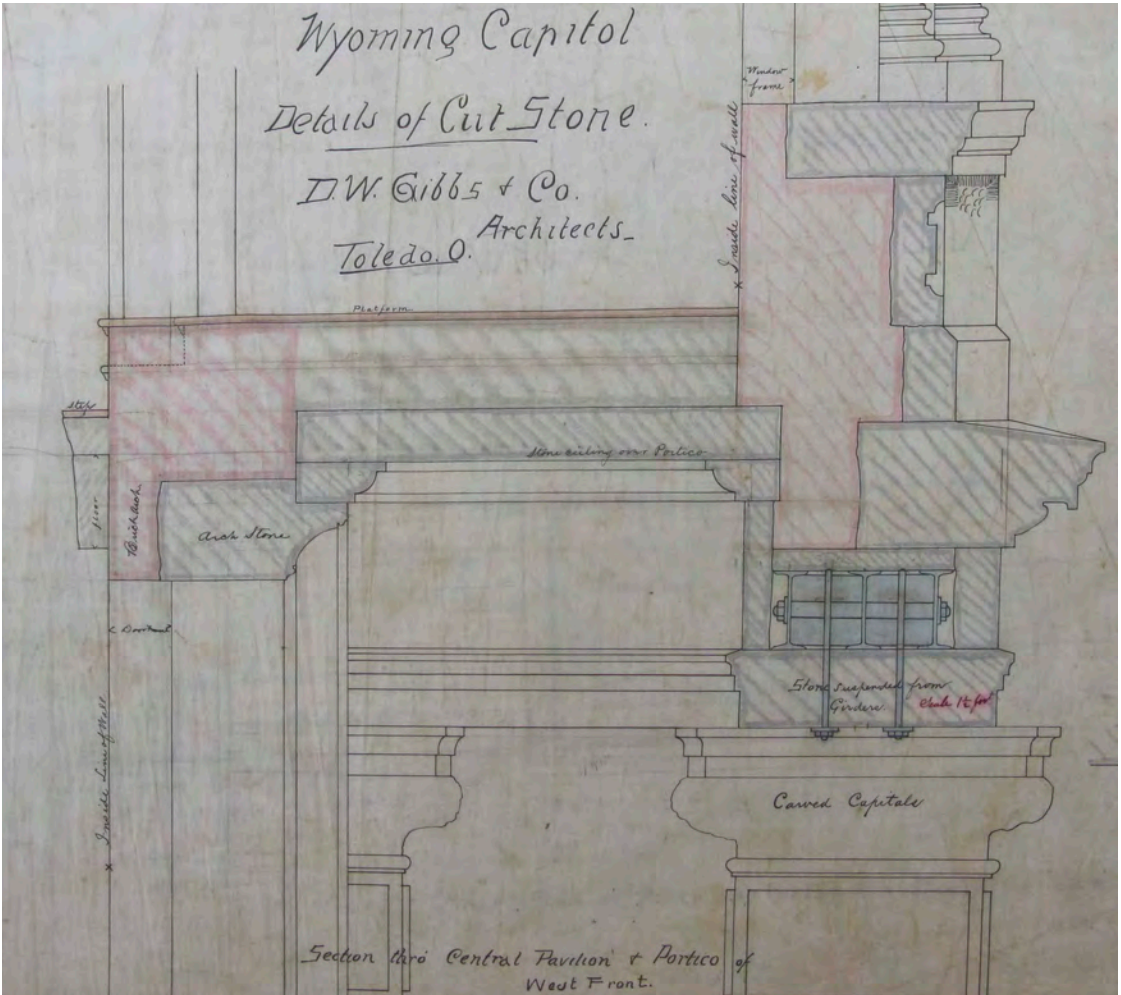
Original shop drawings show that at least some of the stone lintels are hung from steel girders at the porticos. [Figures 5.5.31 and 5.5.33] It is assumed that there is a similar condition at some window openings. The cracks observed at the lintels are of some concern because the distress may be related to the oxidation of metal within the walls. Typically, ferrous metal functions in the masonry walls as anchorage and support. The problem with ferrous metals is that, when they rust, they expand, and in expanding, they exert large enough stresses on the masonry to cause it to crack or be displaced. Rust staining was noted on the ends of the threaded rods with the decorative plate washers and nuts, which appear to be original to the building. The corrosion could be related to the corrosion of the end of the rod only or it may

Figure 5.5.31: Original Shop Drawing Showing the Stone Hung from Steel Structure.

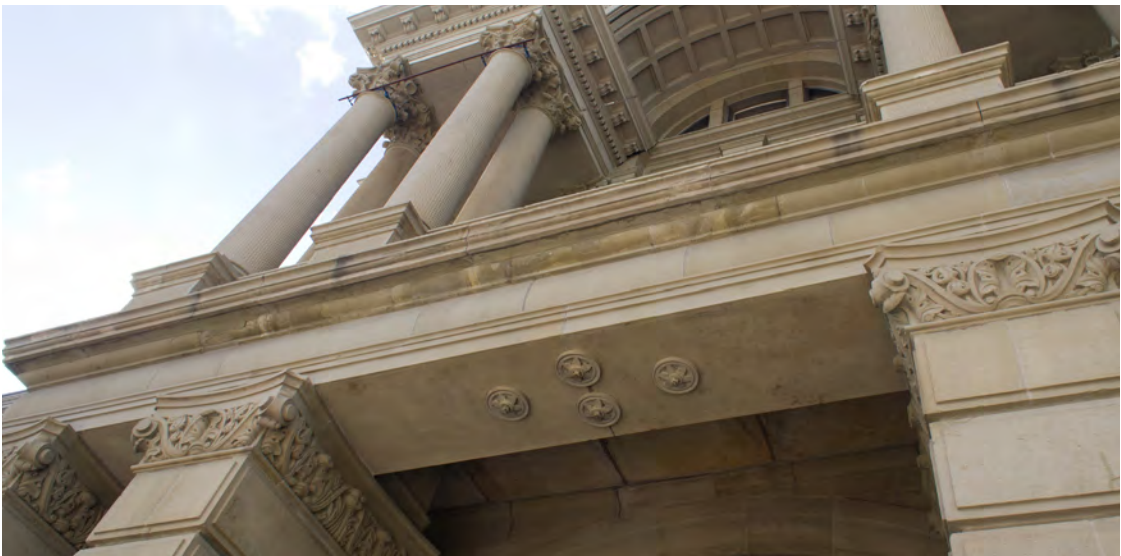
Figure 5.5.33: Decorative Washers, Bolts, and Rods, Part of the Original Design at Some of the Stone Lintels.

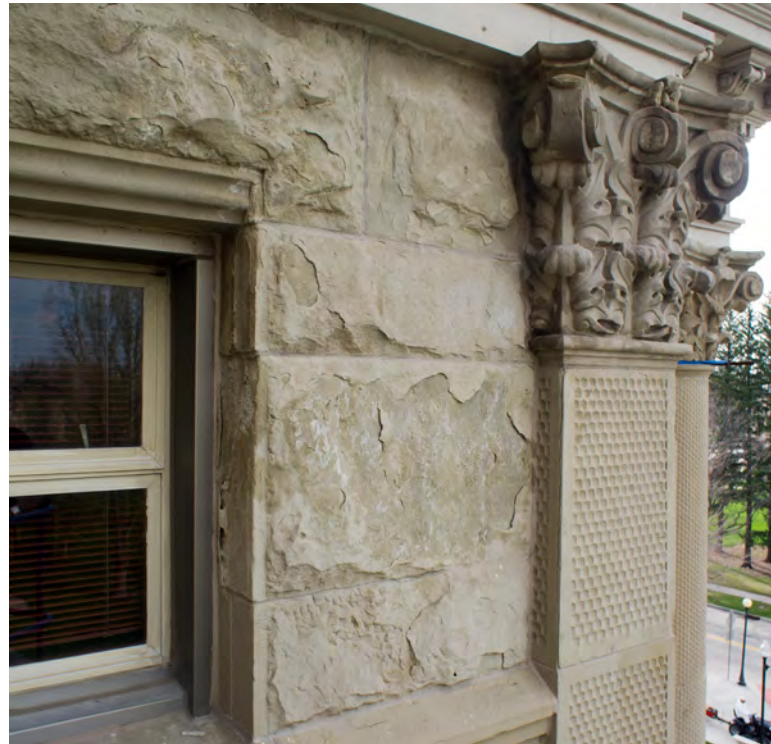
Figure 5.5.34: Delaminated Stone at South Portico Where There Is an Internal Leader.

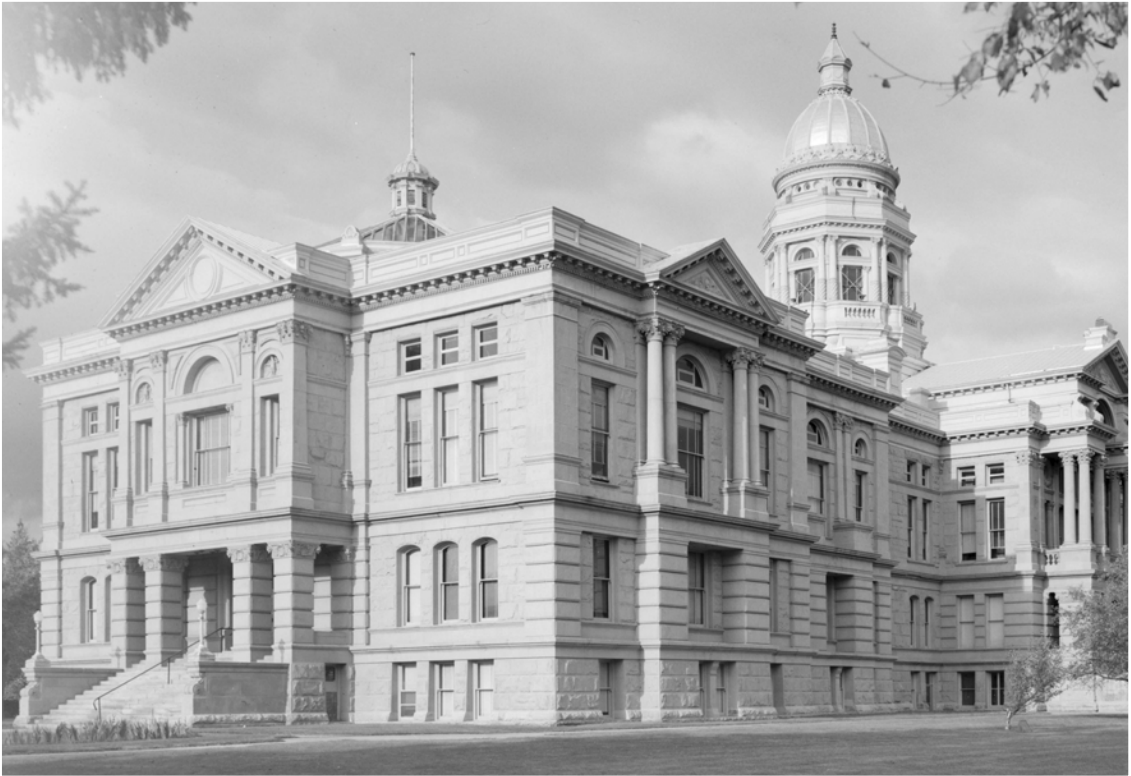
Figure 5.6.3 West Elevation of the Capitol, Looking Northeast, ca. 1979. The photograph was taken as part of the HABS documentation. Note that the original third floor windows have been replaced, while the remaining windows are original.

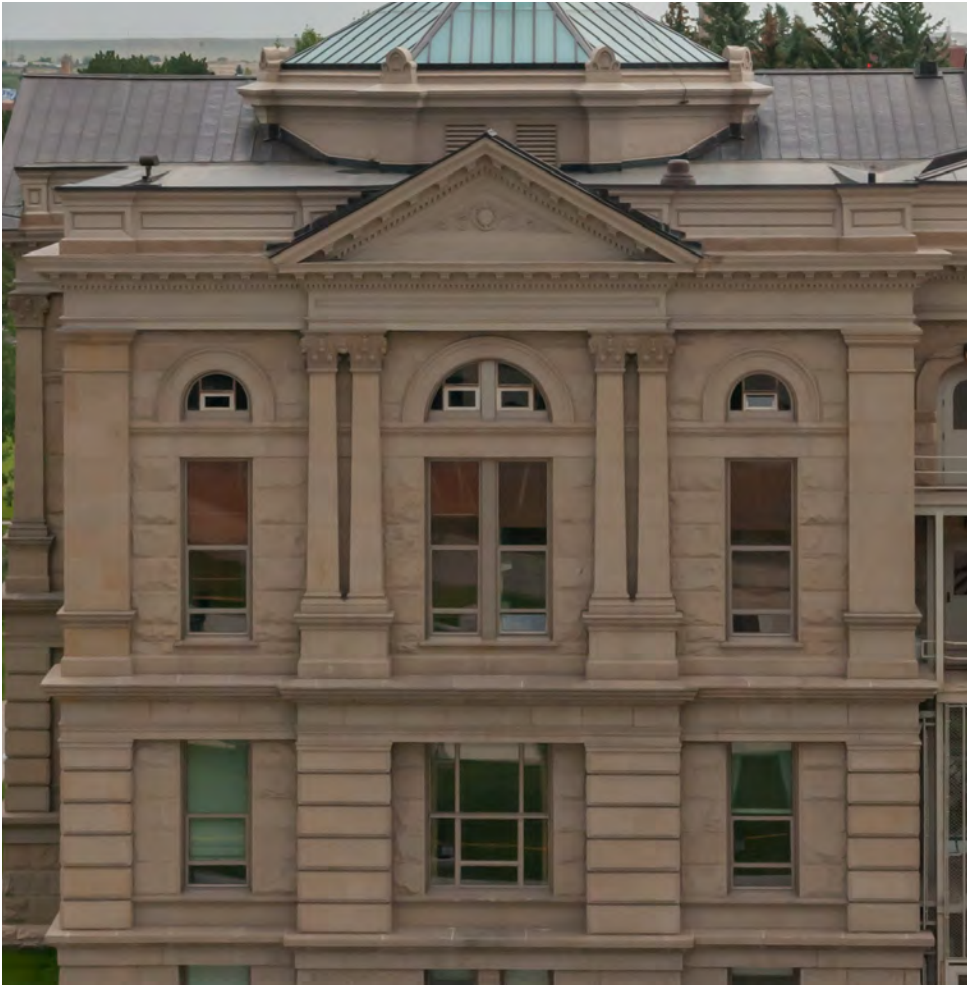
Figure 5.6.5 Detail of North Elevation Looking South. Note Replacement Windows.

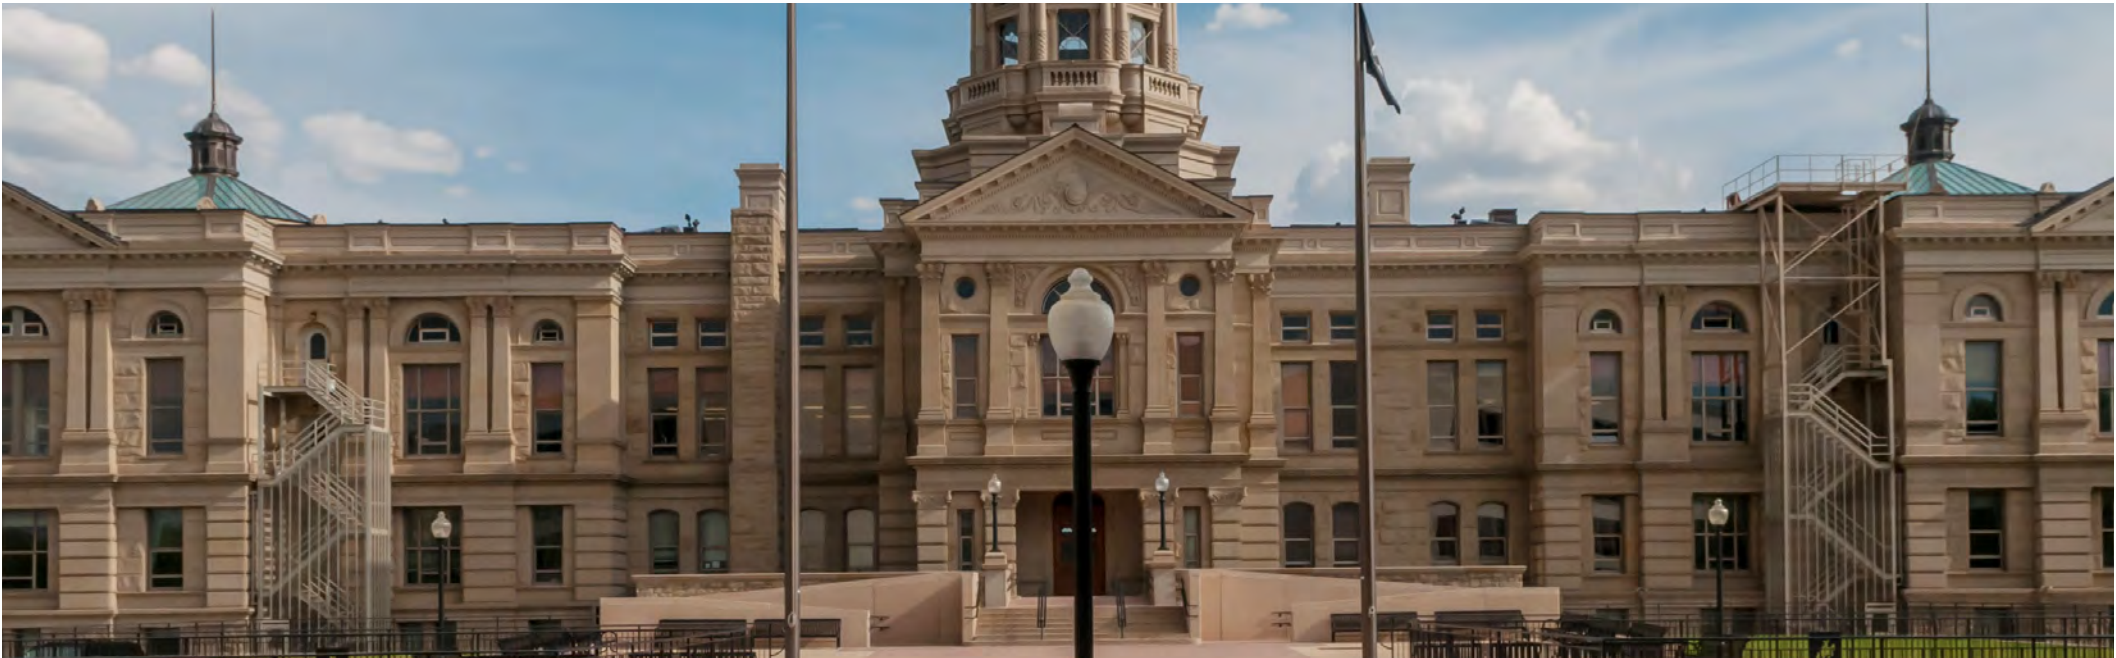
Figure 5.6.7 Replacement Windows at North Elevation, Looking South.
