Section 7 : Proposed Scope of Work

7. Proposed Scope of Work

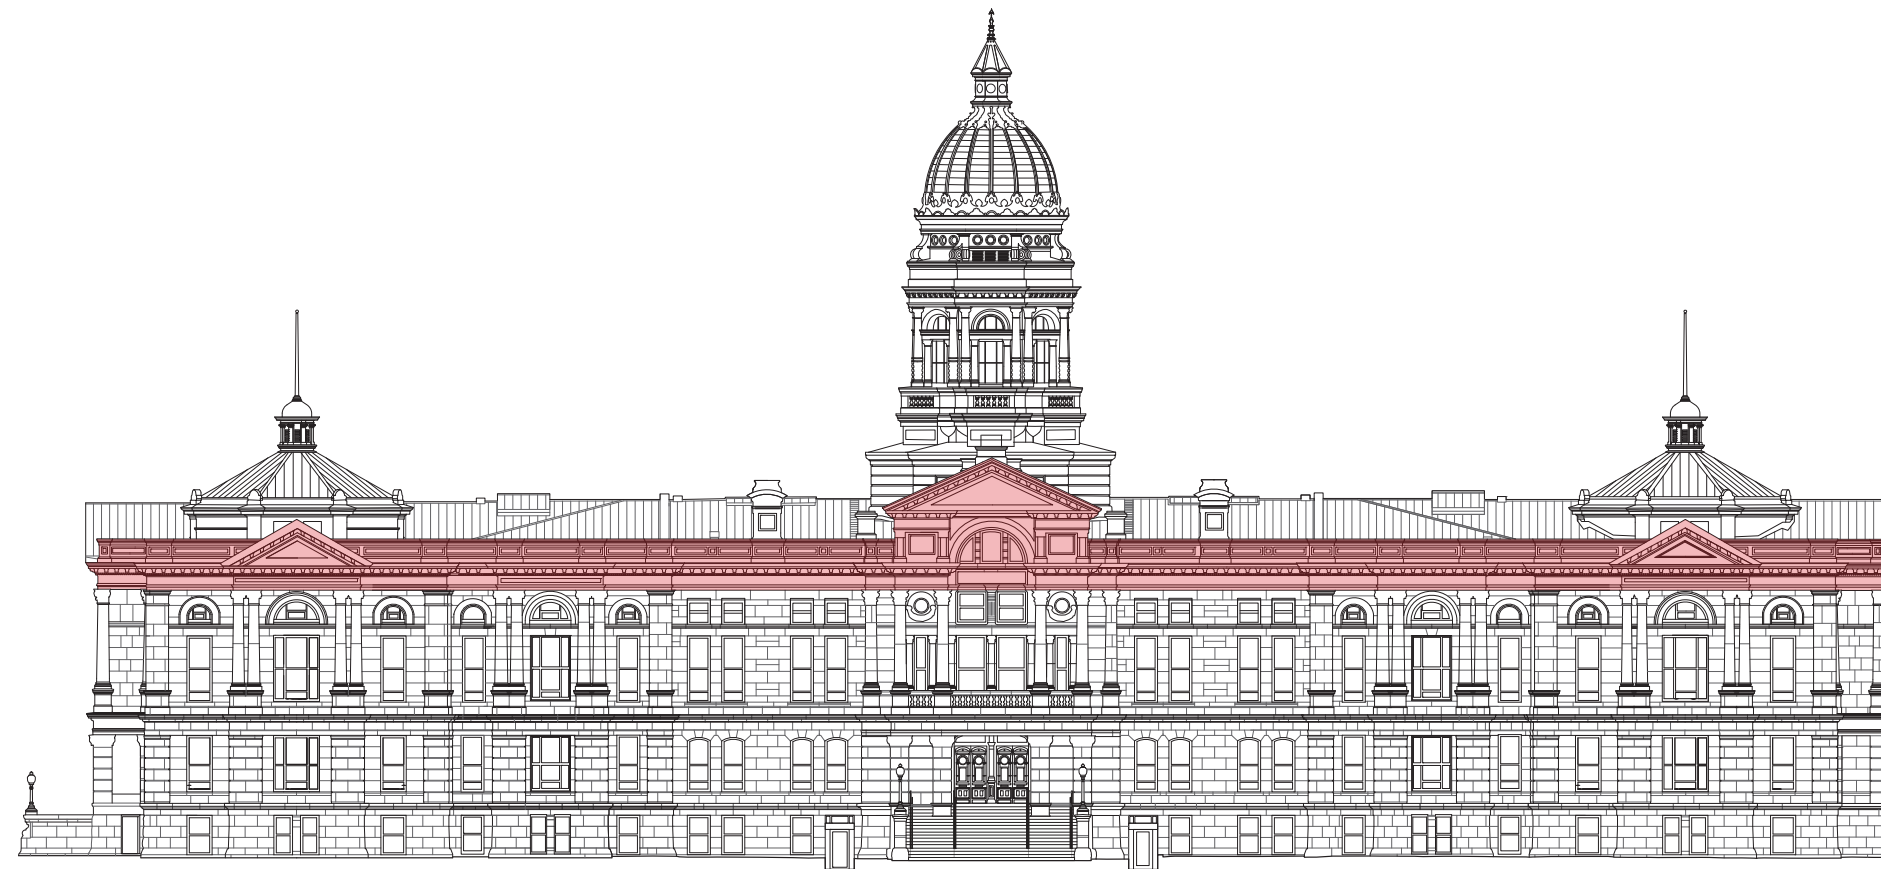
Figure 7.2.3: South Elevation Drawing. The cornices are indicated in red.

- Removal of all protective coatings and cold fluid-applied layers.
- Removal of all paint layers to expose the metal.
- Repairs to all metal surfaces and replacement as required.
- Introducing proper - but imperceptible – pitch to ensure proper water removal.
- Install caps where needed to protect joints [“belt-and-suspender” approach].
- Re-prime and paint parapets, with proper colors, assuming they are acceptable to the State.

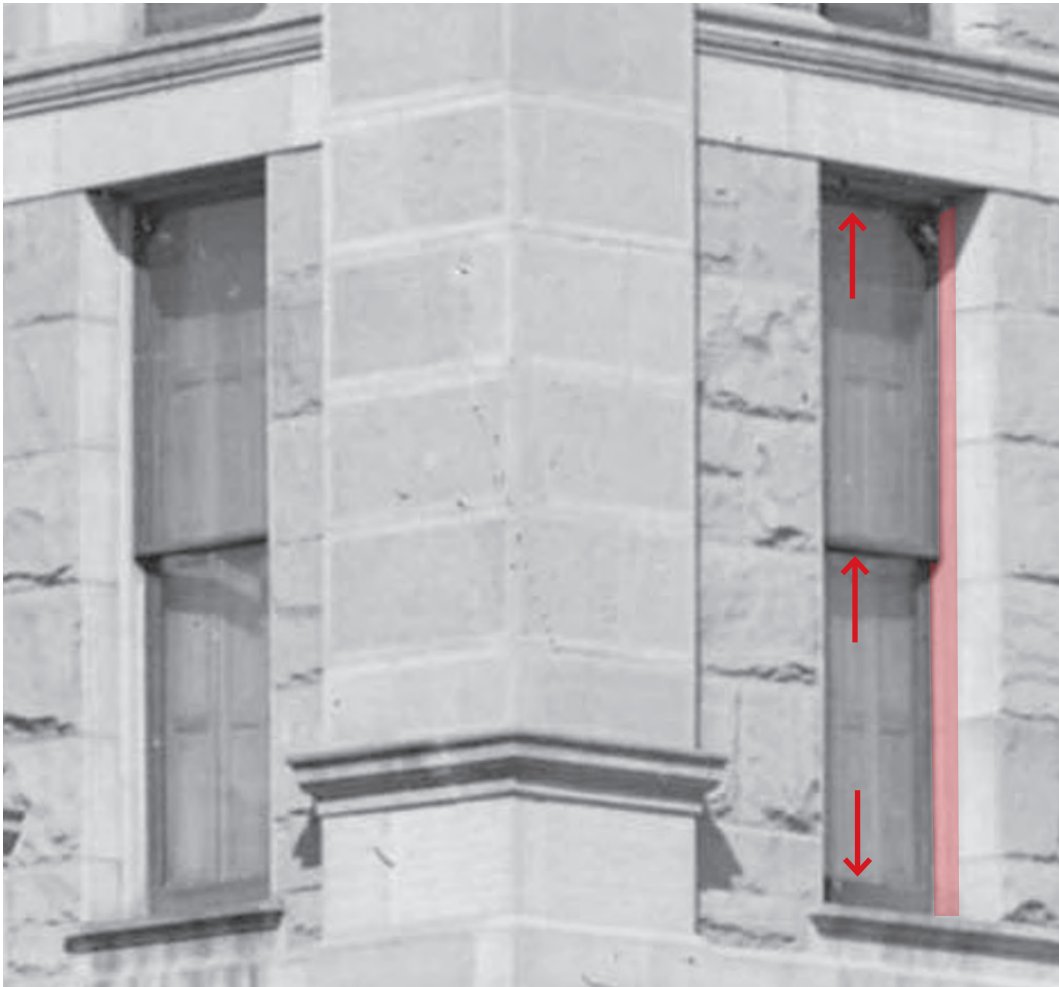
The placement, selection and richness of the colors and finishes represented a specific aesthetic that has been lost as a result of uninformed decisions. They can be recaptured through paint analysis and be reproduced, allowing the appearance of the building to be restored to the original design intent of the builders of the Capitol. This is a decision that needs to be made by the State. These finishes can last for decades with proper cyclical maintenance.

Figure 7.2.6: Detail of Original Wood Windows, ca.1902. The sand colored frame is highlighted in the above image. The dark painted sash is indicated with the red arrows.

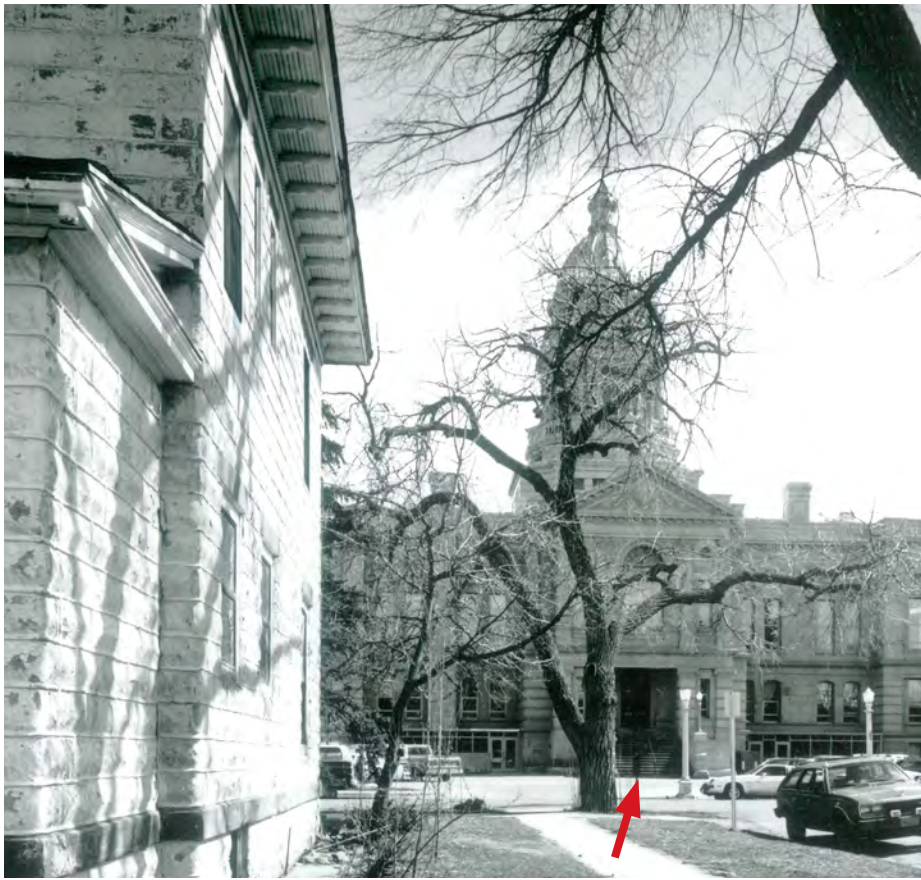
Figure 7.2.11: Historic Photograph of the Capitol Building North Elevation Prior to the Construction of the Herschler Building, ca. 1980. The original North Portico Stair is indicated in the distance.

Careful analysis and review of the existing conditions, renovation drawings and historic photographs indicates that these elements can be removed, the original steps can be reconstructed and the elegance of the historic design can be restored. ADA accessibility, serviceability of the Capitol and parking can be addressed through unobtrusive alterations to the Herschler Garage and Connector areas.

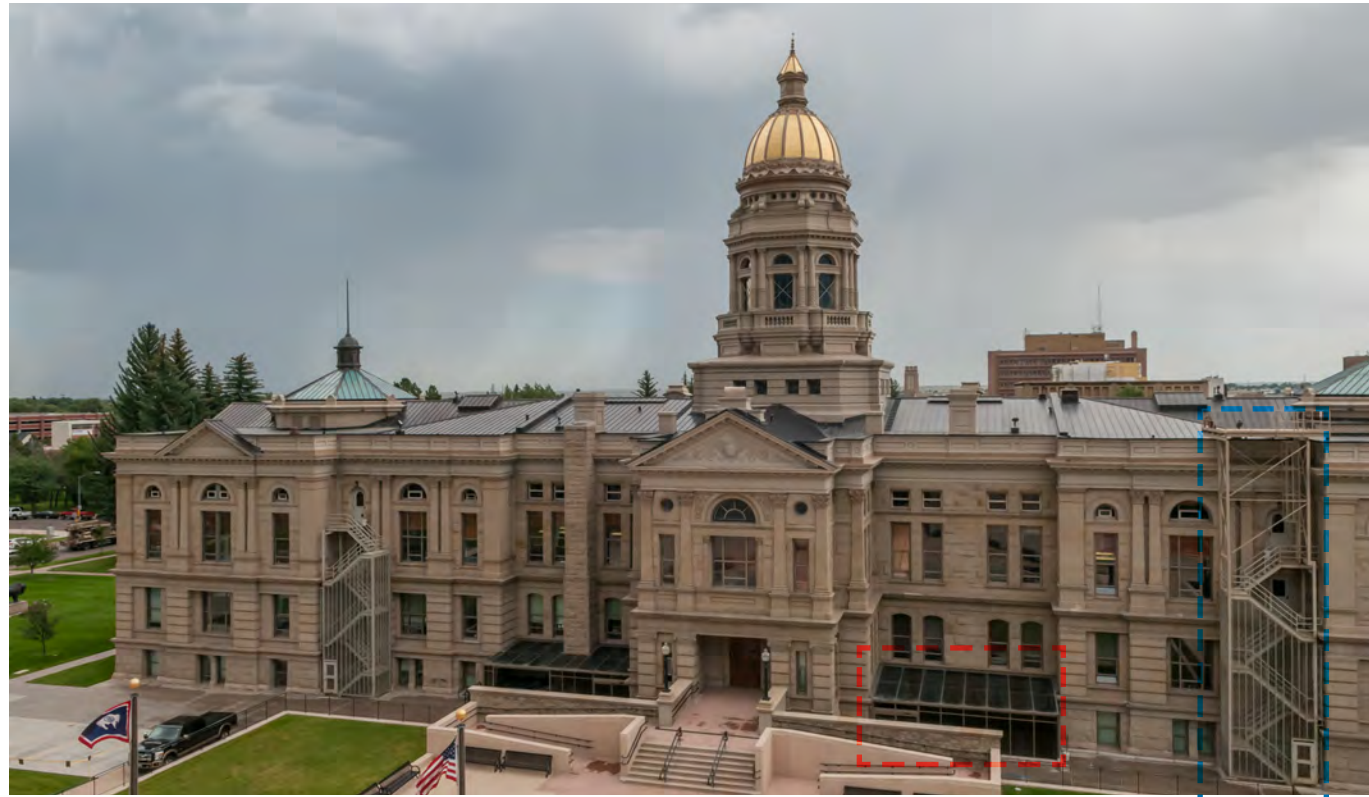
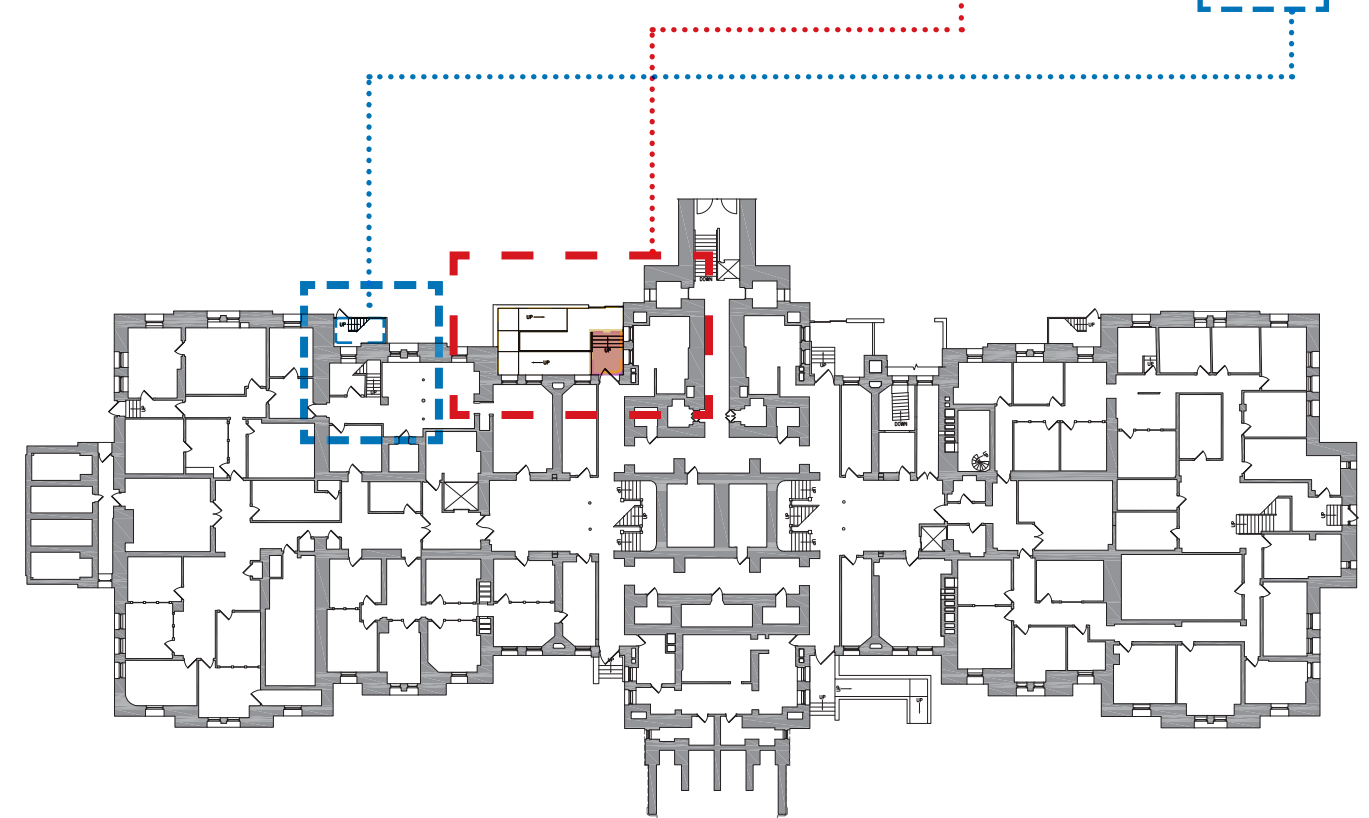
The monumental doors are still in place, albeit modified. The Basement / Lower Level Doors have been replaced with inappropriate storefront-type aluminum and glass doors.

Figure 7.2.12: “As-Found” Basement Level Floor Plan.

All of these items are proposed to be removed and the north masonry facade to be fully restored. *Pages 7.6 and 7.7* delineate these items.
