**WYOMING STATE CAPITOL
REHABILITATION & RESTORATION**

**LEVEL I RECONNAISSANCE /
LEVEL II FEASIBILITY STUDY**

**EXECUTIVE SUMMARY
AND
FREQUENTLY ASKED QUESTIONS**

17 FEBRUARY 2014

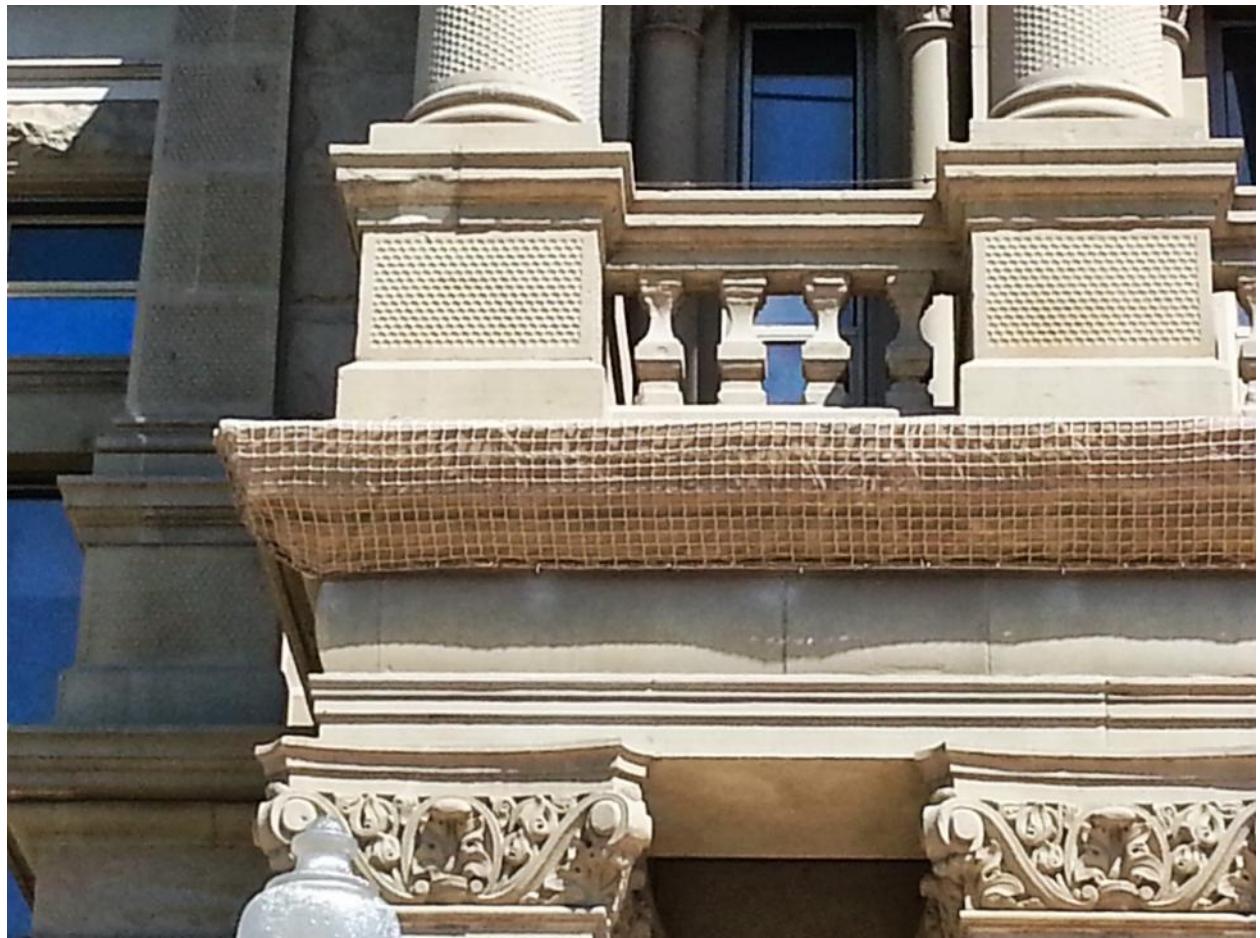
- The stone on the Capitol exterior walls is generally sound, however significant localized issues exist.
 - In July of 2013, a stone over the front steps was found to be loose. A net was specified to stabilize the area; however, during installation of the net, a portion of the stone simply landed in the contractor's hands. Many stones need attention.
- The roof and dome are badly damaged from hail.
- The skylights are leaking over the stained glass and chambers.
- The dome appears to be generating cracks at the rotunda area through either rotation or some other issue.
- Other cracks appear to be associated with how the Herschler corridor connects to the Capitol.

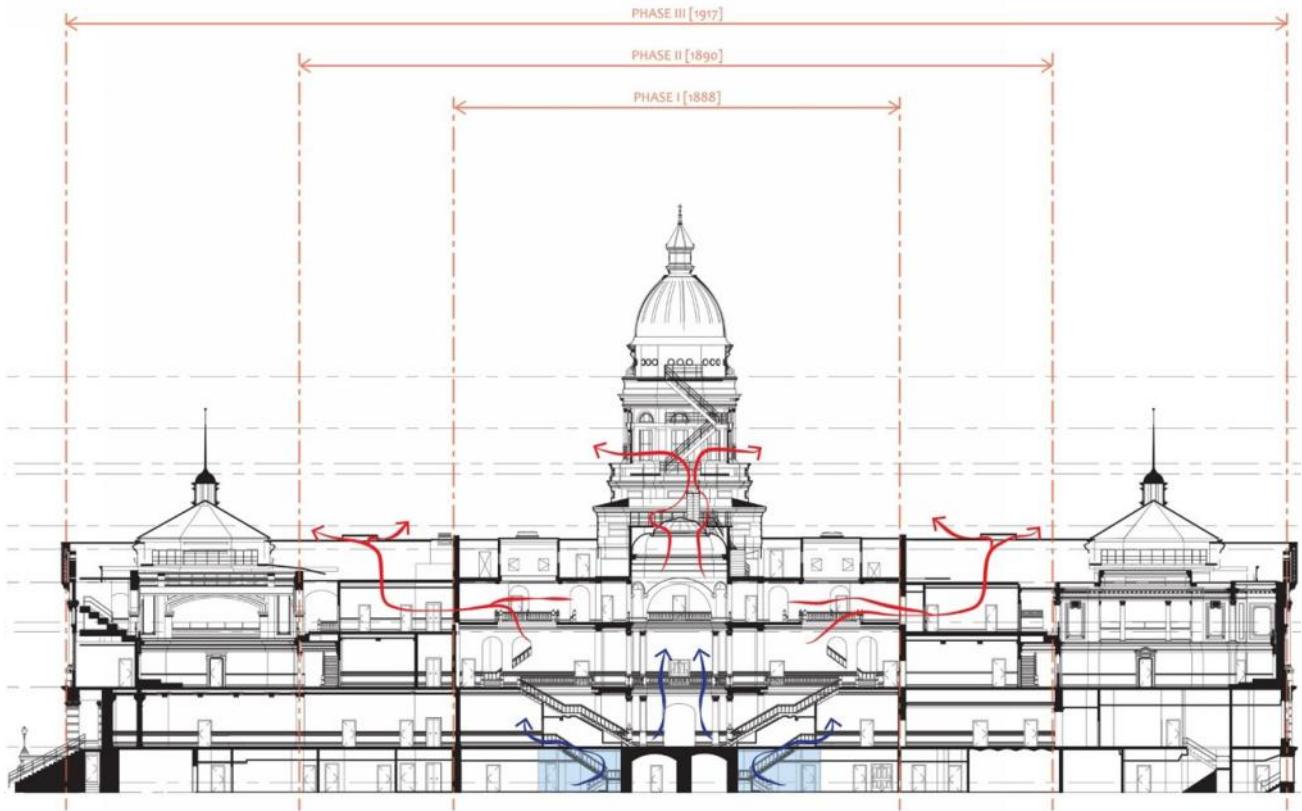
The last system is required since **the building's is a single volume structure**. In simple terms, the building's **five** levels, i.e. **Basement, First, Second, Third and Attic** are interconnected to a form a

Figure 9.1: Longitudinal Building Section [East-West] Illustrating the Proposed Smoke Evacuation System. Smoke is indicated in Red and Make-up Air is indicated in Blue.

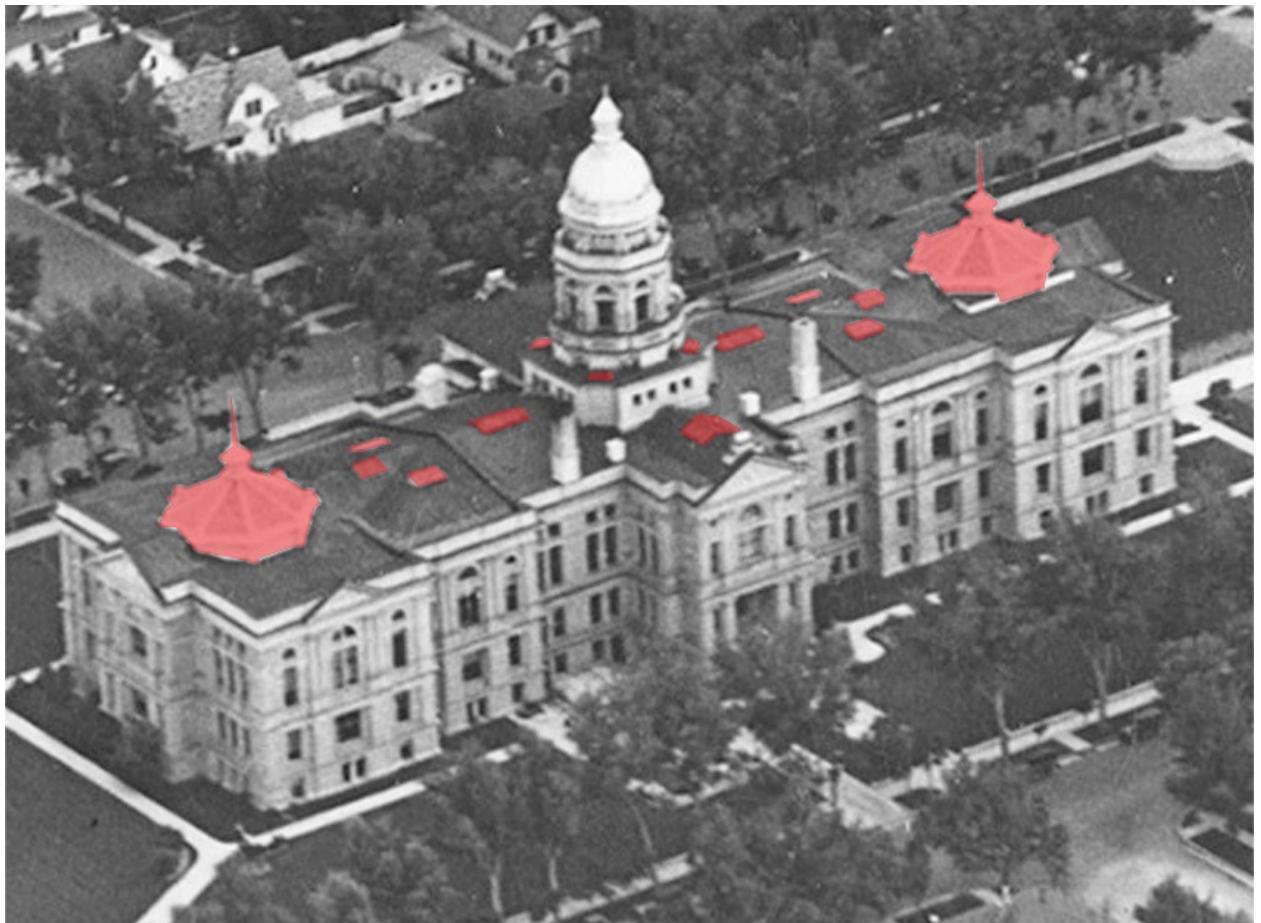
Figure 11.3: Aerial Photograph of the Capitol, ca. 1930. The Locations of the Skylights are Highlighted in Red.

- a. The original House and Senate Chamber Skylights [ornamental pyramidal roofs in aerial photo above] were replaced with a new skylight system. There are several active leaks along the edges of these skylights due to corrosion of the metal cladding.
- b. The existing standing seam metal roofs have widespread hail damage.
- c. The existing EPDM roof has numerous patches, and the maintenance staff states that they patch the roof on an annual basis. The EPDM roof is nearing the end of its useful life and will require replacement in the near future.

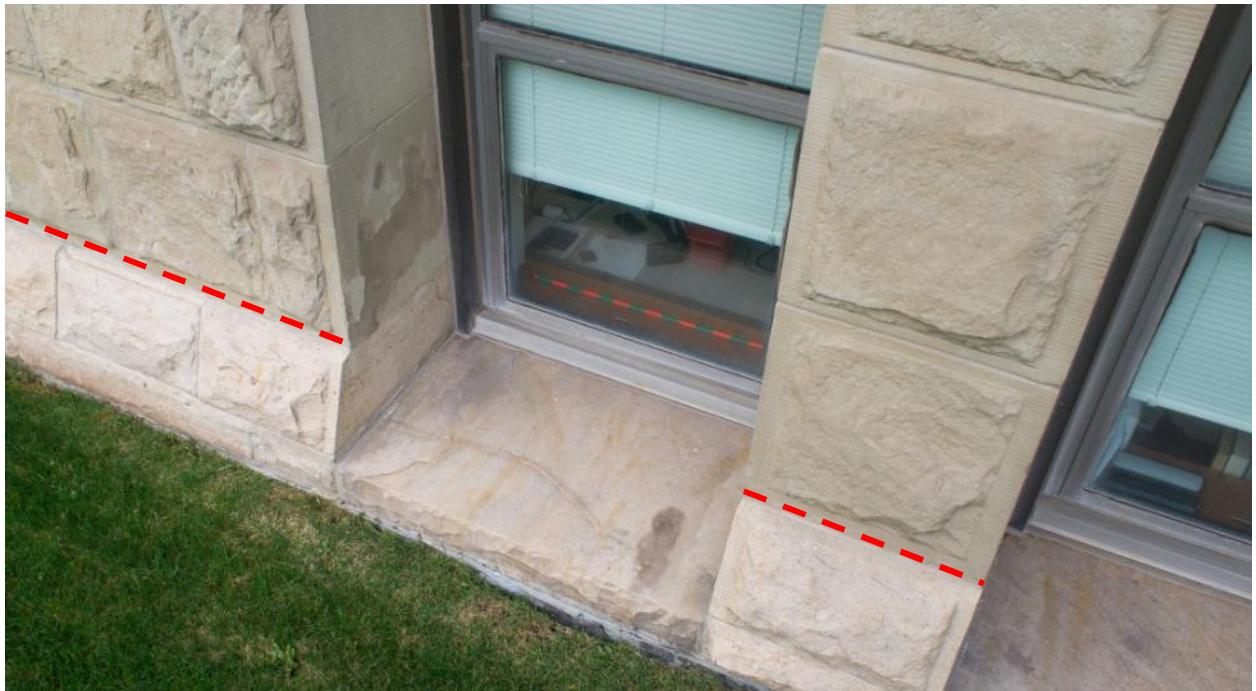
Figure 11.5: The Arrow Points to the First Two Courses of Sandstone, which is Buff/Pink Sandstone from Fort Collins, Colorado. The Remaining Sandstone is Quarried from Rawlins, Wyoming, 2013.

2. The above mechanism of moisture infiltration, freeze, expansion and delamination or cracking of stone can be a significant risk as it was demonstrated in the recent discovery over the Main Entrance of the building.

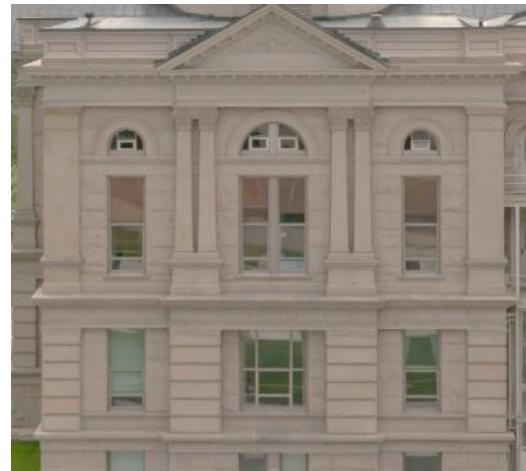
Figure 11.7: Existing North Elevation Windows.

The replacement program, a typical practice of the period, did not follow any of the best practices and preservation standards. Instead, commercial units were installed, that were significantly different in appearance and design than the original windows.

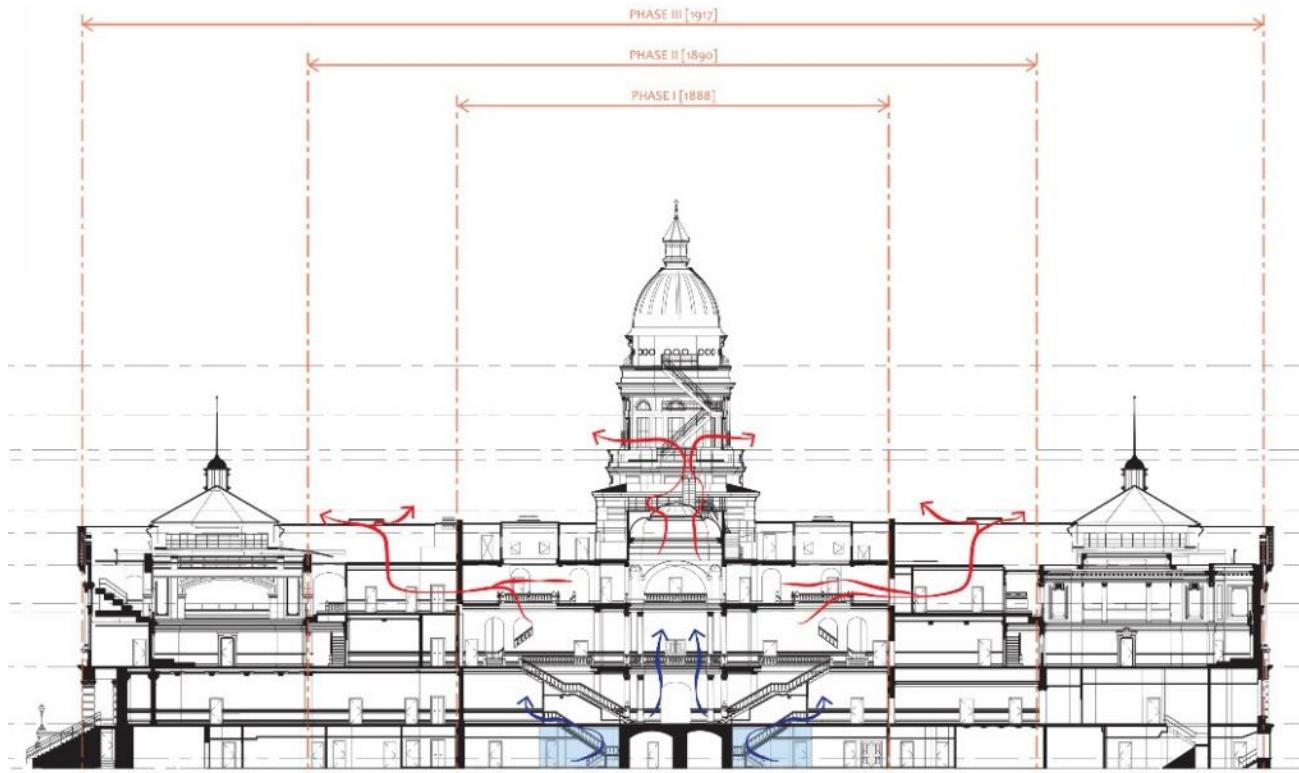
Figure 13.1: Longitudinal Building Section [East-West] Illustrating the Proposed Smoke Evacuation System. Smoke is indicated in Red and Make-up Air is indicated in Blue.

The Rotunda, the monumental stairs, the communicating stairs, the attic and the Dome, i.e. the most important architectural features of the building, are connecting all the levels of the building into a single “box”.

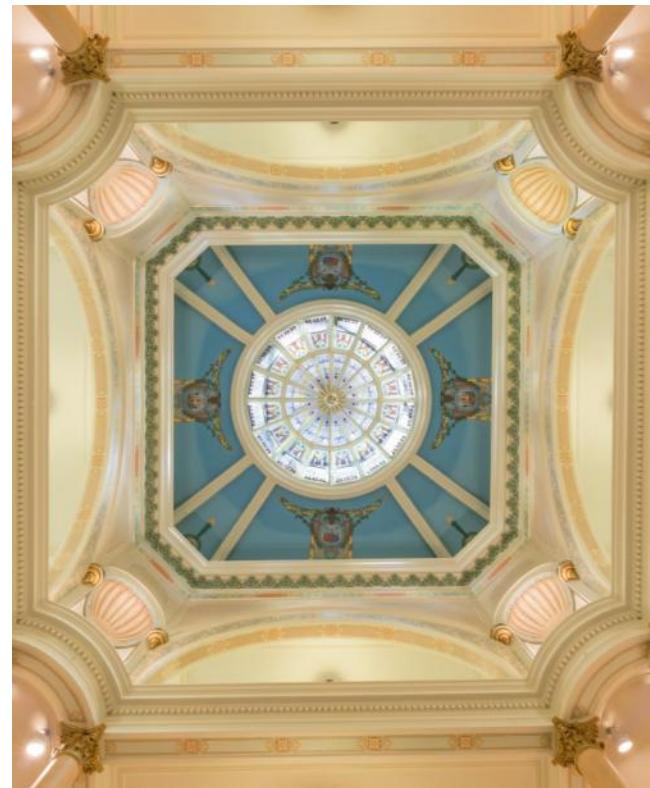
Figure 28.2: 1974-1980 Paint Scheme, 2013.

The selection of finishes was not based on historic research and factual evidence, and was done in violation of the accepted best practices and standards of the field of historic preservation.

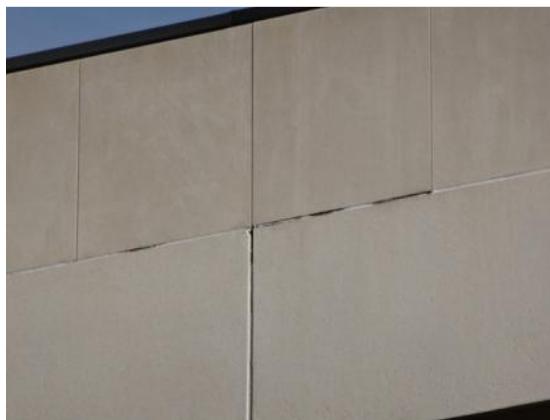
Several areas on the exterior of the building indicate a dis-coloration of the limestone and precast cladding indicating a presence of moisture. An in depth investigation is required to confirm this issue by utilizing a series of non-destructive probes to penetrate the exterior wall system for visual confirmation of the design team's concerns.

View of Existing North Herschler Façade

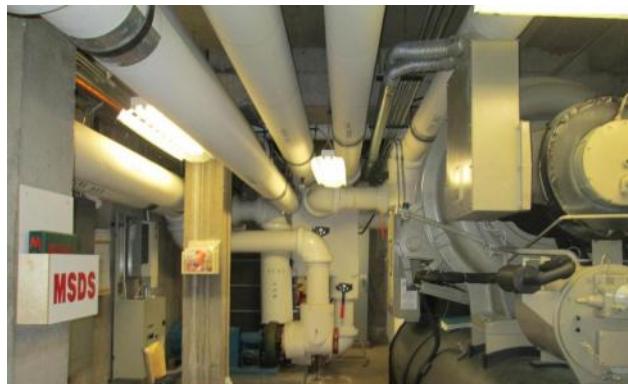
The distribution and most plant equipment are well maintained, in very good condition, and within their life expectancy (Mechanical and Electrical). The new Central Utility Plant (CUP) involves accommodating the expanded needs of the Capitol and Herschler. The best placement of the new CUP is being finalized. The security of systems is an additional component being explored and considered.

View of Existing MEP Systems at Underground CUP
