Saving Wyoming's *architectural treasure* for future generations

The first comprehensive renovation in the Wyoming Capitol's 129-year history is fixing critical safety issues, replacing outdated, failing systems and almost doubling the building's public meeting spaces.

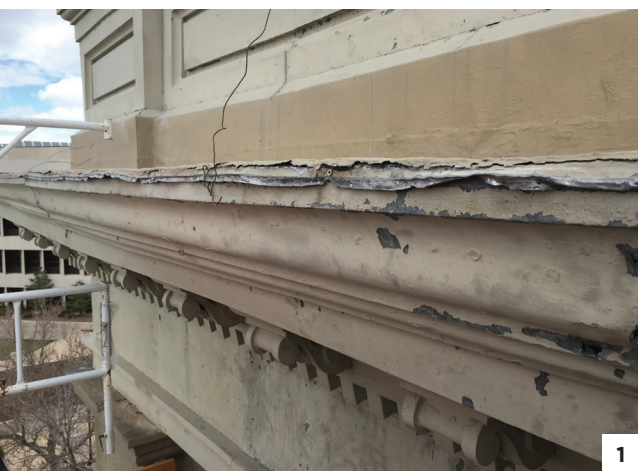
- 1 The damaged external entablature, made of sheet metal, is being replaced and a structurally sound steel system will secure it to the building.
 - 2 The repaired stone appears lighter in color but will match the rest of the sandstone as it weathers with time. The new entablature is also shown in this picture above the stone.
 - 3 The building's plumbing and steam systems are badly corroded. Water and sewer pipes suffer frequent leaks causing substantial damage.
 - 4 The removal of the dropped ceilings has uncovered hidden archways, coffered ceilings, historic paint, and decorative columns. The invasive infrastructure work necessary to repair the building allows for the restoration of many of these elements.

While the exterior sandstone is generally sound, some stones are damaged and loose, even to the point of falling off the building. To maintain the Capitol's historic look and stay cost-effective, the project will only replace stone for life safety issues and water management. Peeling paint on the metal entablature has caused corrosion

in some areas while in other places water has infiltrated the building through cracks. To fix this, the entire entablature, except for decorative elements, will be replaced.

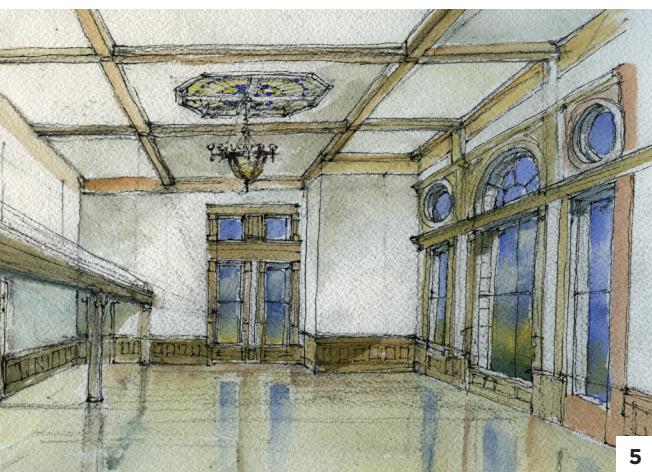
5 The restored room is envisioned in a watercolor design sketch by Paul Brown, a member of the project team. The stained glass laylight and the chandelier were in another room and will be returned to their original location in the historic chamber.

Wyoming Territorial Assembly Chamber. This spectacular room, complete with an ornate stained-glass laylight in the ceiling, will become the Capitol's largest public meeting room. The Wyoming Capitol earned its National Historic Landmark status, not for its architecture, but for its historic importance in the history of women's suffrage.

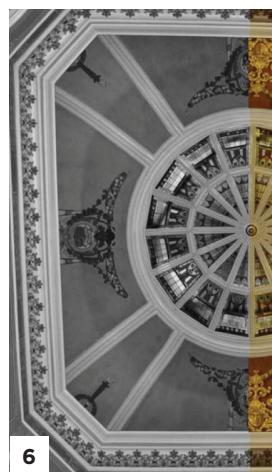
6 A comparison of what the ceiling of the Capitol Rotunda looks like today (black and white photo) and the preliminary design (far right, in color) which depicts the original 1888 design.

All of the interiors will be repainted with historic paint finishes, including the House and Senate Chambers. The decorative ceiling in the Rotunda will be returned to its 1888 design. As for the other parts of the building, as much of the historic fabric as possible will be retained. The woodwork and marble tiles are only being replaced or repaired where needed.

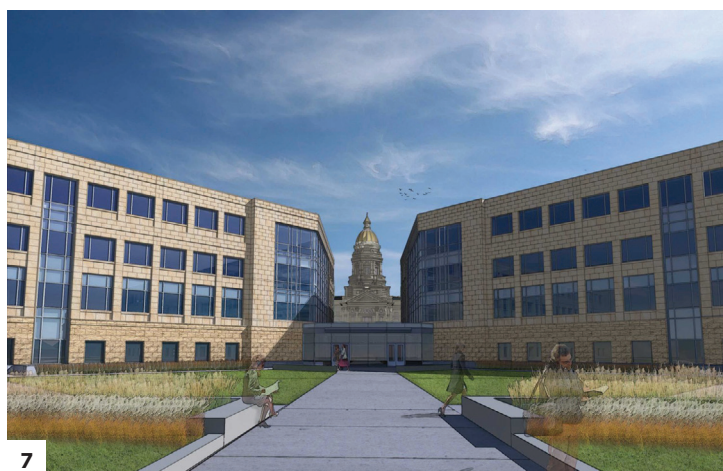
7 A design sketch showing how the removal of the Herschler Building's atrium restores the views to the Capitol.
