5.7.2 Building Interior Architectural Description

5.7.5 Building Interior

5.7.6 Building Interior Building Systems

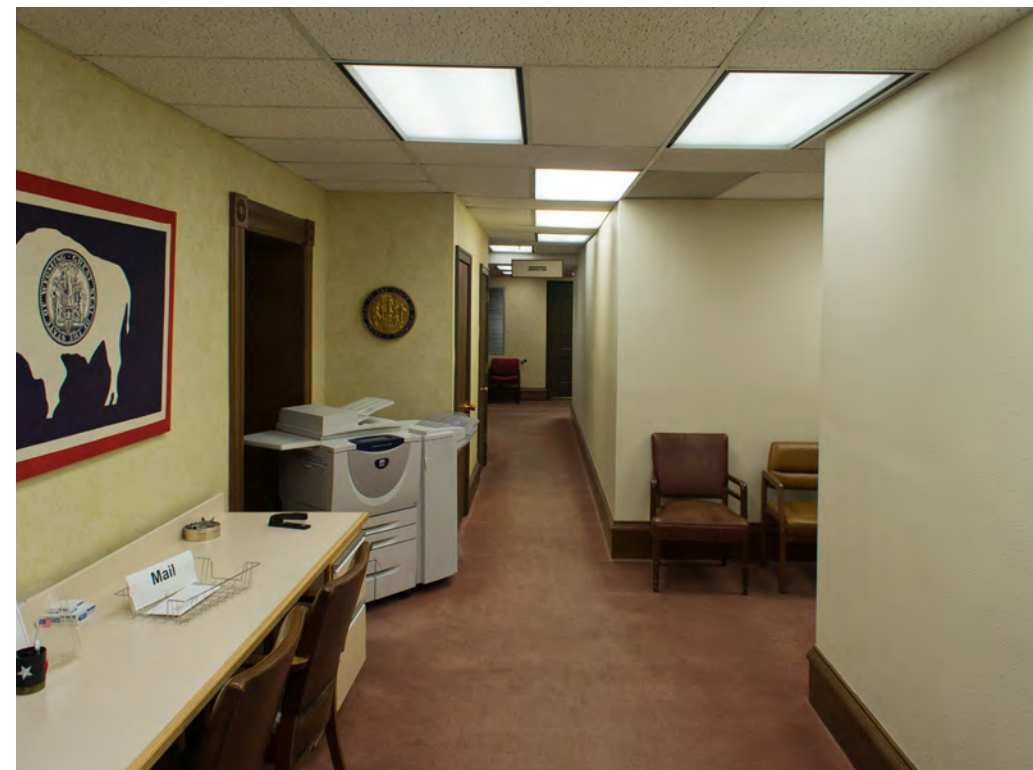
Figure 5.7.2.5: Typical Basement Level Corridor and Existing Finishes.

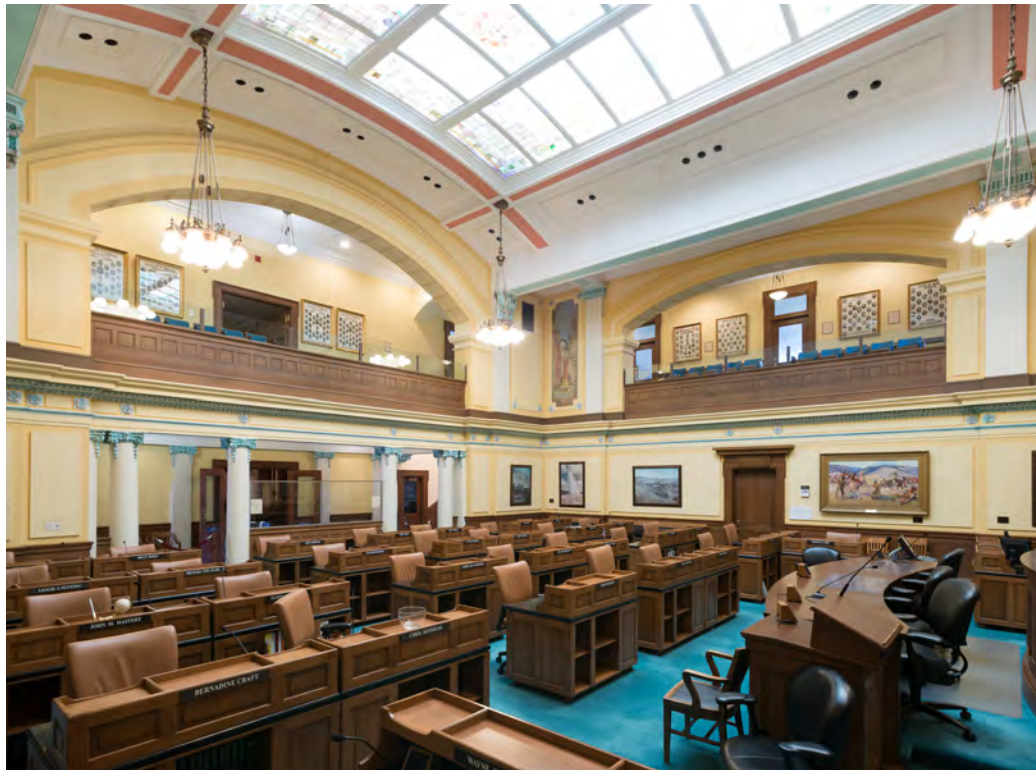
Figure 5.7.2.7: Existing Condition of the Senate Chamber.

1. All non-historic "intrusions" need to be removed [e.g. acoustical tile wall and ceiling panels];
2. Installation of new infrastructure, including HVAC, lighting, electrical and teledata;
3. Fix all areas of distress. Plaster cracking was observed in multiple locations in both the House and Senate Chambers. As discussed in detail

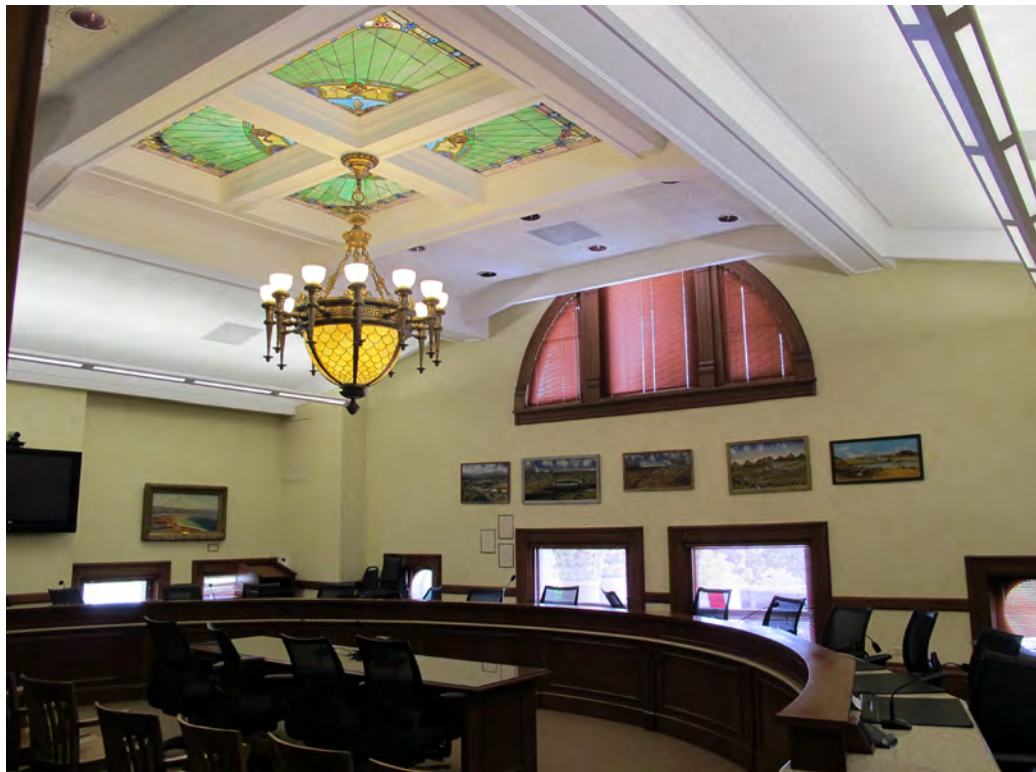
Figure 5.7.2.8: Large Public Hearing Room [Room 302] Located on the Third Floor, South of the Rotunda.

1. Small Committee Rooms that are undersized and their narrow geometry and layout are not conducive to public participation.
2. Large Committee Room - specifically Room 302 - which was recently renovated and is more in line with recommended space requirements for modern committee rooms.

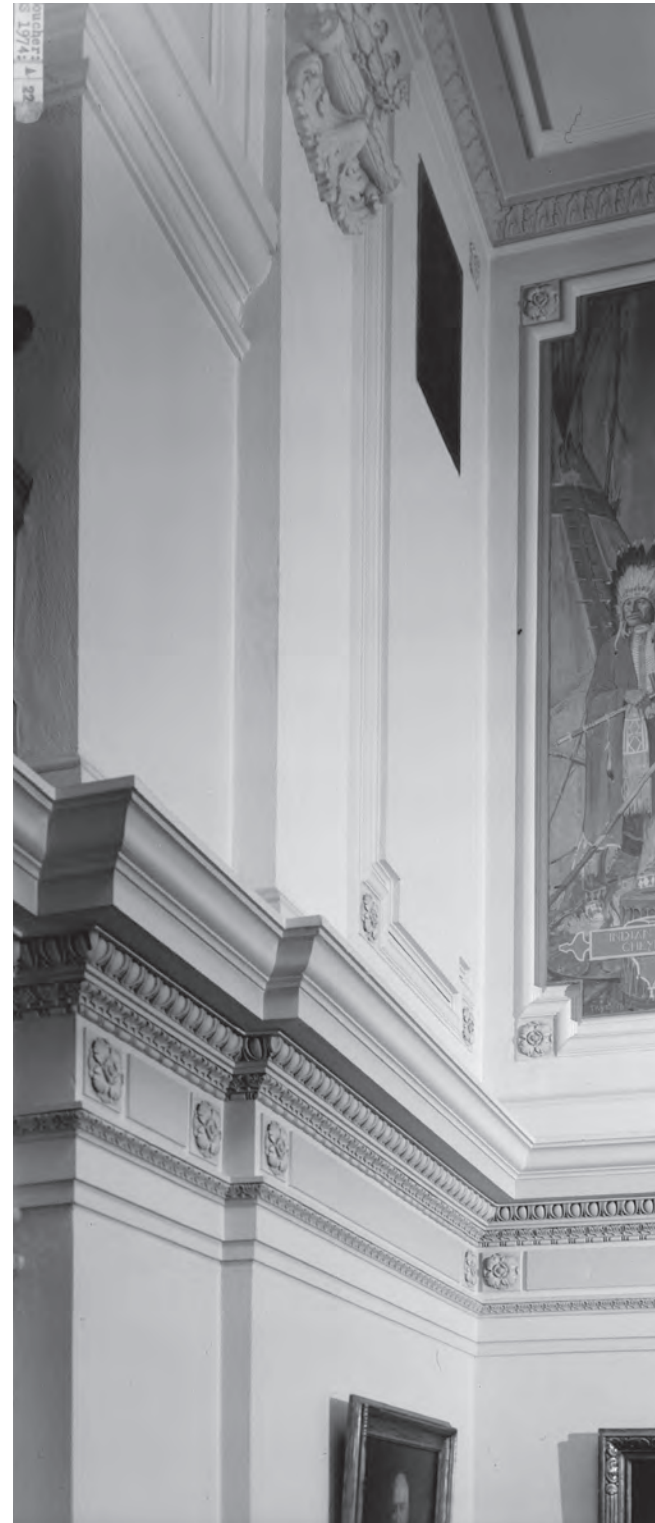
Figure 5.7.3.29: Senate Chamber HABS Photograph, ca. 1974.

Photographs taken during the Historic American Buildings Survey [HABS] of 1974 reflect the finishes scheme seen today. [Figure 5.7.3.29] The darker wall colors and gilded detailing have been replaced with a collection of yellow, green and white pastels. Panels of acoustical tile were added to the walls and ceiling, and various paintings are hung throughout. Moreover, the unadorned green carpeting differs from the patterned carpeting visible in the 1917 and 1927 photographs. [Figure 5.7.3.30]

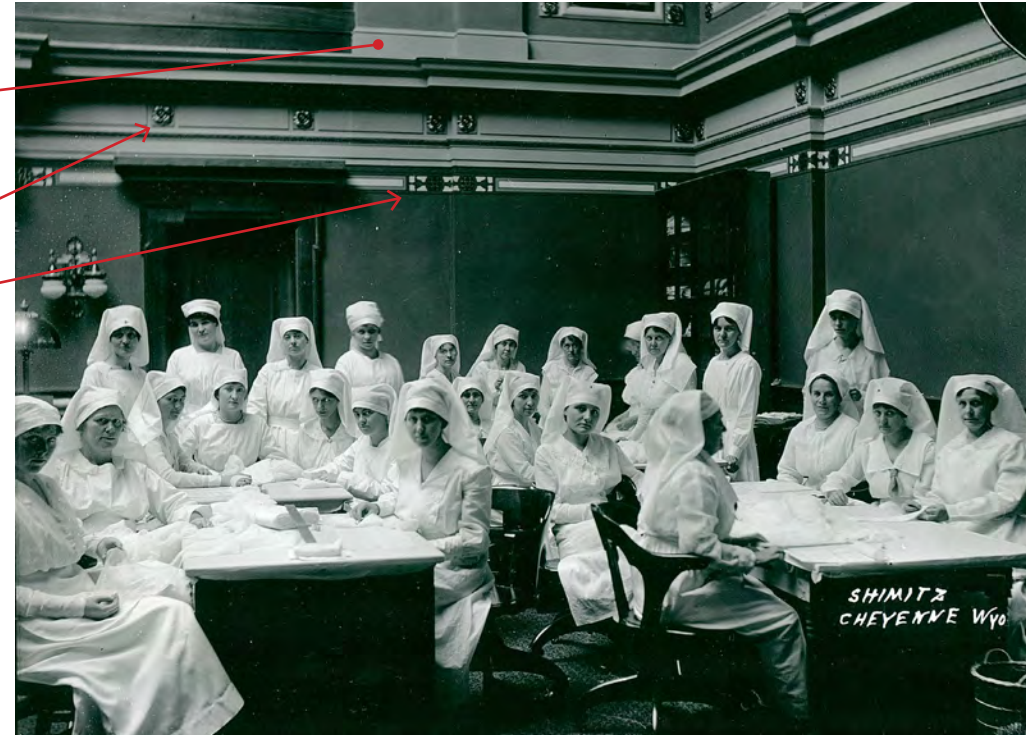
Figure 5.7.3.30: Senate Chamber, ca. 1917.

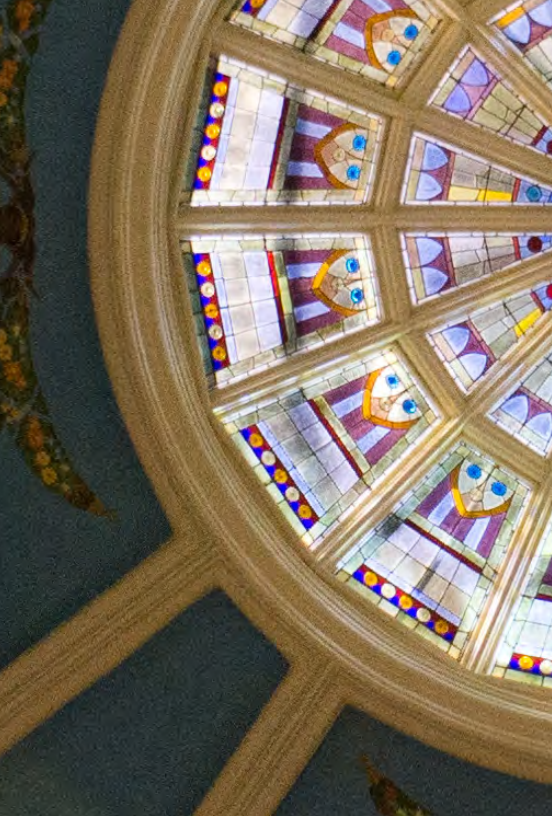
Figure 5.7.4.12: Existing Condition Around the Rotunda Laylight, Without Exposed Incandescent Fixtures.
